MPR-SAT-FE-71-1

APRIL 1, 1971

SATURN V LAUNCH VEHICLE FLIGHT EVALUATION REPORT-AS-509 APOLLO 14 MISSION

PREPARED BY
SATURN FLIGHT EVALUATION WORKING GROUP

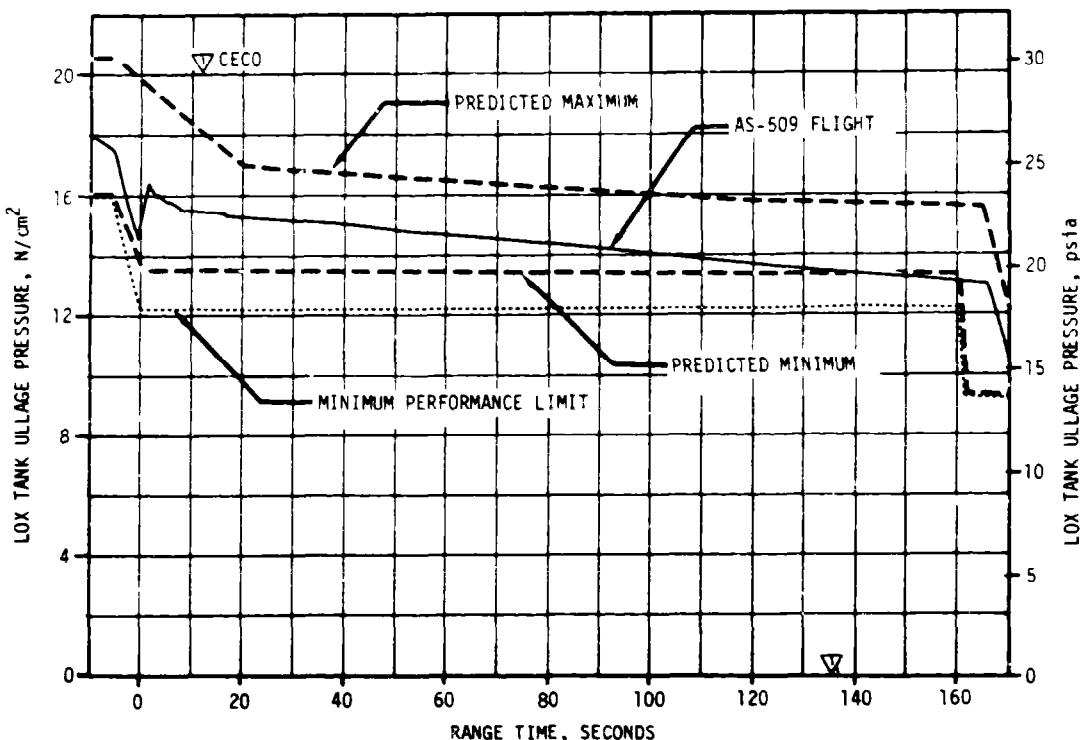
Figure 5-5. S-IC LOX Tank Ullage Pressure

This was the first flight with ECP 3003 incorporated which replaced the GFCV with a venturi. Ullage pressure was maintained within the predicted limits until center engine cutoff. See Figure 5-5. Although

Ullage pressure decreased to slightly below the prediction after CECO, it was still well above the pressure required to prevent flash boiling. The maximum GOX flowrate to the tank after the initial transient was 46.9 lbm/s at CECO. The performance of the heat exchangers was as expected.

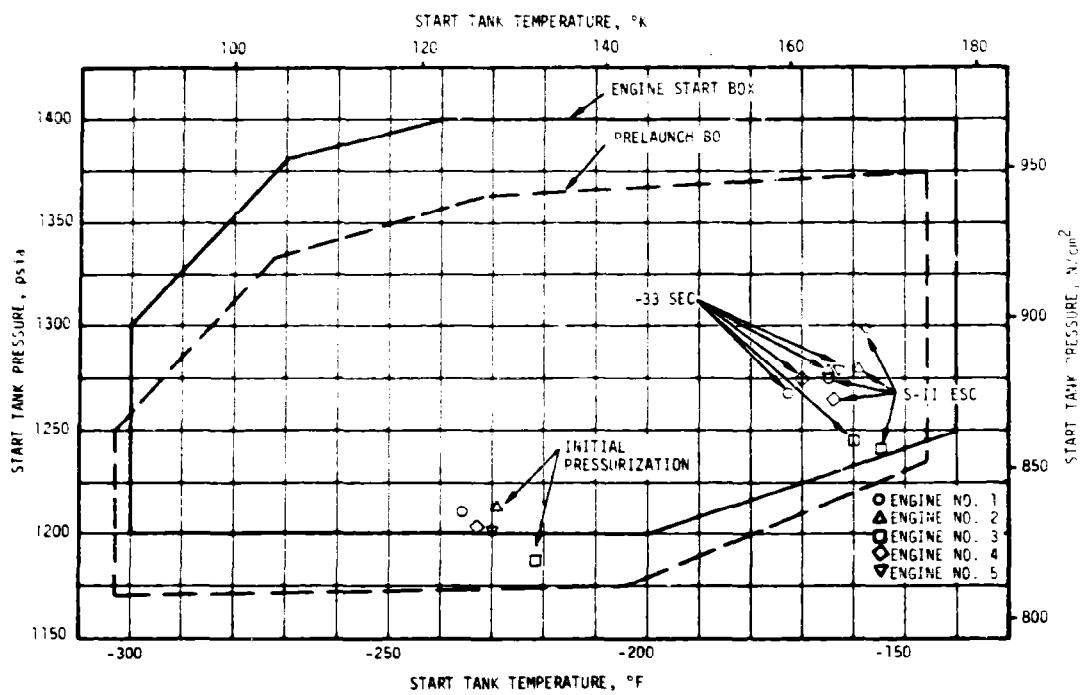
Figure 6-1. S-II Engine Start Tank Performance

Both temperature and pressure conditions of the J-2 engine start tanks were within the required prelaunch and engine start boxes as shown in Figure 6-1. Initial start tank pressurization normally occurs after thrust chamber chill is initiated resulting in nominal start tank temperatures at the time of vent valve closure of approximately -310°F. During initial start tank pressurization the temperature increases from 30 to 40°F and would normally read approximately -270 to -260°F. However, as a result of initiating countdown hold option No. 2 prior to thrust chamber chill, lockup temperatures were between -240 and -225°F or about 40°F warmer than usual.

Total time elapsed between start tank pressurization and S-II engine start including hold time, countdown time, and S-IC boost, was approximately 2550 seconds (00:42:30). During the hold, the start tank temperature increased approximately 85°F. Between pressurization and liftoff the start tanks were vented (using ground emergency vents) at least five times each in order to maintain start tank pressures below 1280 psia (which corresponds to the lowest relief valve setting) to prevent actuation of the relief valves. The actual relief valve settings vary inversely with the start tank temperatures; therefore, as a result of the initial pressurization occurring at a warmer temperature and the subsequent start tank warmup during the hold, the relief valve settings apparently were lower than 1280 psia. Engines No. 1, 2, and 4 start tank vent and relief valves relieved after liftoff at least one time

prior to engine start. Engine No. 3 appeared to be relieving prior to liftoff and through S-IC boost. Although this venting is not desirable, it is considered by the engine contractor to be expected with such an increase in start tank temperature.

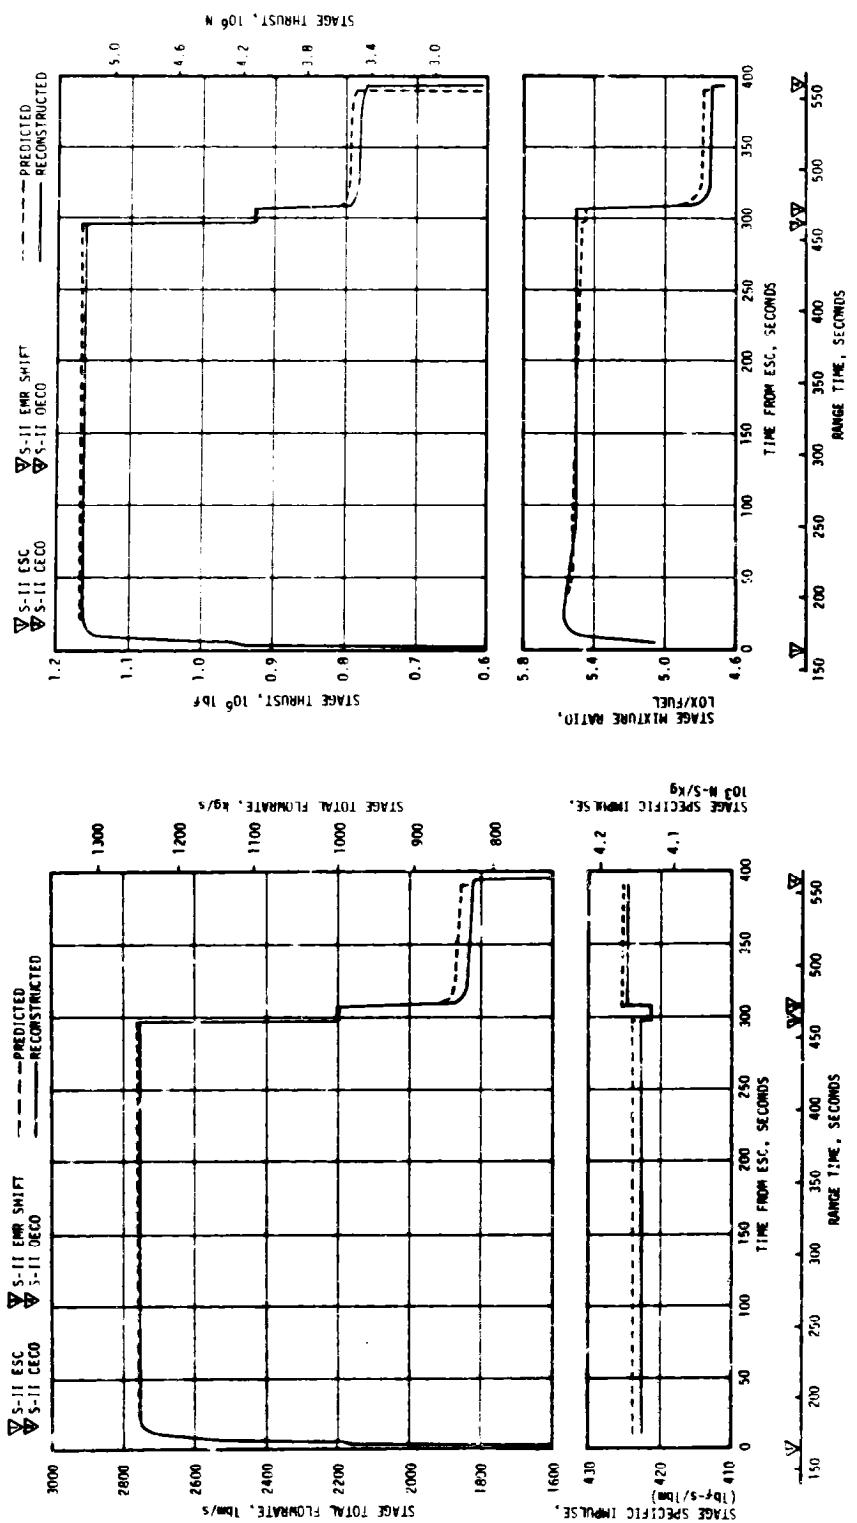
Figure 6-3. S-II Steady State Operation

and mixture ratio versus time is shown in Figure 6-3. Stage performance during the high EMR portion of flight (prior to CECO) was very close to predicted. At the time of ESC +61 seconds, total stage thrust was 1,164,464 lbf which is 2931 lbf (0.25 percent) below the preflight prediction. Total propellant flowrate, including pressurization flow, was 2753.4 lbm/s, 0.12 percent below predicted. Stage specific impulse, including the effect of pressurization gas flowrate, was 422.9 lbf-s/lbm, 0.19 percent below predicted. Stage propellant mixture ratio was 0.18 percent above predicted.

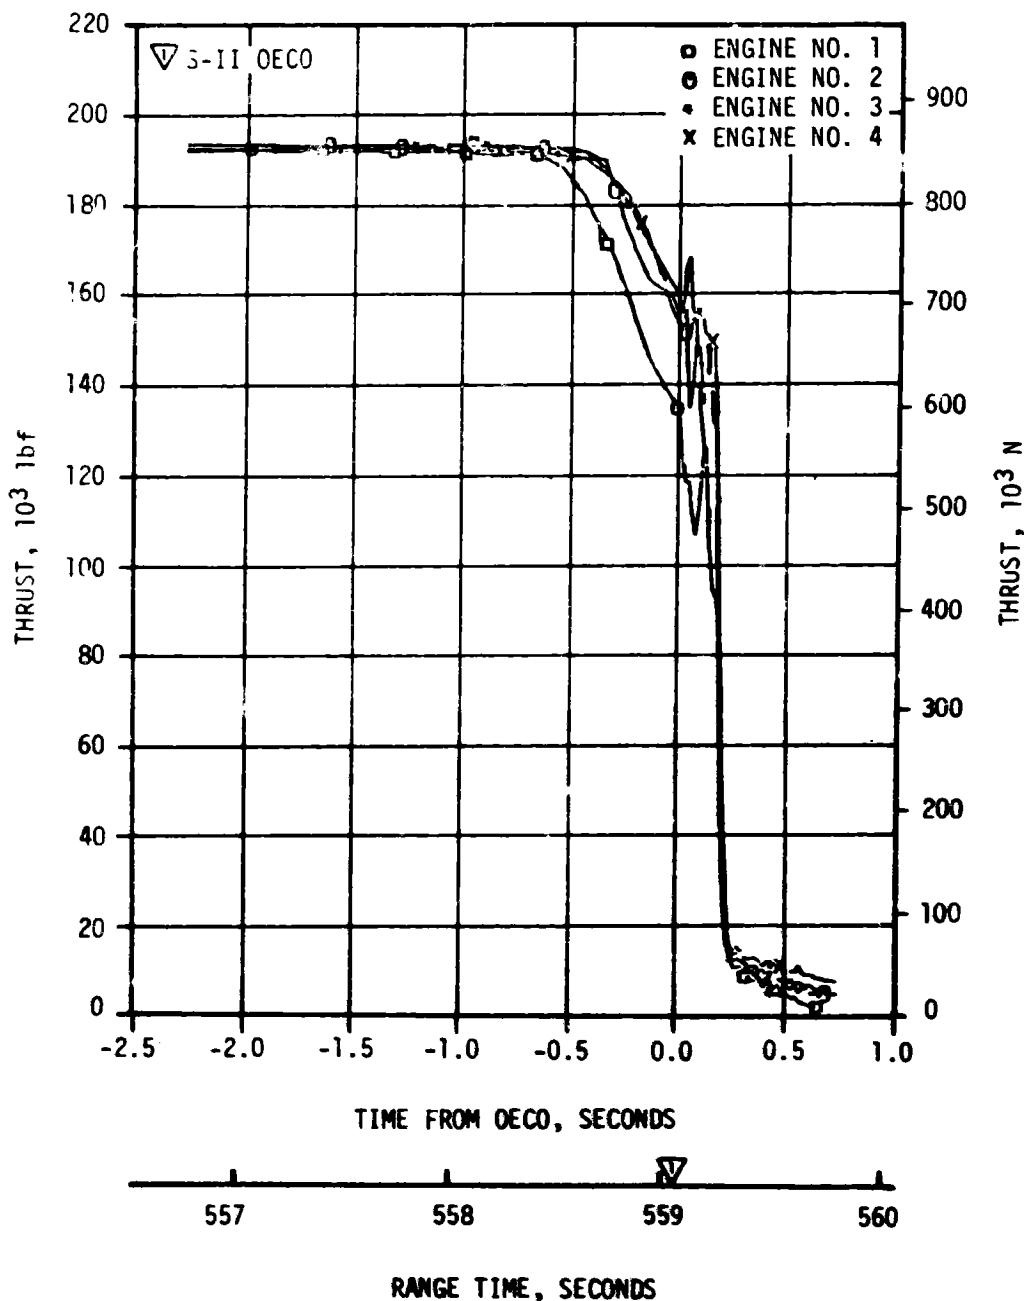
Figure 6-4. S-II Outboard Engine Chamber Pressure Decay

Again, the largest thrust chamber pressure decay was noted on engine No. 1 with first indications of performance change visible at 0.68 second prior to the cutoff signal. See Figure 6-4. Total pressure decay on engine No. 1 was 230 psi while the other three outboard engines were approximately 115 psi over this interval.

Outboard engine cutoff was initiated by the LOX tank propellant depletion system (with a 1.5-second OECO time delay) 2.2 seconds later than predicted due primarily to the lowered propellant flowrates at low EMR. The open-loop PU error at OECO was approximately -375 lbm LH₂ versus a 3-sigma tolerance of ± 2500 lbm LH₂. Based on flowmeter and point sensor system data, propellant residuals in the tanks at OECO were 1213 lbm LOX and 2960 lbm LH₂ (versus 1802 lbm LOX and 3441 lbm LH₂ predicted). These lower than predicted residuals resulted from the use of a 4.8 EMR at OECO for the first time.

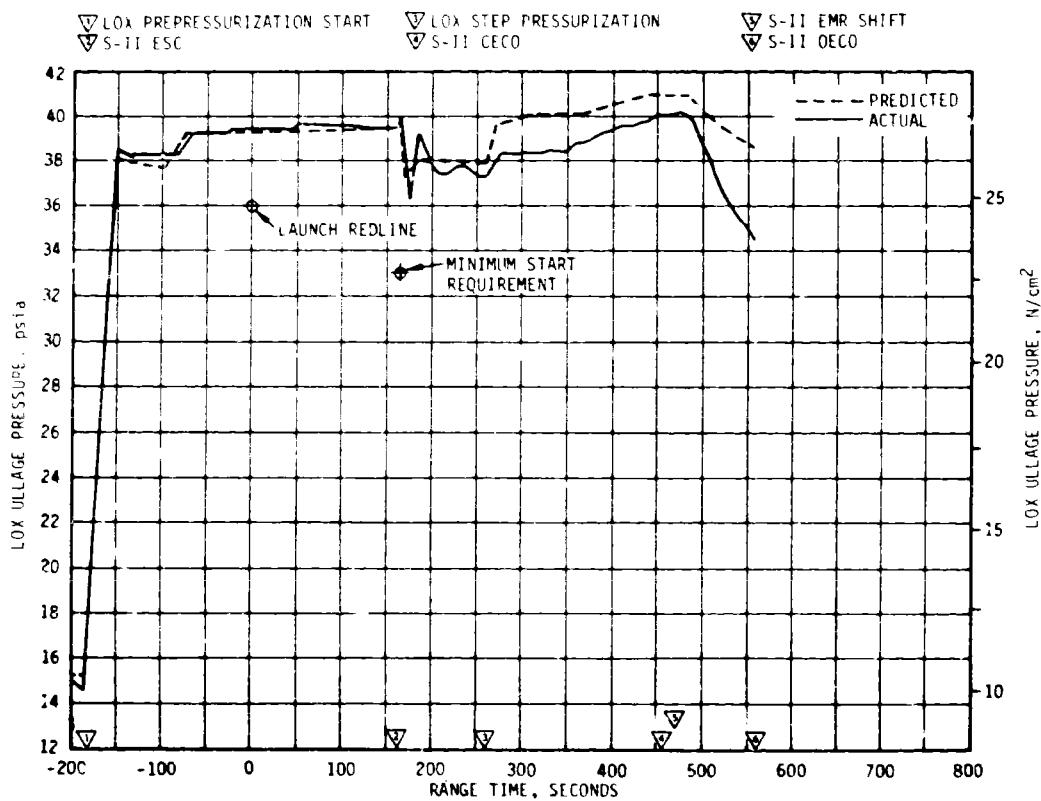
Figure 6-7. S-II LOX Tank Ullage Pressure

As seen in Figure 6-7, the LOX ullage pressure did not increase as rapidly as predicted after the LOX step pressurization command. The LOX pressure regulator potentiometer and oxidizer manifold pressure measurements were used to conclude that the slow pressure rise was a

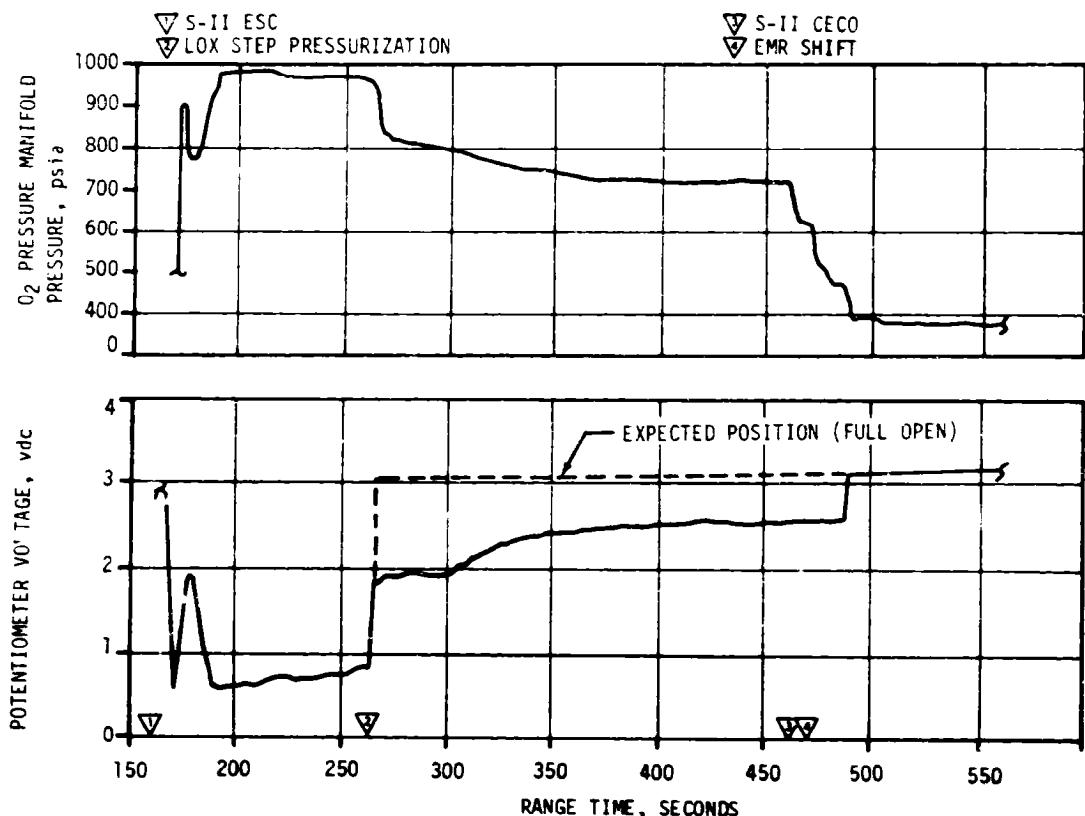
Figure 6-8. S-II Oxidizer Manifold Pressure and Regulator Potentiometer Profiles

Because the regulator was only partially open, it required less mass (approximately 325 lbm less) at a warmer temperature to have the ullage pressure near the predicted pressure level at EMR step. Upon shifting to low EMR, the regulator inlet pressure dropped below the minimum required pressure (450 psia) necessary to keep the bias portion on the regulator active. When the bias portion became inactive, the regulator power bellows lost its force term tending to hold the butterfly closed and permitted the butterfly to go to its maximum opening.

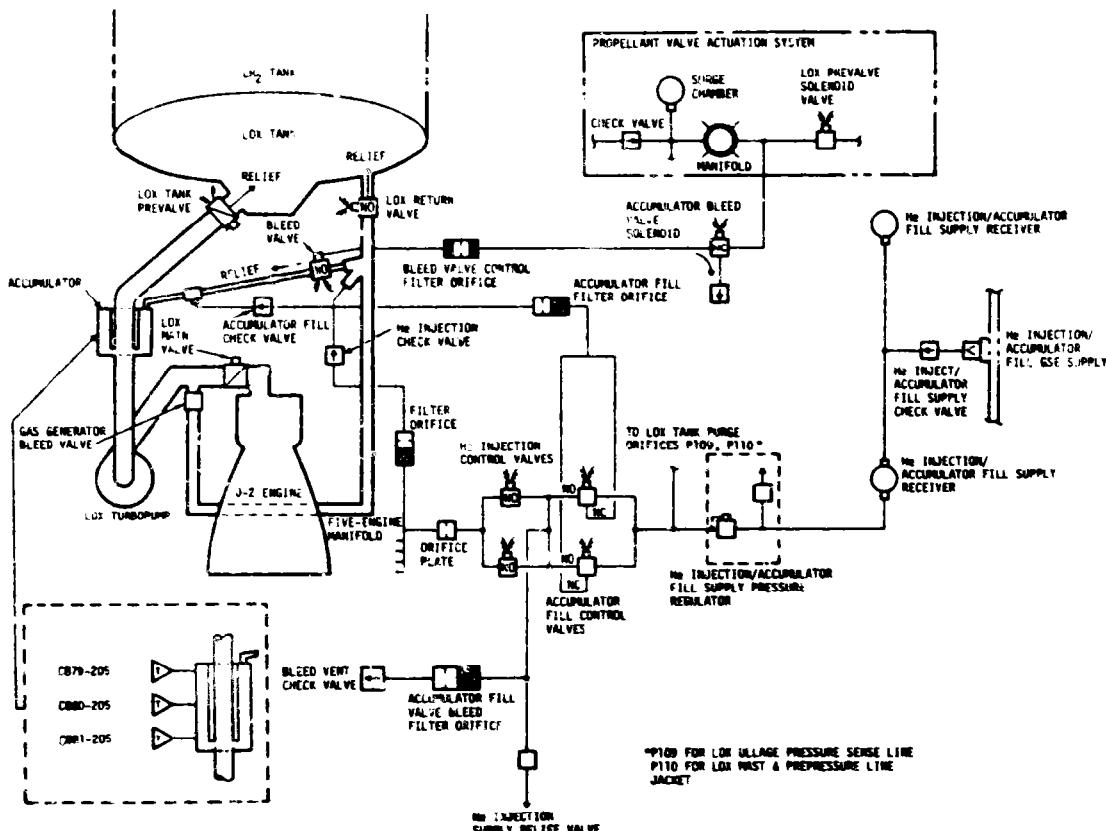
Figure 6-11. S-II LOX Center Engine Feedline Accumulator and Helium Injection System

A center engine LOX feedline accumulator was installed for the first time on this flight as a POGO suppression device. Propulsion/structural analysis indicates that the accumulator did suppress the S-II POGO oscillations. See paragraph 8.2.3 for complete details. A schematic of the POGO suppression system is shown in Figure 6-11.

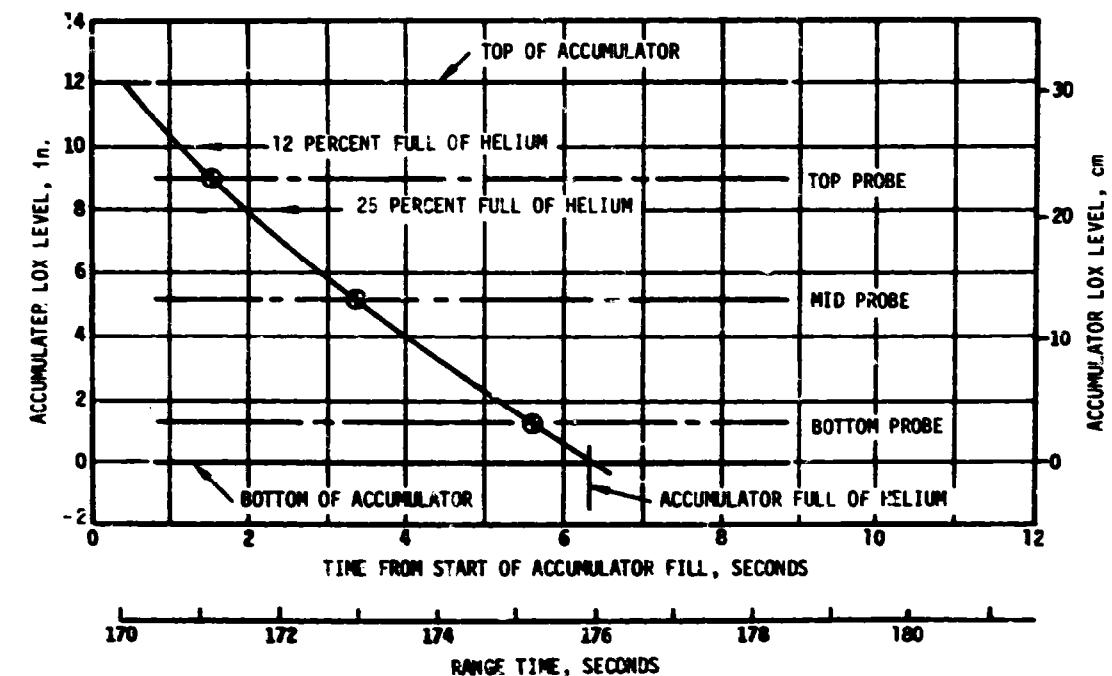
Figure 6-13. S-II Center Engine LOX Feedline Accumulator Fill Transient

Figure 6-13 shows accumulator LOX level versus time during the fill transient as determined from the time the three accumulator temperature probes indicated dry. Based on these data, the accumulator was full of helium 6.3 seconds after the start of fill, thus meeting the 5 to 7 second fill time requirement. After the accumulator was filled with helium (just after engine start), it remained in that state until CECO when the helium flow was terminated and LOX backed up into the accumulator due to the post-CECO feedline pressure buildup. There was no sloshing or abnormal liquid level behavior observed in the accumulator while the center engine was operating. Figure 6-14 shows the performance of the helium supply portion of the accumulator fill system.

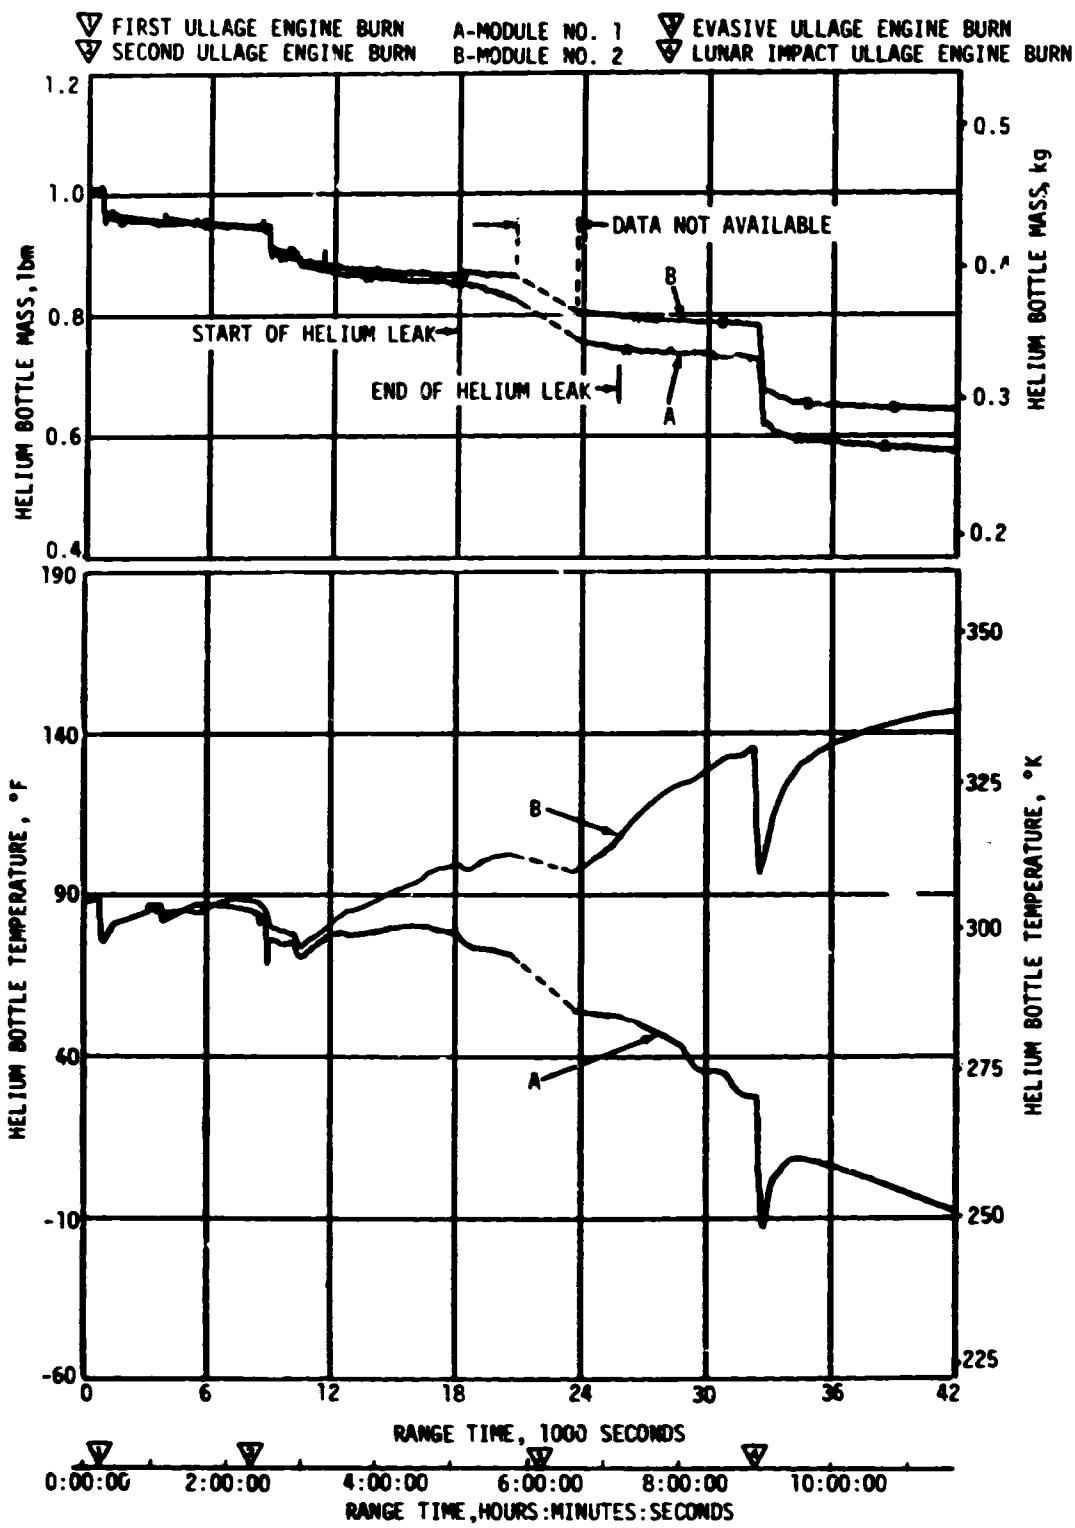
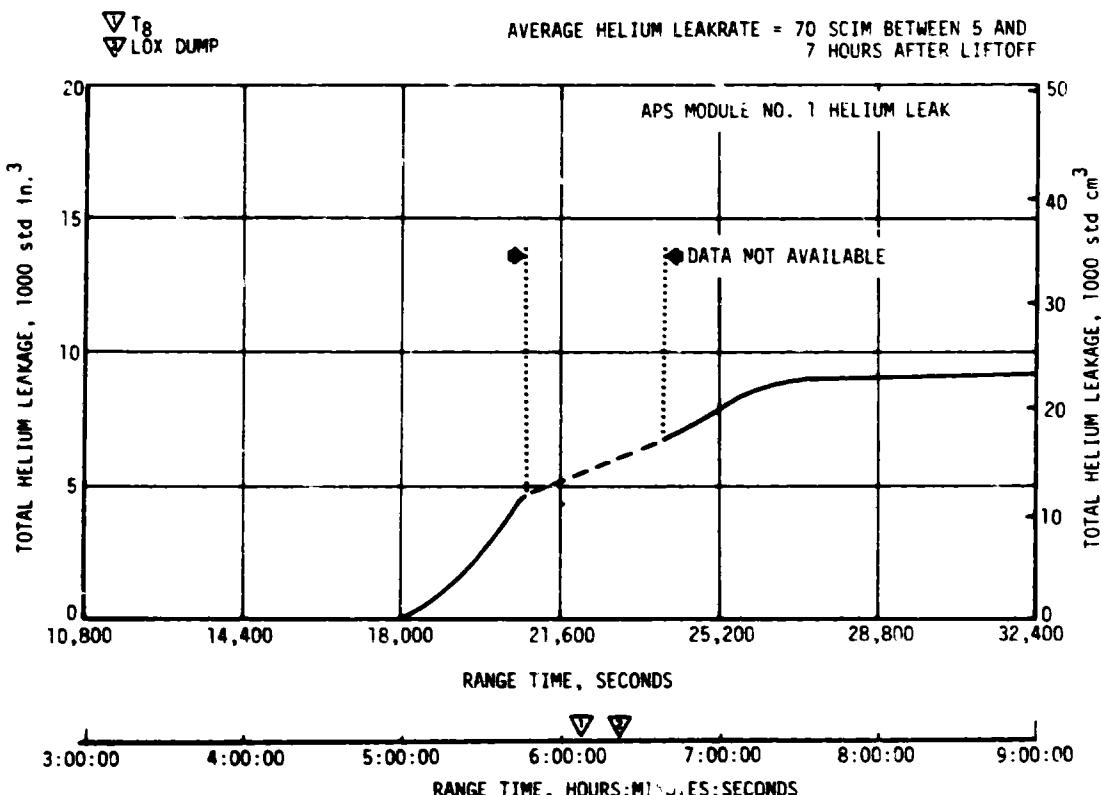
Figure 7-16. APS Helium Bottle Conditions (Sheet 1 of 2)

The APS pressurization systems demonstrated nominal performance throughout the flight with the exception of a helium leak in Module No. 1. The leak started at approximately 5 hours and continued until approximately 7 hours as shown in Figure 7-16. The average leak rate was about 70 SCIM during this 2 hour period. The total helium leakage was approximately 0.05 lbm which is 5 percent of the quantity loaded. Figure 7-16 shows the helium bottle masses and temperatures for Module No. 1 and 2. As in flights AS-504 and AS-505 when helium leaks were observed, the leak occurred in the cold module when the helium bottle temperature began to decrease. The leak rate for this flight was less than those previously experienced. AS-504 had a leak rate of approximately 235 SCIM while AS-505 had a leak rate of 180 SCIM. The allowable helium leak at liftoff is 60 psi/hr which is equivalent to a 63 SCIM leakage. As in the AS-504 and AS-505 flights there is no way of determining where in the system the leak is occurring. The magnitude and duration of this leak was not large enough to present any problems.

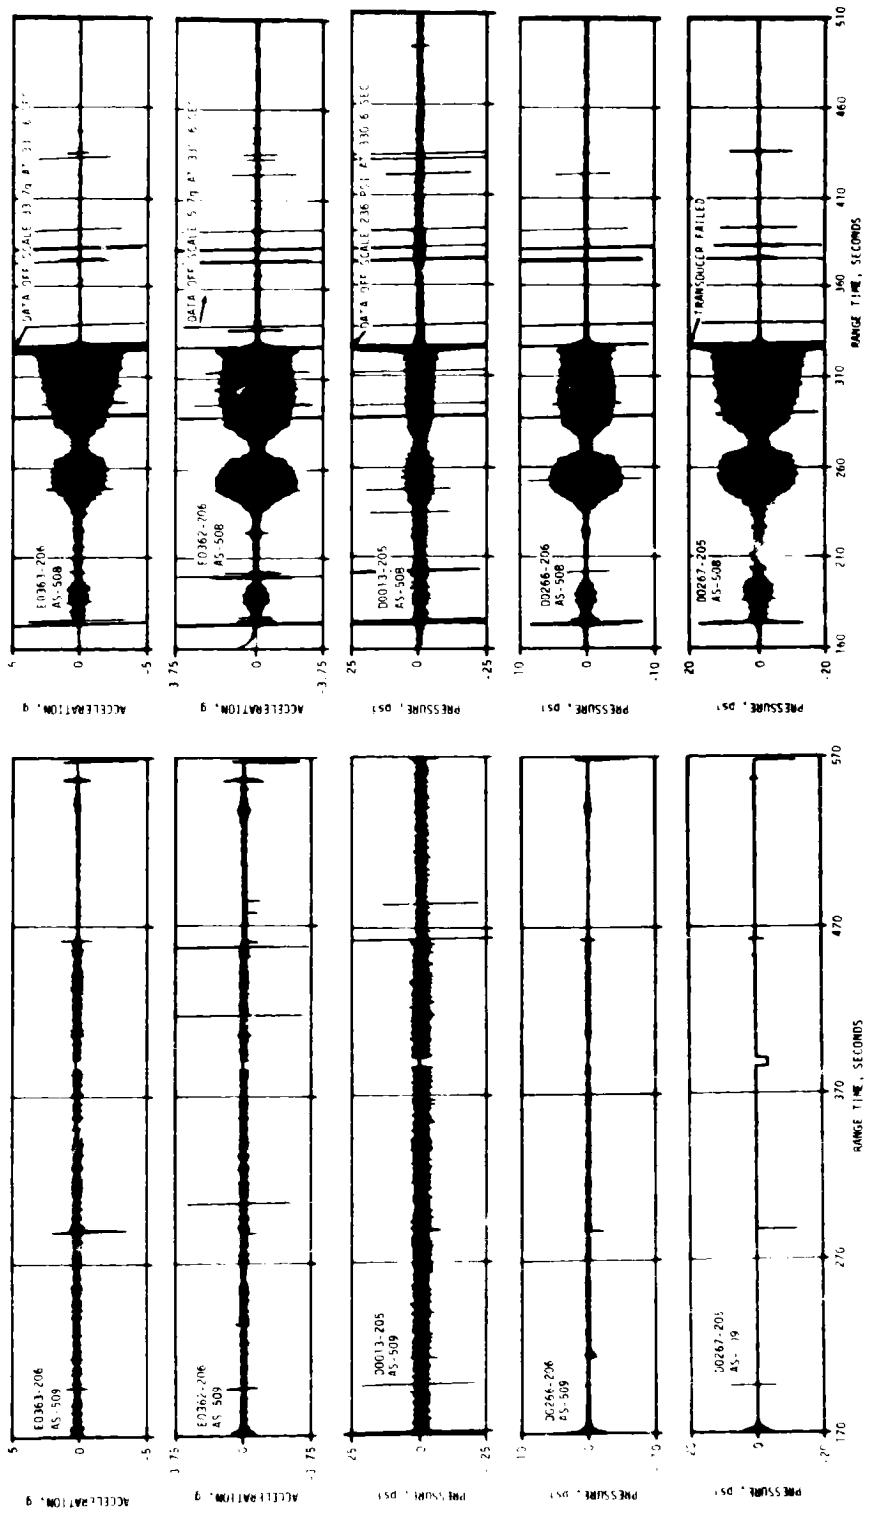
Figure 8-6. AS-509/AS-508 Acceleration and Pressure Oscillations During S-II Burn (8 to 20 Hz Filter)

The S-II 14 to 16 hertz POGO oscillations encountered on AS-508 were not observed on AS-509. The AS-509 vehicle incorporated a center engine accumulator in the LOX feedline of the S-II stage to inhibit such oscillations by "de-tuning" or uncoupling the structural and propulsion responses. Figure 8-6 shows a comparison between the AS-508 levels and the responses seen on AS-509. The peak gimbal pad response of approximately ± 33.7 g (reconstructed value) on AS-508 compares to a peak response of ± 0.6 g on AS-509. The ± 0.6 g level is typical of the maximum response throughout the steady-state regime when the center engine was operational. The effectiveness of the accumulator system in suppressing the POGO oscillations generally exceeded expectations.

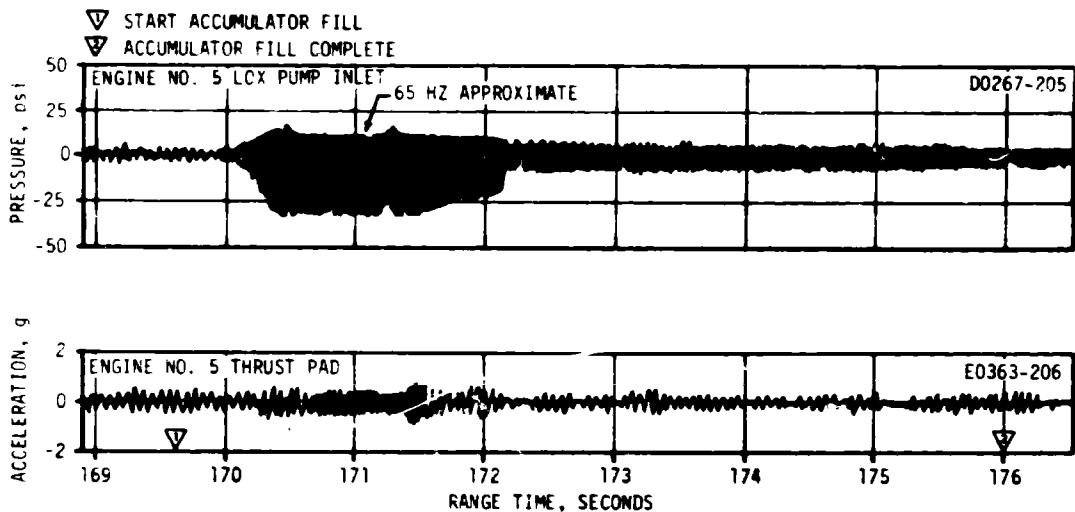
Figure 8-7. AS-509 Pump Inlet Pressure and Thrust Pad Acceleration Oscillations during Accumulator Fill Transient (0 to 110 Hz Filter)

at 16 hertz. Details of accumulator operation can be found in paragraph 6.9. The response of the center engine gimbal pad during accumulator fill was about ± 0.8 g as shown in Figure 8-7, well within the expected value. During the fill of the accumulator, the center engine LOX inlet pressure underwent a buildup that was sustained for a short time interval. This buildup to a maximum of about 44 psi peak-to-peak with a frequency of about 65 hertz is shown in Figure 8-7. This phenomena was expected since it had been noted on several static firings. The static firing of S-II-15 displayed a similar trend with a pressure buildup of about 37 psi peak-to-peak with a frequency content of about 80 hertz. Evidence of the 65 to 80 hertz frequency can be seen in the center engine gimbal pad at a very low amplitude of less than ± 0.5 g. This low level shows that there is no strong coupling between the pressure pulses at the pump and structural response; likewise, there is no evidence that these phenomena contributed to any engine performance degradation.

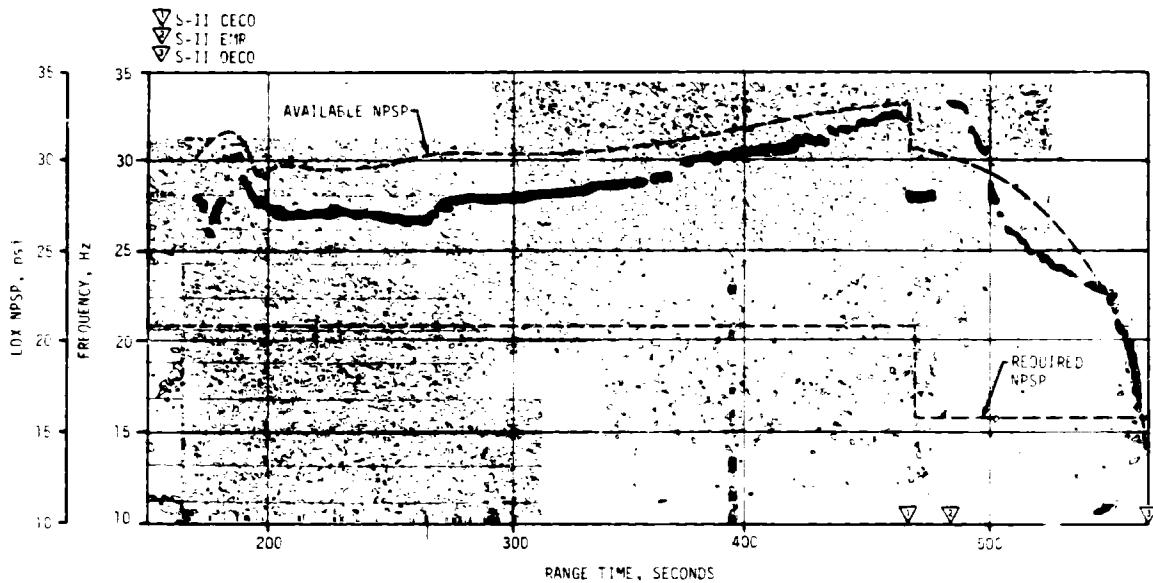
Figure 8-8. S-II Engine No. 1 LOX Pump Inlet Pressure Contourgram/NPSP Comparison

which is considered significant is the probable definition of the fundamental mode of the outboard LOX feedline. Figure 8-8 shows a contourgram of the amplitude/frequency density of the engine No. 1 LOX pump inlet pressure. The solid line has been sketched on top of the contour to indicate the frequency time history trend of the outboard LOX line. Sensitivity of the line frequency to NPSP and EMR can be inferred by comparing the trends of NPSP with the suggested fundamental feedline frequency (Figure 8-8).

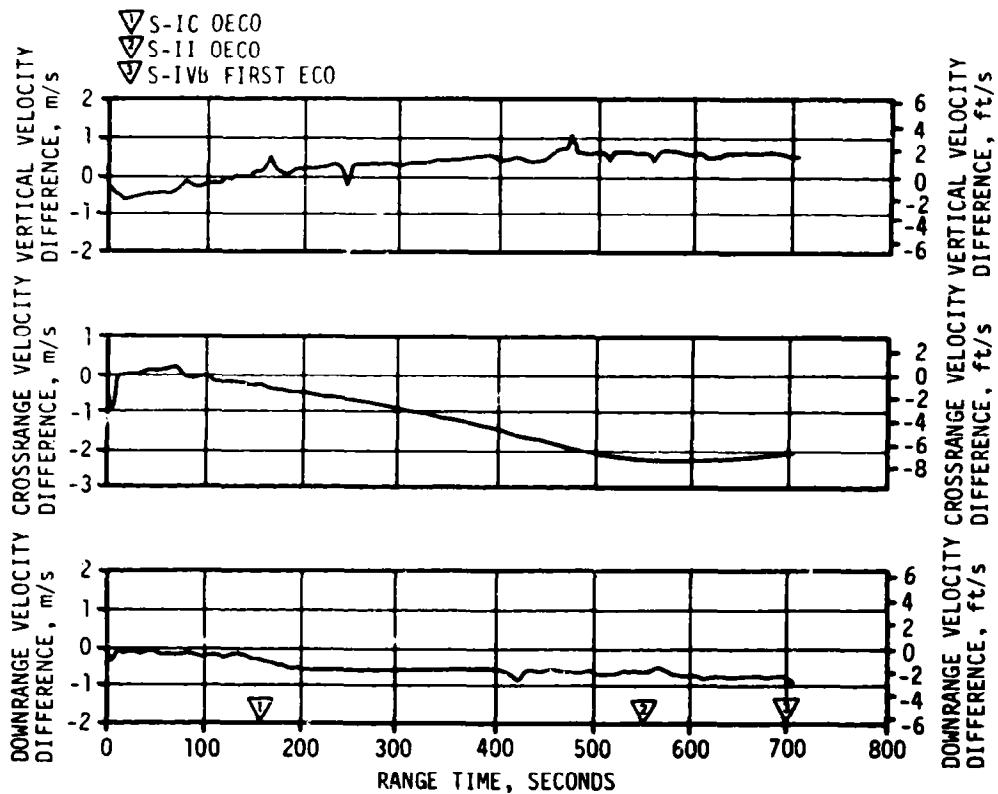
Figure 9-1. Trajectory and ST-124M-3 Platform Velocity Comparison
Boost-to-EPO (Trajectory Minus Guidance)

The postflight guidance error analysis was based on comparisons of the ST-124M-3 platform system measured velocities with the final postflight trajectory established from external tracking data (see paragraph 4.2). Velocity differences for boost-to-Earth Parking Orbit (EPO) are shown in Figure 9-1. A positive difference indicates trajectory data greater than the platform system measurement. The velocity differences at first S-IVB Engine Cutoff (ECO) were 0.30 m/s (0.98 ft/s), -2.09 m/s (-6.86 ft/s), and -0.82 m/s (-2.69 ft/s) for vertical, crossrange, and downrange velocities, respectively. These differences are relatively small and well within the accuracy of the data compared and the expected hardware errors. Telemetry indicated no velocity shift as seen on AS-508 during the AS-509 thrust buildup and liftoff.

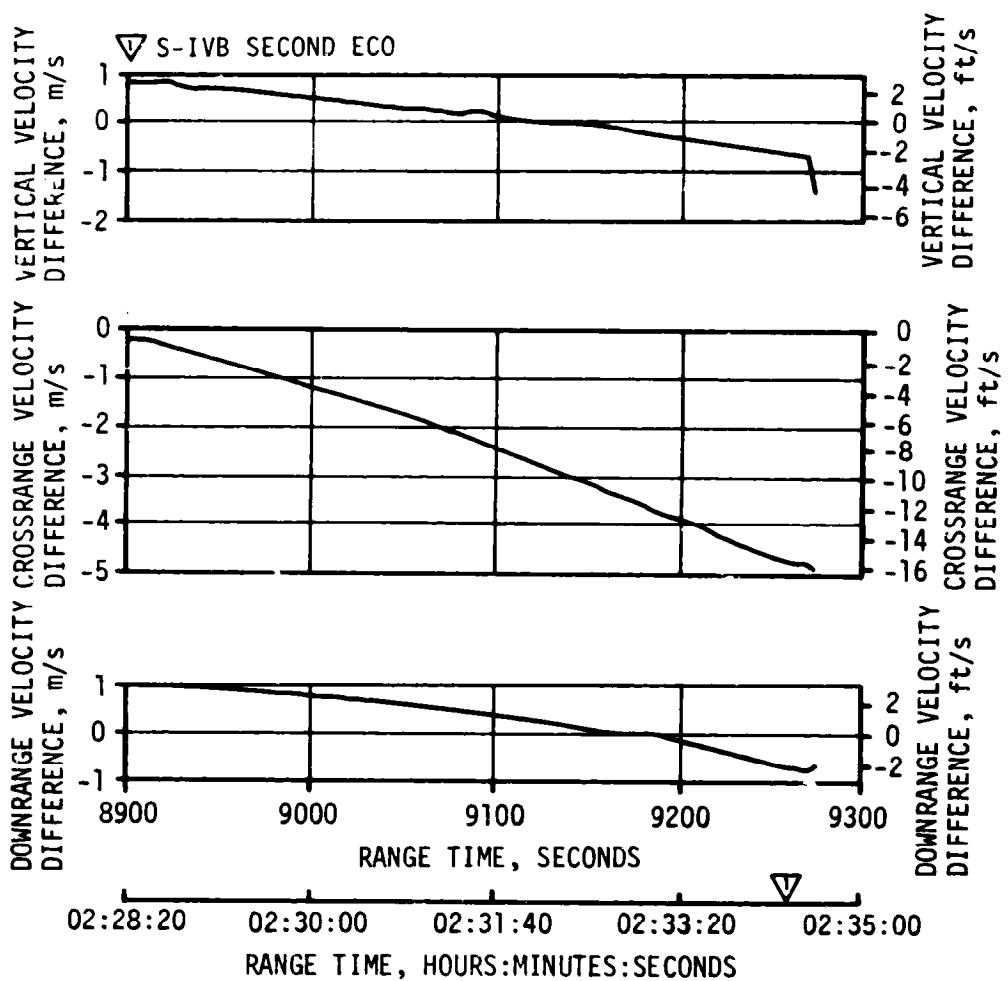
Figure 9-2. Trajectory and ST-124M-3 Platform Velocity Comparison at S-IVB Second Burn (Trajectory Minus Guidance)

The platform velocity comparisons for the second S-IVB burn mode are shown in Figure 9-2. The curves represent the differences in velocity accumulated from Time Base 6 (T_6) initiation. The crossrange velocity differences are consistent with the boost-to-parking orbit data. The vertical and downrange velocity differences are not compatible with the boost-to-parking orbit data and/or hardware errors. The second burn trajectory was constructed by constraining the telemetered platform velocity measurements to parking orbit and translunar orbit solutions. The in-plane velocity differences indicate some inconsistency between the two orbit solutions. Since both the vertical and downrange differences have built up to about 1 m/s (3 ft/s) at ignition, the trajectory state vector at ignition for the Translunar Injection (TLI) solution appears more accurate than the EPO solution.

determined from the platform measured velocities during second burn was close to nominal. At TLI, the guidance characteristic velocity was 0.05 m/s (0.16 ft/s) higher than the postflight trajectory and 0.17 m/s (0.56 ft/s) lower than the OT. However, the measured velocity increase between cutoff signal and TLI was 0.44 m/s (1.44 ft/s) higher than the OT. The velocity increase after first S-IVB cutoff was also higher than the OT by 0.16 m/s (0.52 ft/s).

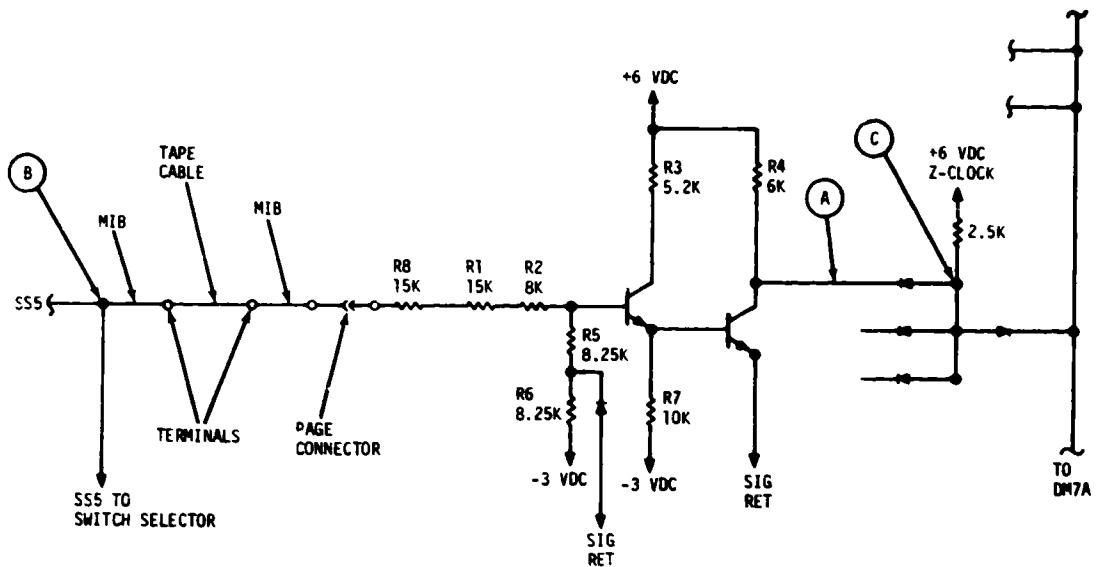
Figure 9-6. Switch Selector Bit 5 Driver Monitor Circuit

For each switch selector function command that required a logical one output from switch selector register bit 5, the SSDO word indicated that bit 5 was a logical zero. For each case, the switch selector function and switch selector feedback outputs were correct. Therefore, the failure mechanism did not affect the SS5 driver output function.

A review of system test data indicates that the failure was present at liftoff and occurred prior to or during IU-509 systems test. Further investigation revealed that the LVDA component level tests as presently configured will not detect the observed failure. Recommendation of changes to the LVDA component level tests and to systems test data evaluation are in progress.

The multiplexer latch and multiplexer serializer logic circuits and the telemetry storage select and delay line logic circuits through which the SS5 driver output status signal flows are common with other data signal flow. The only circuits which are unique to the SS5 driver output monitor are Discrete Input, Type A (DIA) circuit, AND circuit, and interconnecting networks from the SS5 driver to the multiplexer latch input (DM7A). The failure mechanism, therefore, is constrained to these circuits.

For the observed indications, any mechanism which could produce the equivalent effect of a voltage, \leq 2.5 vdc, at point A of the circuit in Figure 9-6 is a possible cause of the failure which existed between points B and C.

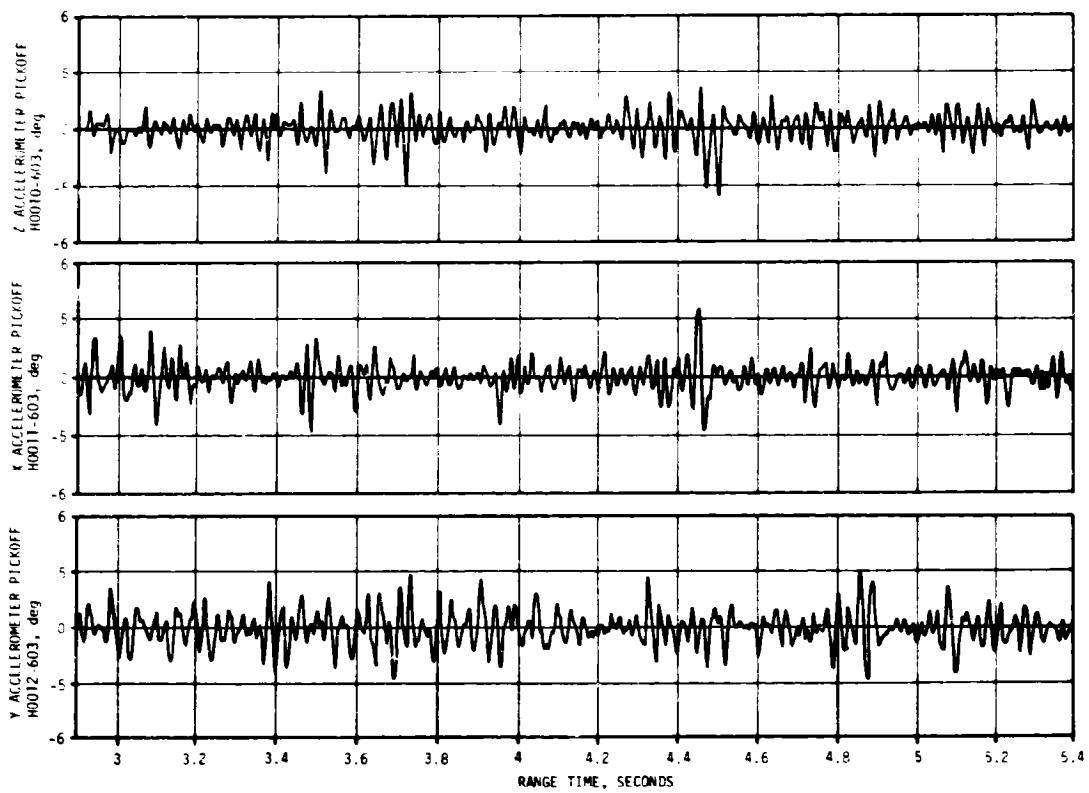
Figure 9-7. Accelerometer Head Deflections

The accelerometer servo loops operated properly even though the vibration levels at liftoff were slightly higher than those on IU-508 where a velocity anomaly occurred. As on previous vehicles, the E0009-603 measurement showed a slightly higher burst of vibration at 3.3 seconds. This is the time period where the velocity anomalies occurred on IU-506 and IU-508. As can be seen on Figure 9-7, the Y (crossrange) accelerometer pickoff perturbation was small in this time period.

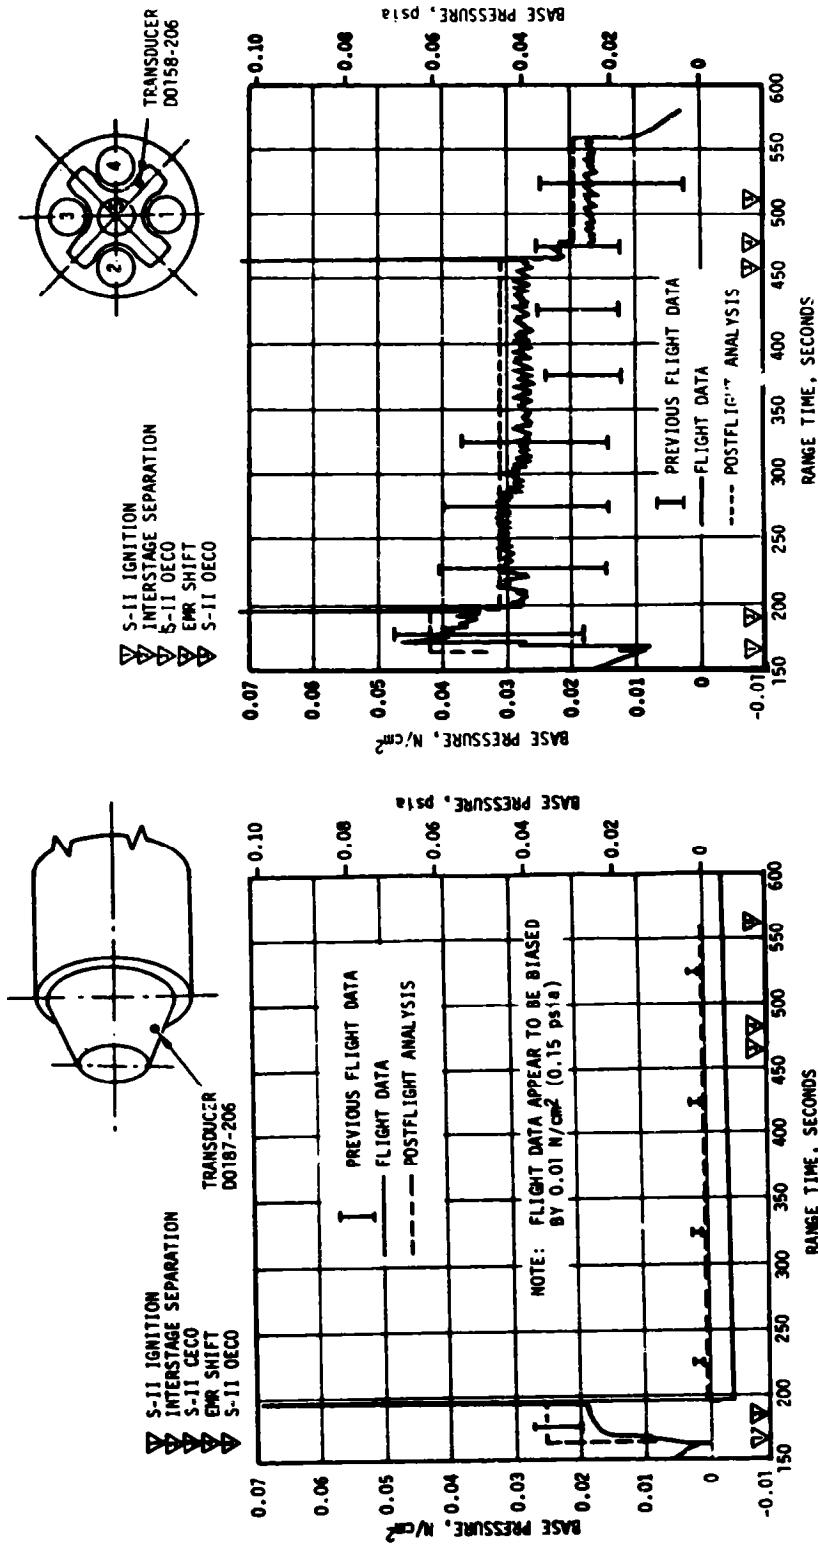
Figure 12-3. S-II Thrust Cone Pressure

The AS-509 thrust cone static pressure data presented in Figure 12-3 appear to be biased by approximately 0.15 psia, based on the pressure prior to J-2 ignition when compared to transducers D0150-206 (Figure 12-2) and D0158-206 (Figure 12-4). After interstage separation, the transducer records a constant negative value which again indicates that the transducer is biased. Under the assumption that the data is biased by 0.15 psia, good agreement is obtained between flight data, postflight analysis, and previous flight data prior to interstage separation. Following separation the AS-509 pressures would be slightly higher than on previous flights.
