openreach

AEI/AEC/B349

Maximum Wire Loadings

For Non Radial (One side loaded) Poles

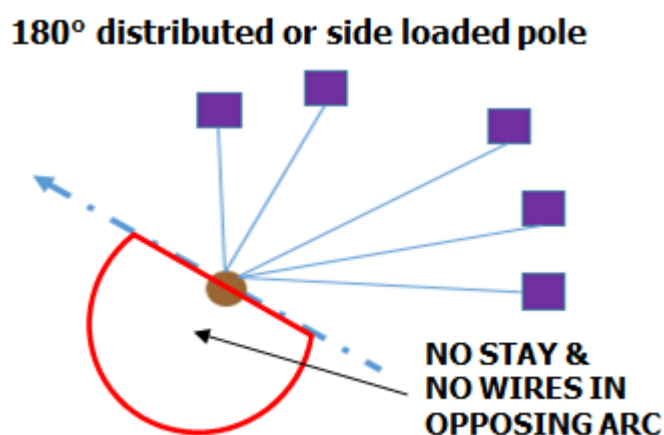
Fig 1

To prevent such cases, Chief Engineer and the Plant Safety team are introducing new wire loading rules for non-radially fed poles. Non radial poles are defined as those that are un-stayed and where all wires are attached in a single 180° Arc, with zero wires or stays in the opposing arc. Please see fig 1 below.

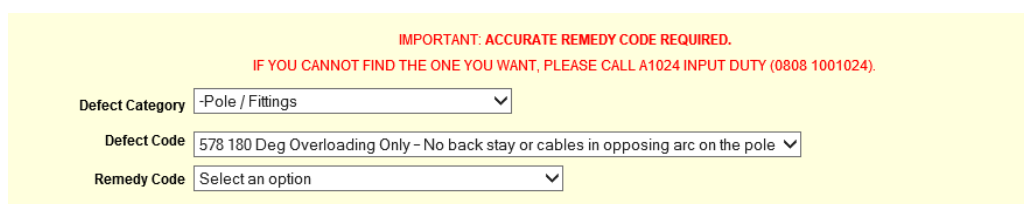
Please see an example of the Artisan A1024 input screen below. The same defect codes apply to the App which is shown in fig 4, 5 and 6 within this section.

IMPORTANT: ACCURATE REMEDY CODE REQUIRED.
IF YOU CANNOT FIND THE ONE YOU WANT, PLEASE CALL A1024 INPUT DUTY (0808 1001024).

Defect Category: Pole / Fittings

Defect Code: 578 180 Deg Overloading Only – No back stay or cables in opposing arc on the pole

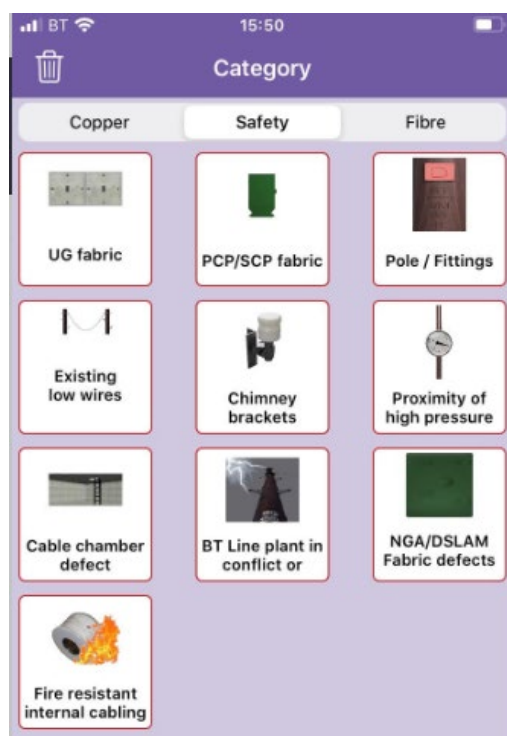
Fig 4

Upon selecting the A1024 App, choose the Pole/Fittings category as shown below.

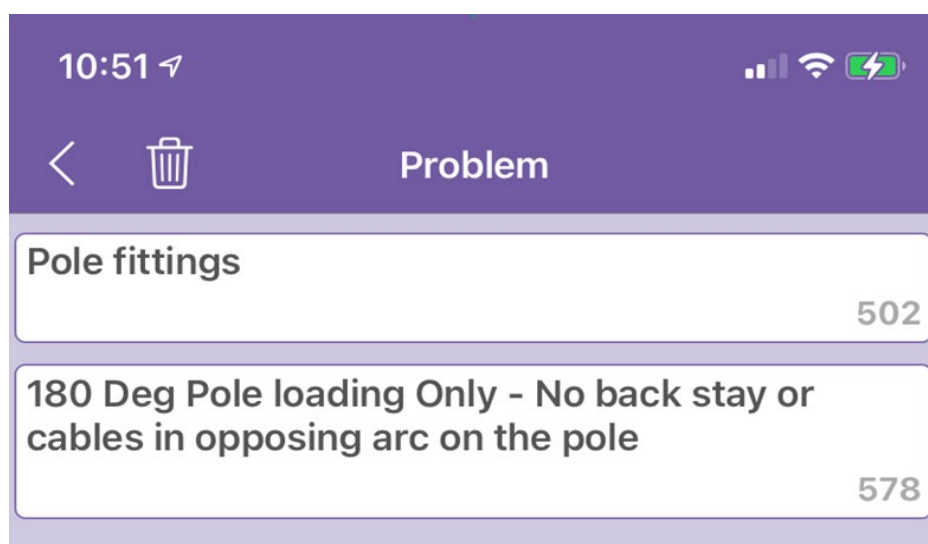
Fig 5

On entering the Pole/Fittings category, defect code 578 will appear.

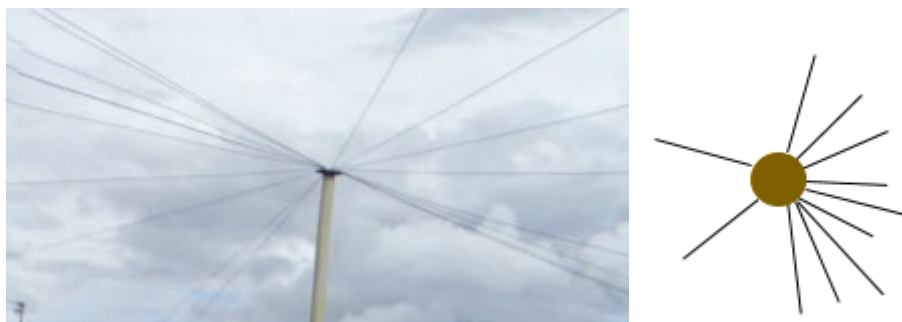
Figures 7 & 8 – Typical Radial loading

Radially loaded poles are excluded from the process described above.

Figures 7, 8 and 9 shows typical varying degrees of radial loading.

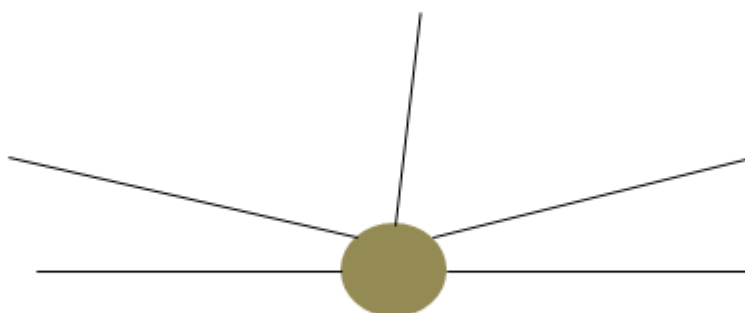
In the scenario below, the pole is still one side loaded but with a wire count of 3 **NOT 5**. The in-line dropwires are not included as they effectively cancel each other out.
