MPR-SAT-FE-71-1

APRIL 1, 1971

SATURN V LAUNCH VEHICLE FLIGHT EVALUATION REPORT-AS-509 APOLLO 14 MISSION

PREPARED BY
SATURN FLIGHT EVALUATION WORKING GROUP

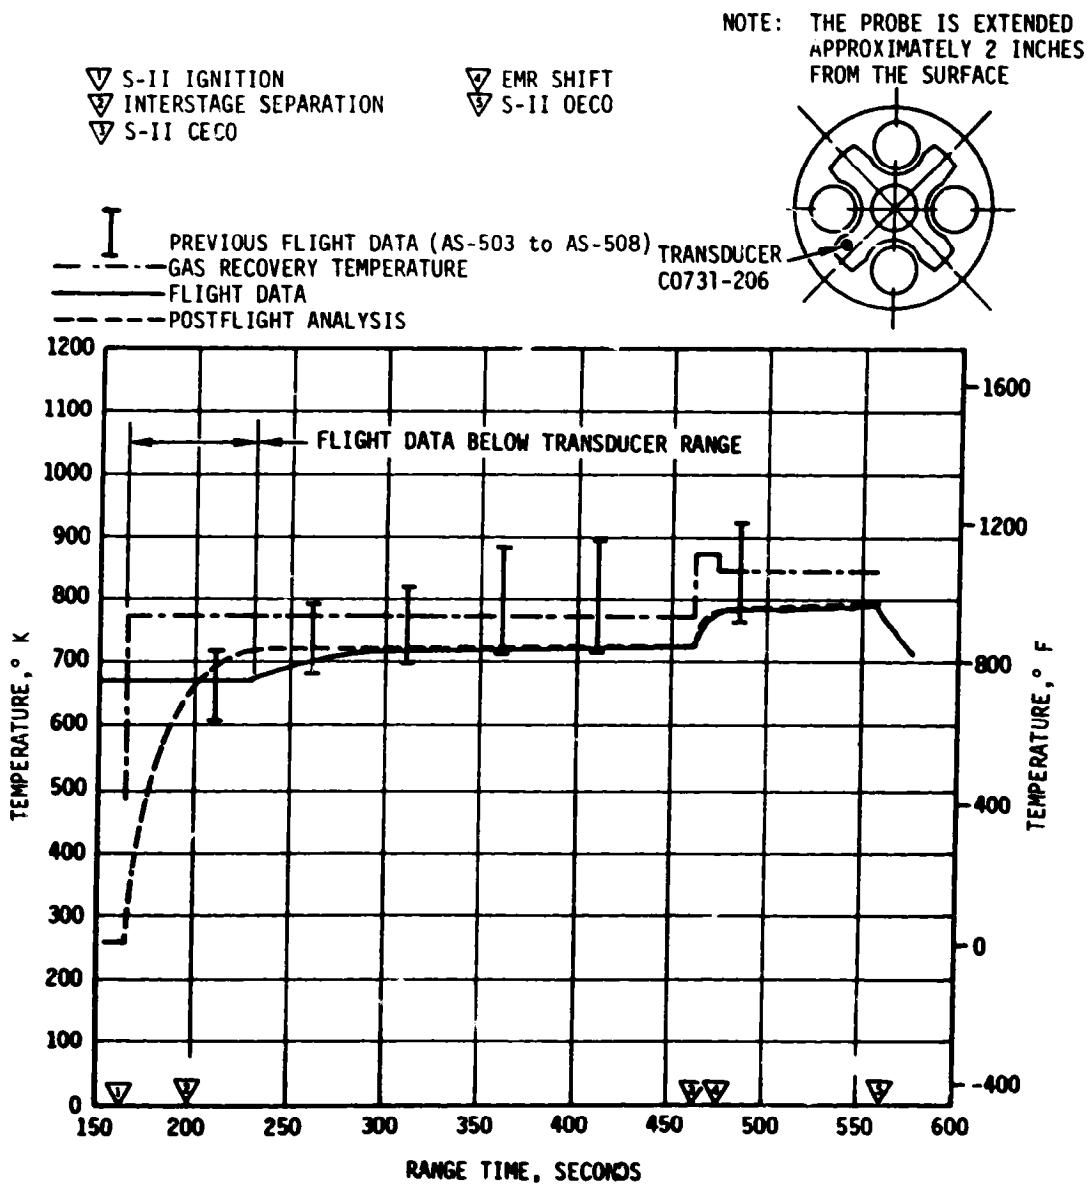
Figure 13-5. S-II Heat Shield Recovery Temperature

Figure 13-5 shows the AS-509 flight data and postflight analysis of the heat shield recovery temperature transducer C0731-206. The analytical temperature curve represents a calculated transducer reading based on math models using key flight parameters. The gas recovery temperature is an analytically derived value computed from the flight measurement data. Note that the flight values are the probe temperatures and not the

gas recovery temperatures. As shown in Figure 13-5, the AS-509 flight gas recovery temperature values were on the low side of the previous flight data envelope. This is contrary to the expected trend, since the steady-state engine deflection pattern indicates that the engines were gimbaled closer inboard prior to CECO than on previous flights. However, as indicated by the previous flights data envelope, a considerable probe temperature variation exists between different flights which cannot be explained by the variation of the parameters considered in the

analysis alone. Also, since the initial temperature is below the probe range, it is not possible to determine if the probe temperature is biased, which might possibly account for the apparent discrepancy between the measured high total heat flux and low gas recovery temperature.

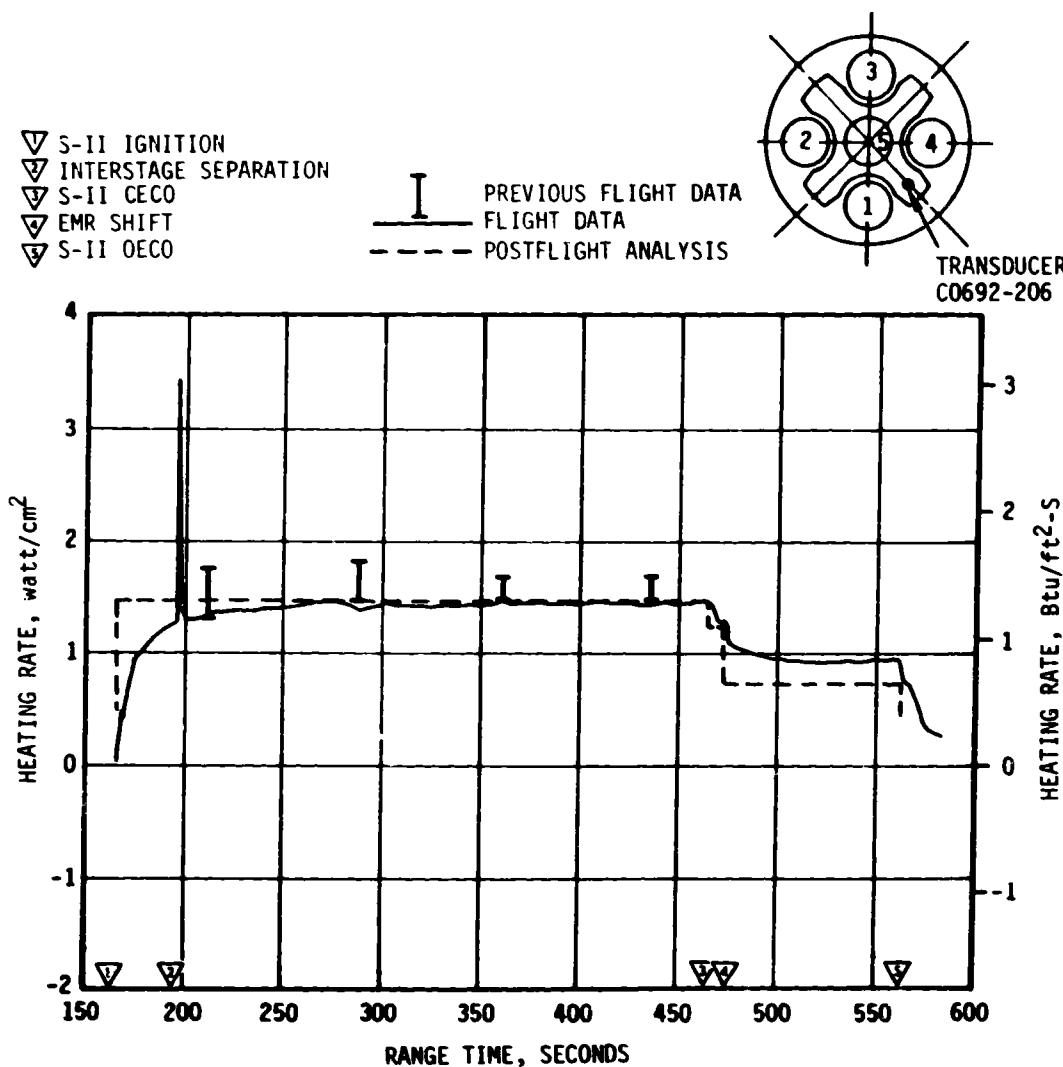
Figure 13-6. S-II Heat Shield Aft Radiation Heat Rate

Figure 13-6 shows the AS-509 flight data and postflight analysis of the heat shield aft radiation heat rate. The analytical radiation heat rate represents the heat rate at the transducer location and is derived from a math model. Good agreement is obtained between flight and the postflight analytical values which do not include engine position effects. Comparison with the previous flight data envelope shows that the AS-509 data

were on the low side which is contrary to the expected trend based on the AS-509 closer inboard steady-state engine control positions.

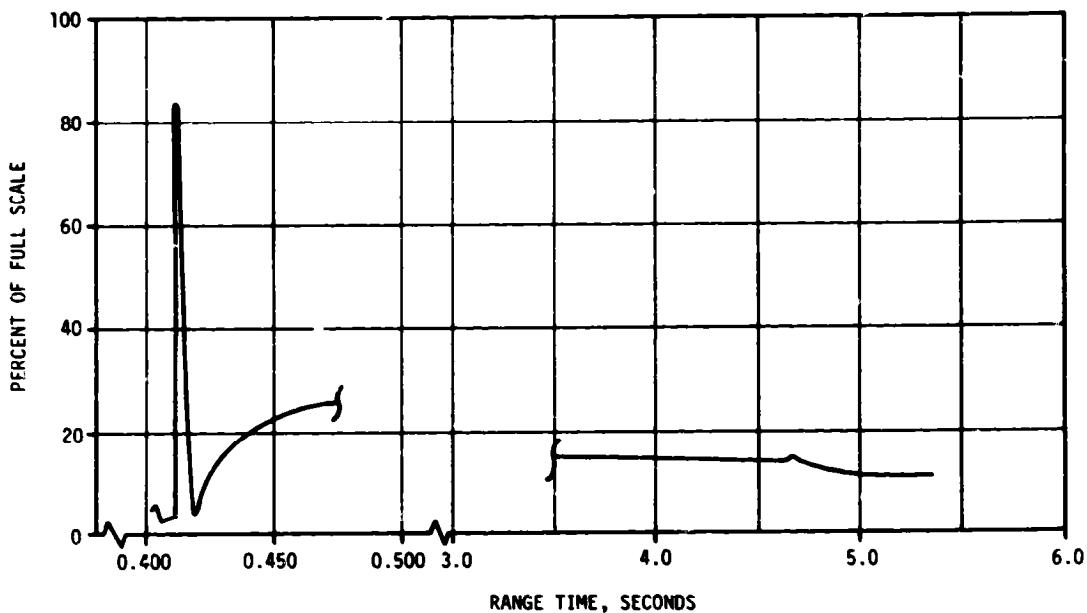
Figure 15-2. DP1-A0 270 Multiplexer Analog Data

All data channels showed an abrupt change followed by a transient, as shown in Figure 15-2. The data tended to level out at 14.3 percent of full scale until 4.63 seconds when it decayed to 11.6 percent of full scale within 250 milliseconds.

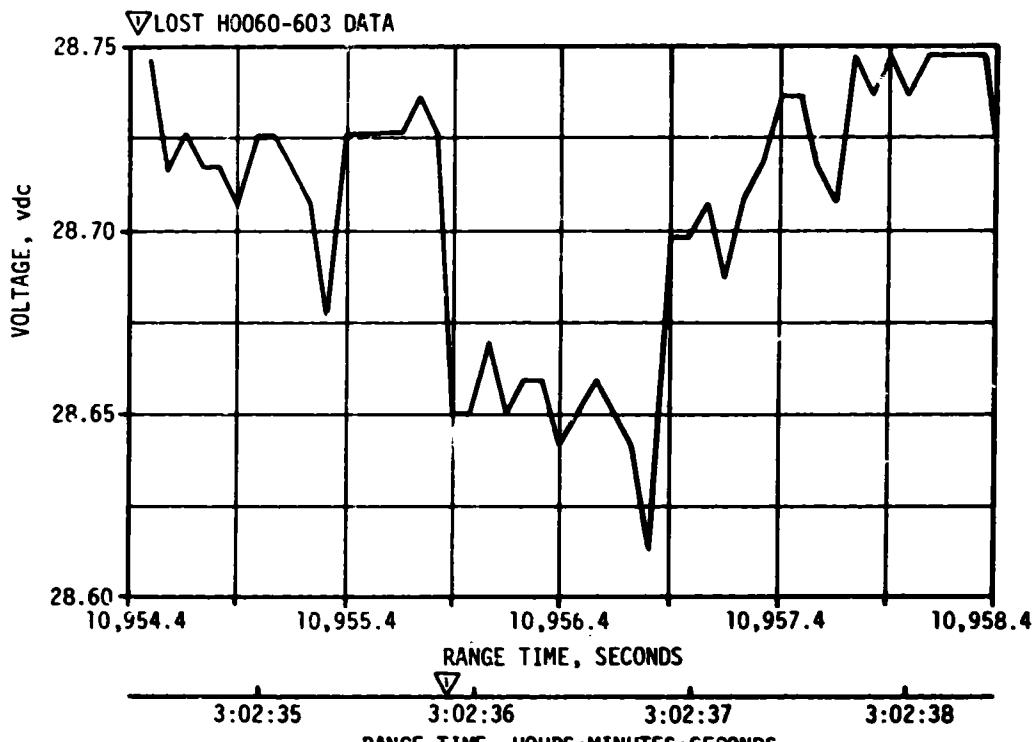
Figure 15-3. 6D31 Bus Voltage

The 410K multiplexer is supplied by the 6D30 battery. There was a discernible excursion in the 6D31 bus voltage and the 6D30 battery current at the time of the failure as can be seen in Figures 15-3 and 15-4. The voltage dropped from 28.74 to 28.65 volts while the current rose from 20.72 to 22.52 amperes. This disturbance lasted for 1.162 seconds and then the voltage abruptly increased and the current decreased. When the current decreased, it leveled out at an average of 0.2 ampere lower than the current prior to the problem. The voltage increased to an average of 0.01 volt higher than the voltage prior to the problem. The IBM acceptance test for the 410K multiplexer (S/N 442), showed a current drain of approximately 0.18 ampere. This tends to indicate that the 410K multiplexer ceased to draw current. The first effect seen in the failure sequence was the abrupt loss of data and a sudden increase in current and decrease in battery voltage. The second effect observed was an abrupt return of current to a lower value and tends to indicate involvement of the 410K multiplexer power supply. A simulation of these events using engineering hardware is being attempted.
