8 - APL - Troubleshooting

Haas Automatic Parts Loader - Service Manual

8.2 COMPACT APL - TROUBLESHOOTING

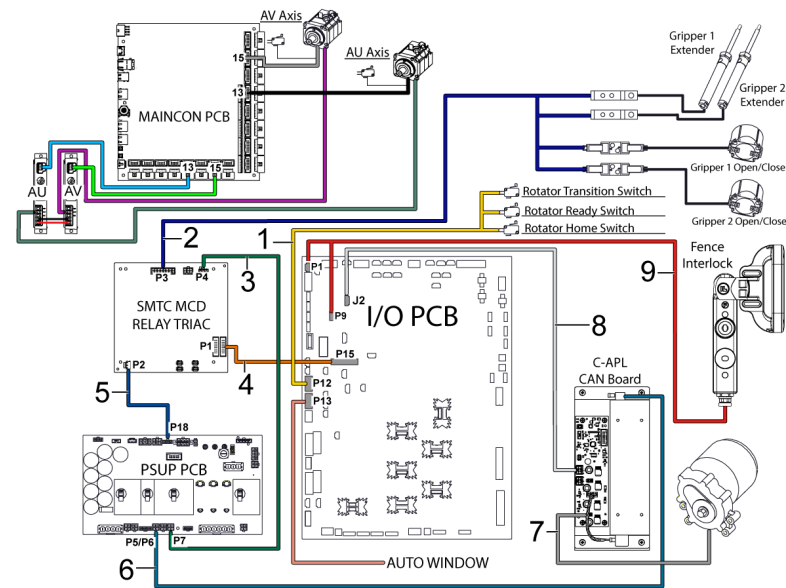
Compact APL Electrical Schematic

ALARM / CAN CODE	POSSIBLE CAUSE	CORRECTIVE ACTION
<p>Alarm 9105: IO BOARD COMMAND EXECUTION FAILURE</p> <p>The machine outputs the following alarms with this alarm:</p> <ul style="list-style-type: none">• 2001.003: EMERGENCY STOP SWITCH ERROR• 2002: OPERATOR'S PENDANT EMERGENCY STOP SWITCH ERROR• 120: LOW AIR PRESSURE OR FLOW	<p>Outdated main I/O firmware.</p>	<p>Updated the main I/O firmware to the latest version.</p> <p>Refer to the Firmware Update procedure.</p>
<p>Alarm 17.9920/18.9920: POSITION ERROR TOO LARGE</p>	<p>Electrical connections to the C-APL AV or AU servo amplifiers may be swapped.</p>	<p>Reference the C-APL electrical schematic below.</p>

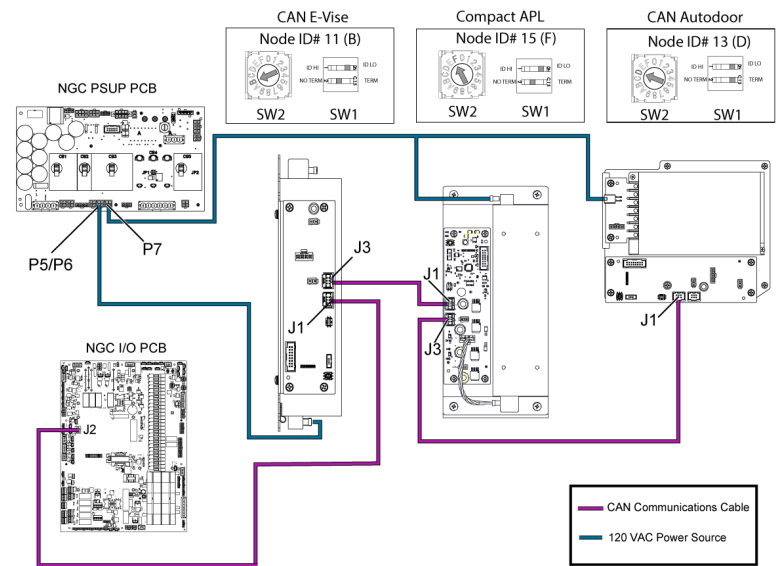
CAN Bus sequence when a machine has a CAN E-Vise, Compact APL, and CAN Autodoor.

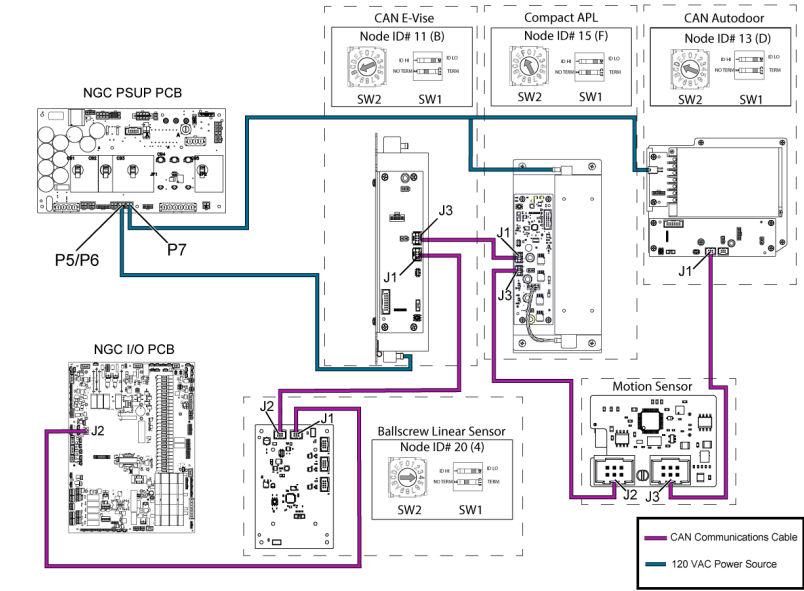
CAN Bus sequence when a machine has Active Ballscrew Compensation, CAN E-Vise, Compact APL, Motion Sensor, and CAN Autodoor.
