Avant Service Bulletin 28. 03. 2011

The boomerang part of the Avant boom P/N: **A47000**.

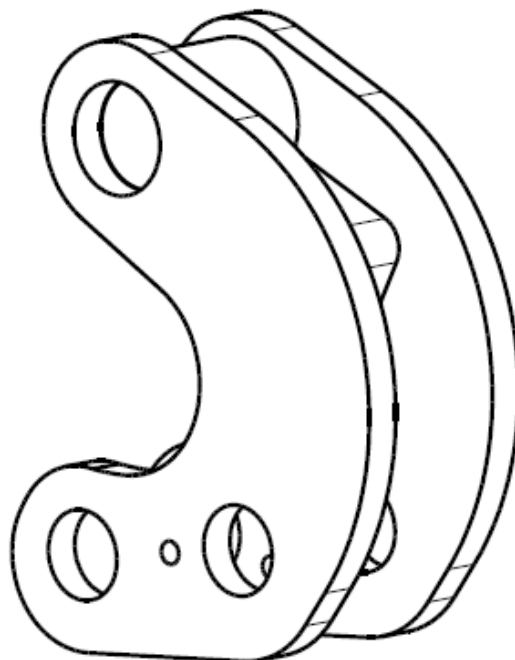
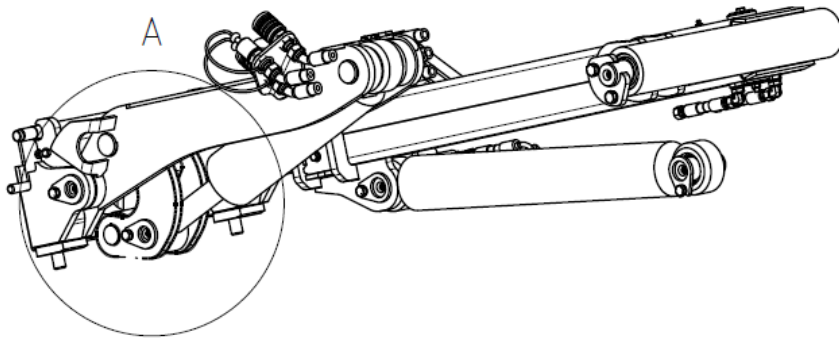
If such a boomerang gets damaged, or it has worn out, there is a now stronger new version available, and this will automatically be sent to replace the original part including a new part number.

The new assembly part number is : **A411430**.

This assembly includes following items:

2 pcs	p/n A411429	new thinner S=6 spacer rings
2 pcs	p/n A411432	new longer pins
2 pcs	p/n 72798	grease nipple
2 pcs	p/n 64912	bushing bearing
1 pcs	p/n A411418	boomerang

This renewed boomerang assembly is interchangeable with the old one.

New spare part
No: **A411430**
