This document sets out to validate the Large Soil Moisture Probe Temperature readings and counter readings (Counter readings have already been confirmed to meet requirements).

XP1=1<sup>st</sup> Cast Probe, XP2=2<sup>nd</sup> Open Probe

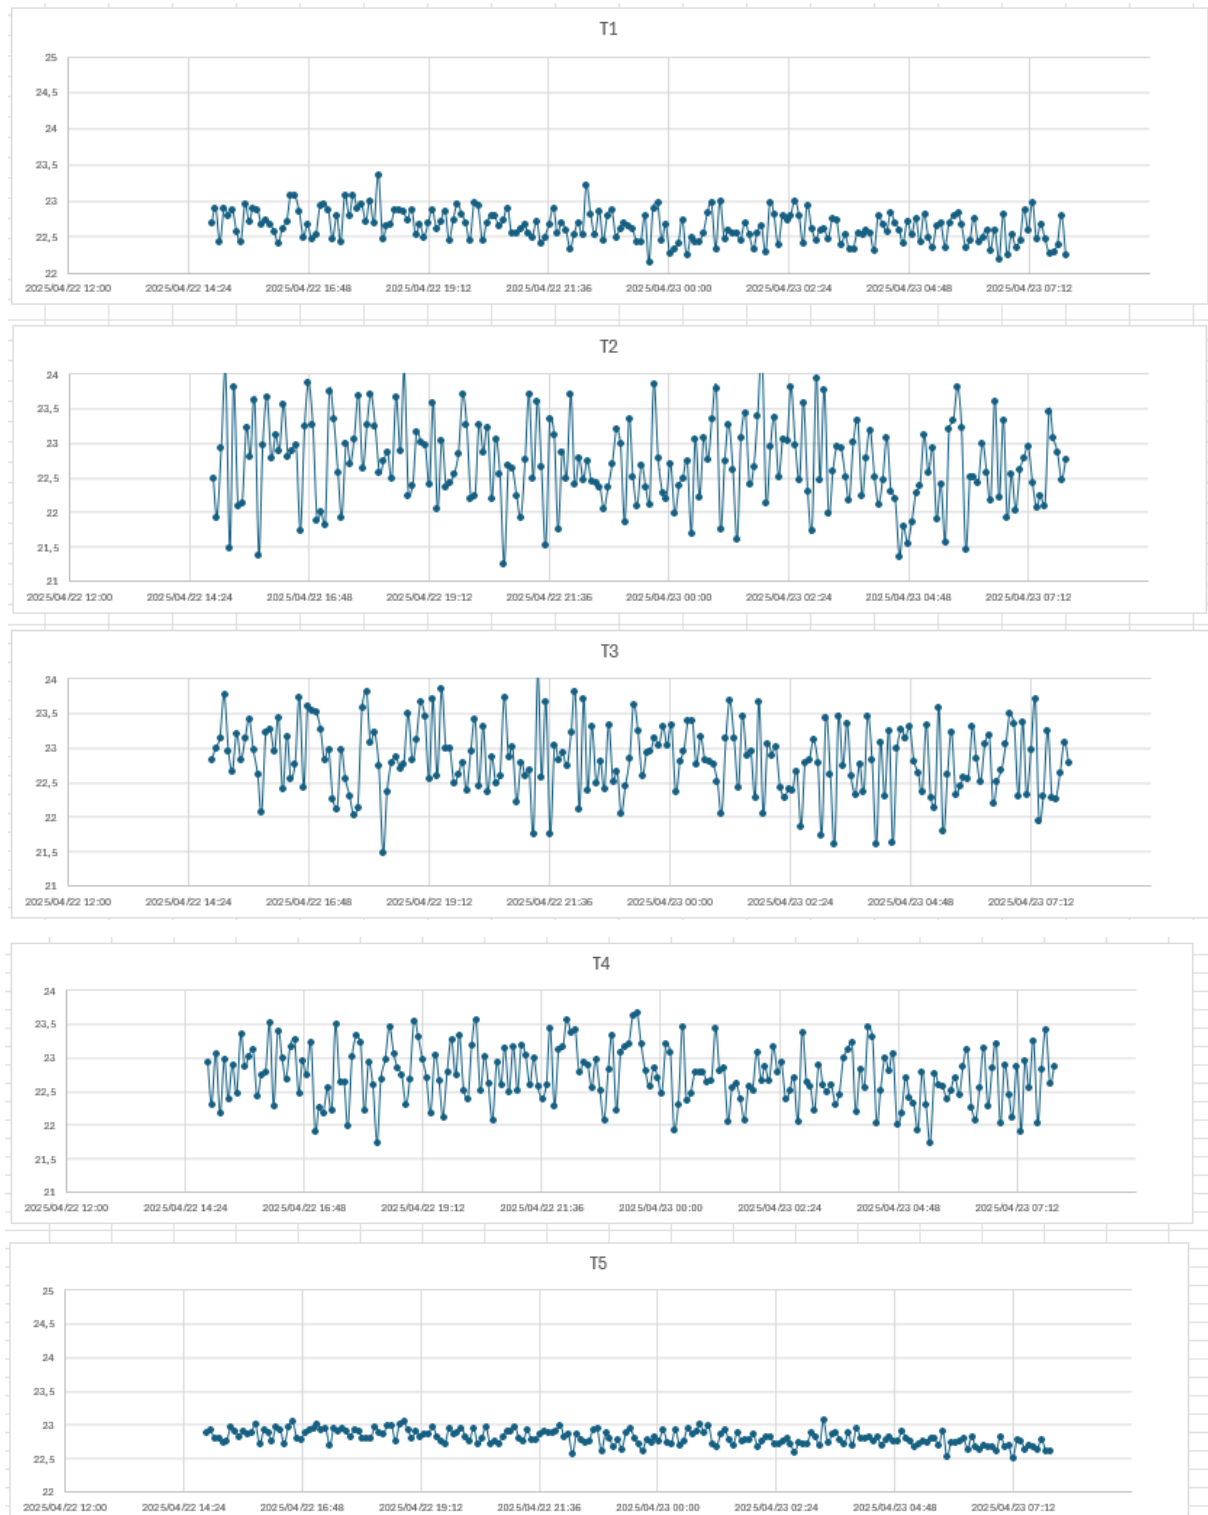
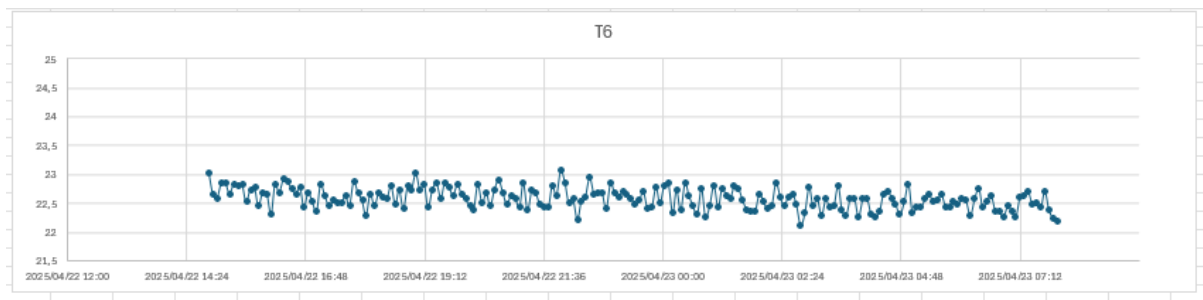
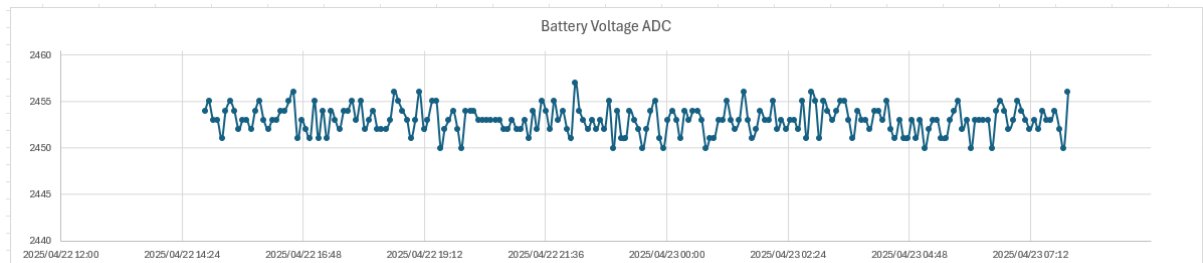
Open probe is now using 10k NTC along with 10k voltage divider circuit. Overnight Temperature readings using the open test probe are shown below:

The above graphs do not meet the requirements for the temperature validation due to high noise on temperatures 2,3 and 4. Potential reasons for the noise include RS485 communication cable running through sense boards 1-4, or discrepancies in build quality of the sense rings. The RS485 cable was removed along with swapping sense ring #1 and #2 to see if a noticeable occurs. Also shown above is the battery voltage control test which shows an extremely high level of accuracy of the ADC.

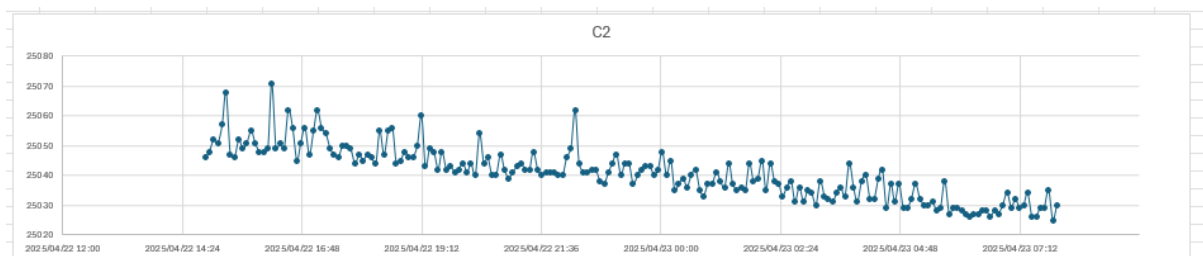
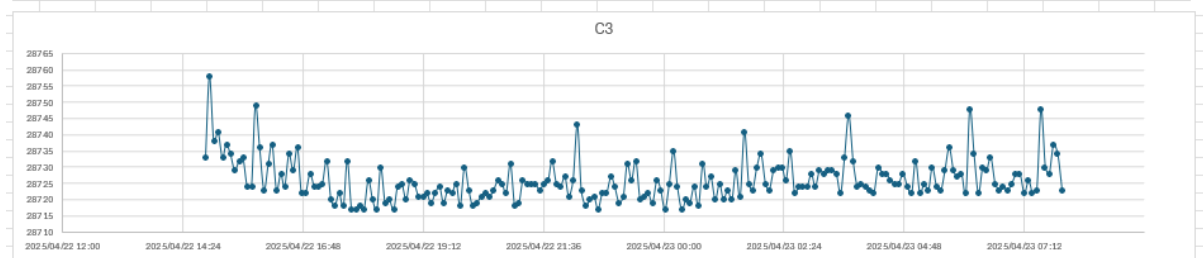
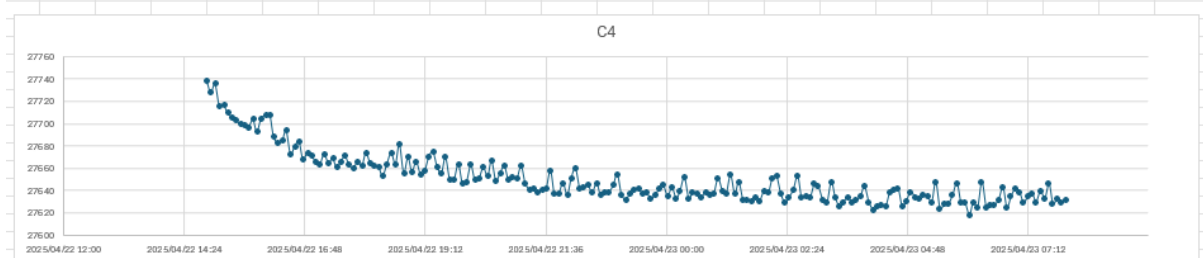
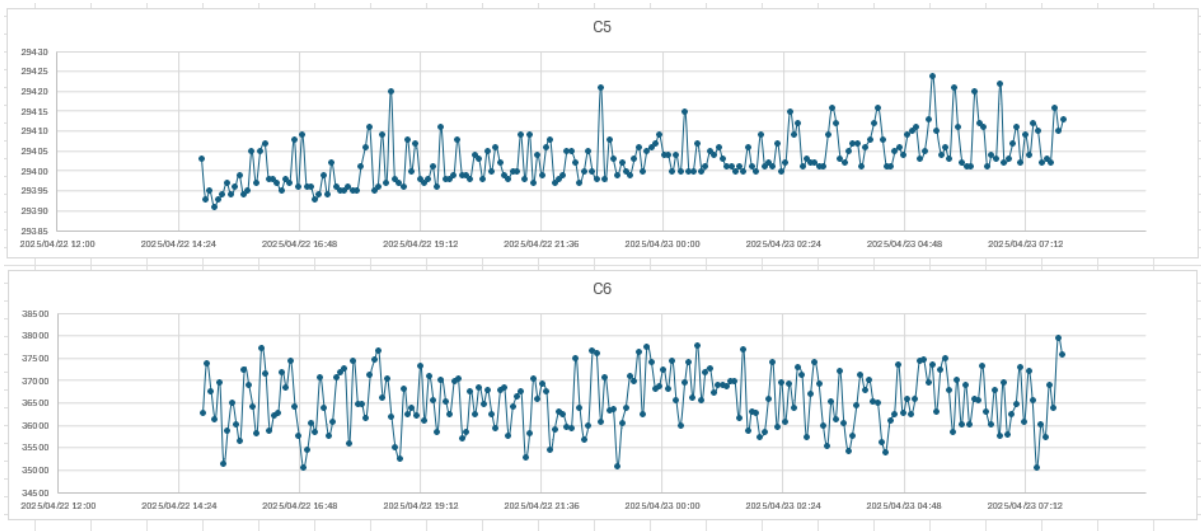
The graphs below are taken from XP2(the open test probe). They show that the counter value is still within the required specs except for Counter 6. Counter 1 is excluded in this test due to space requirements on Irricheck and the inclusion of the battery voltage adc.

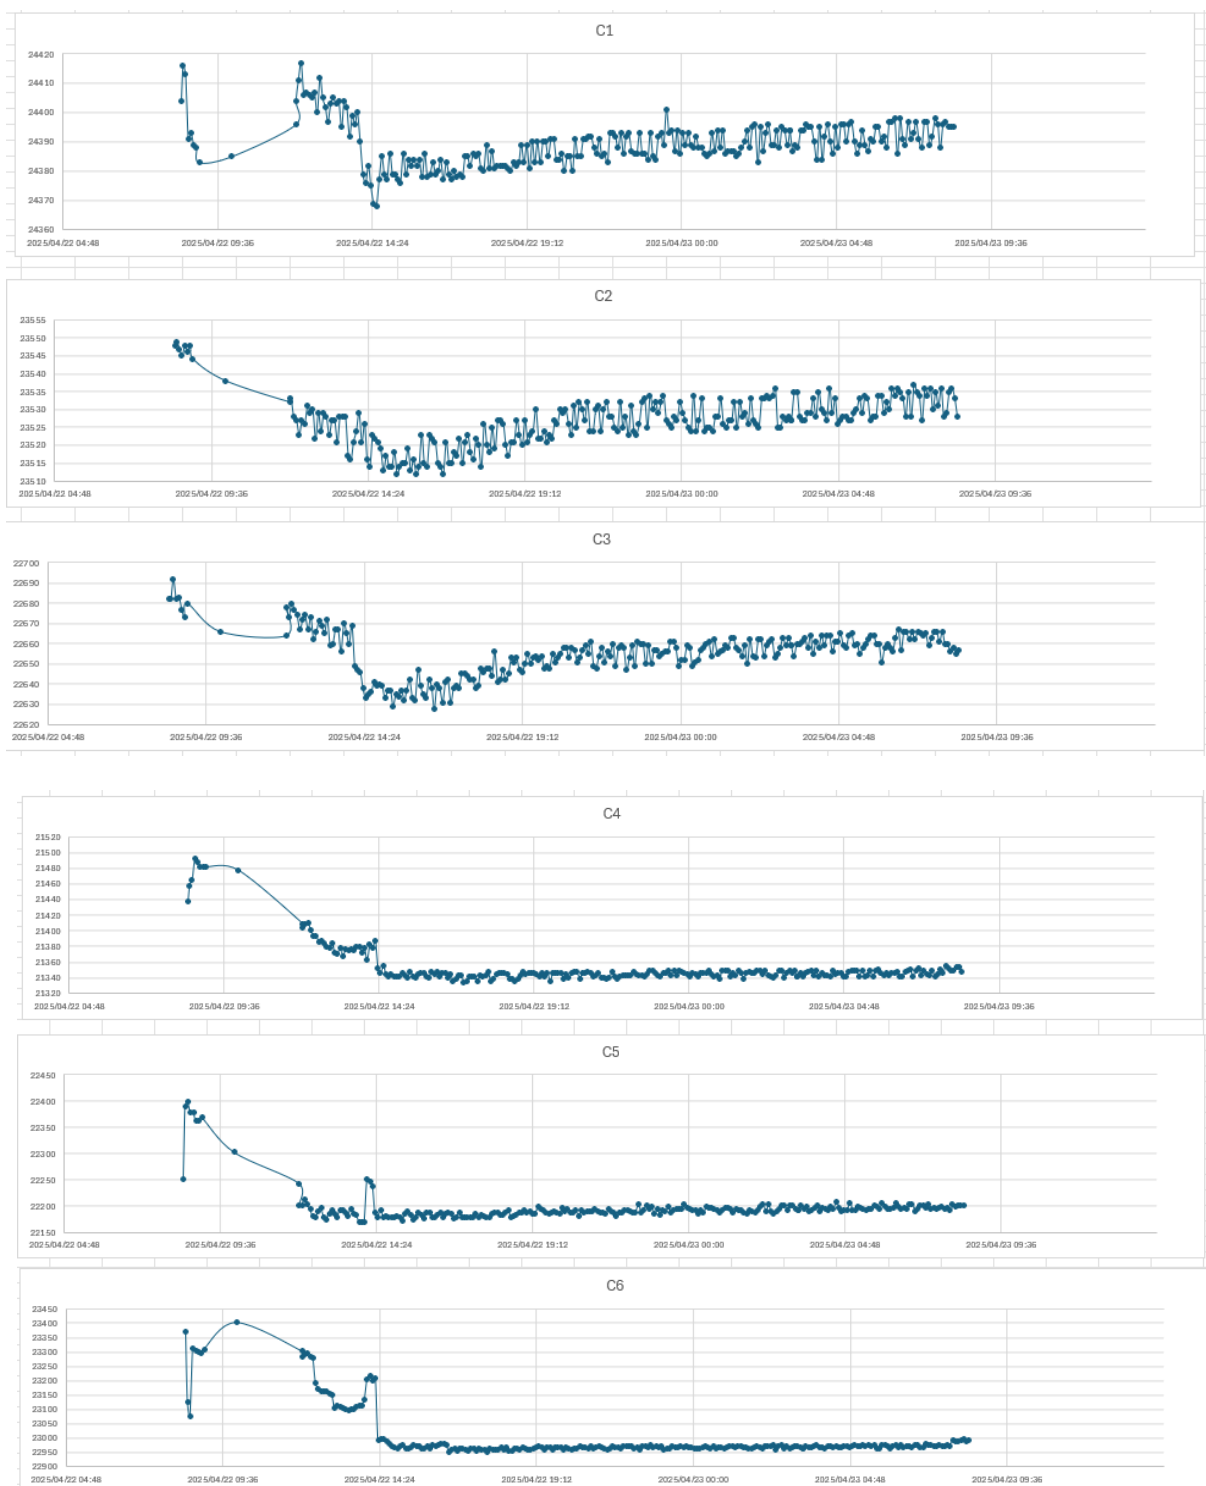
Counter validation can be confirmed using the cast test probe, with the data collected from the 22<sup>nd</sup> of April 2025 08:30 until now(23<sup>rd</sup> April 2025 08:30):

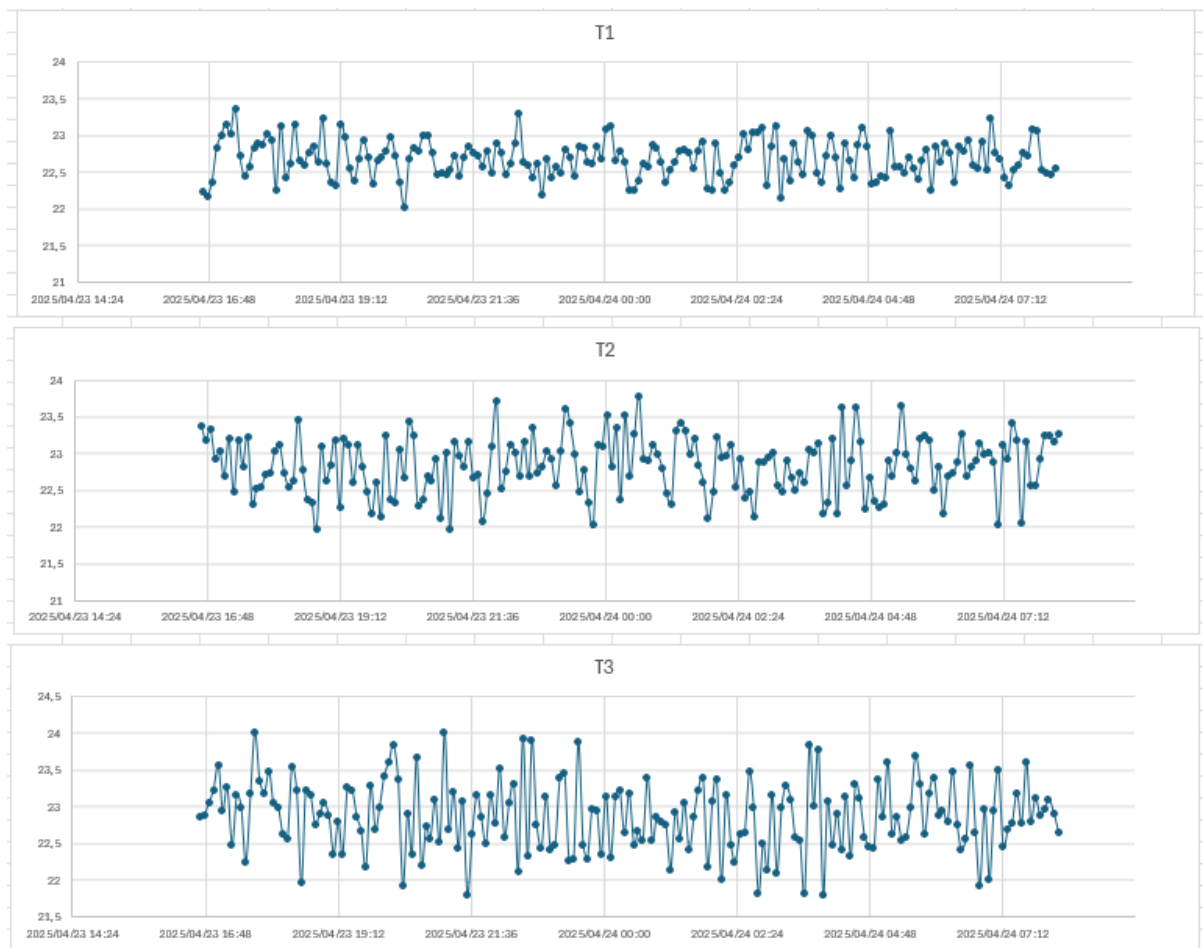
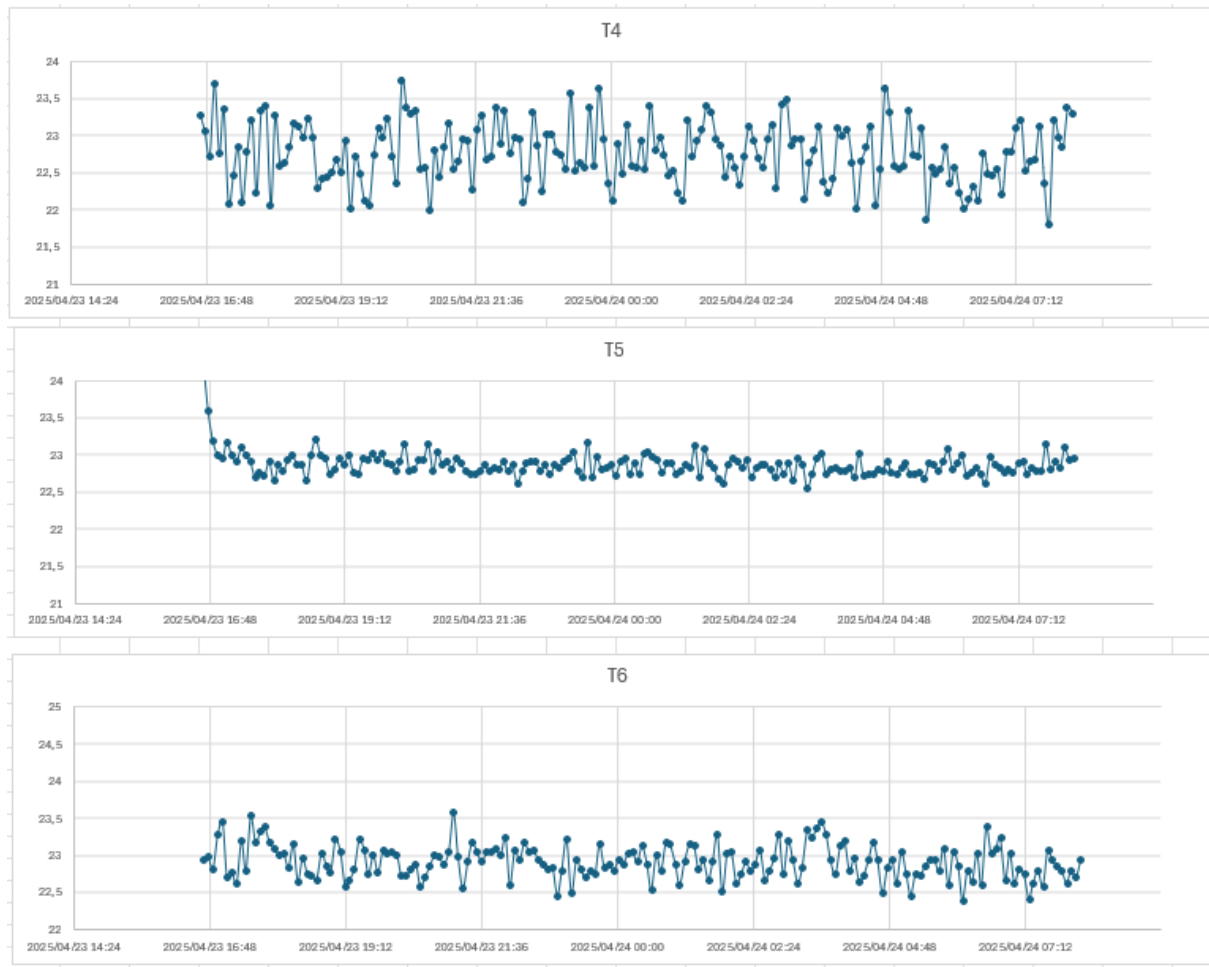
Below are the readings taken from 23/04/2025 16:51 to 24/04/2025 08:15 of the open test probe, showing the temperature readings.

Ring 4 is swapped with the spare ring (Ring 6 from the morning readings on the 23/04/2025) to confirm if the software or hardware is causing the inaccuracy.

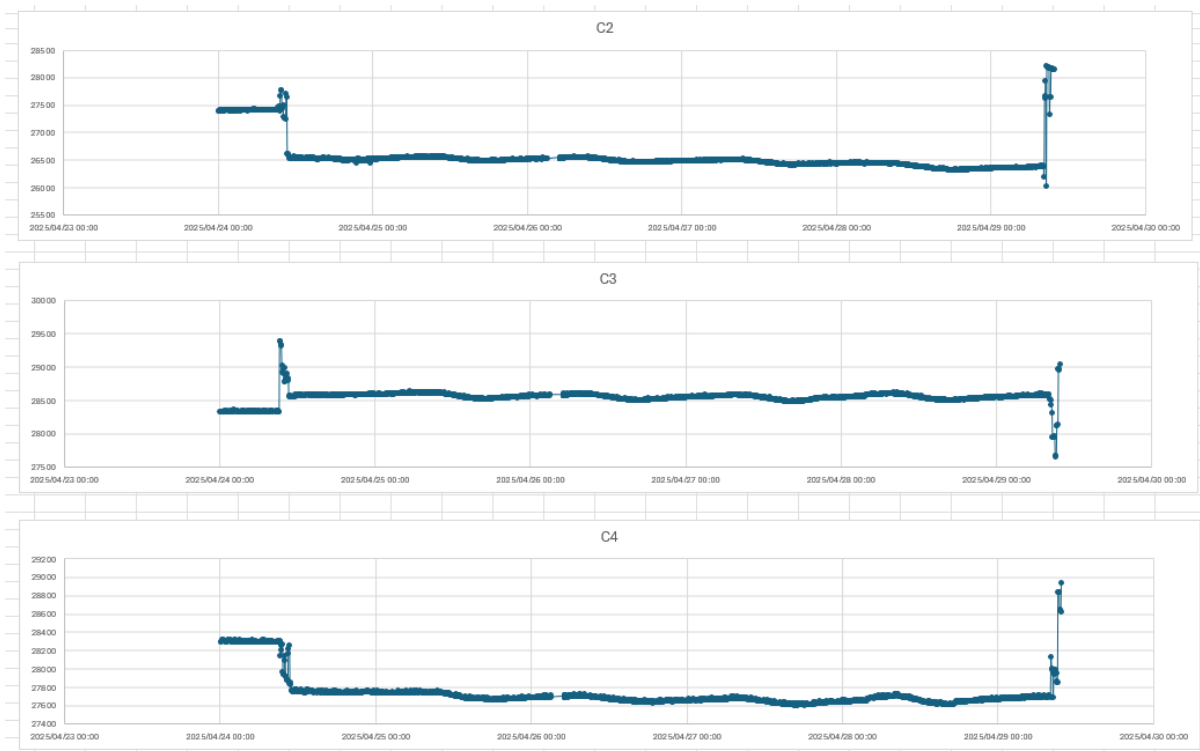
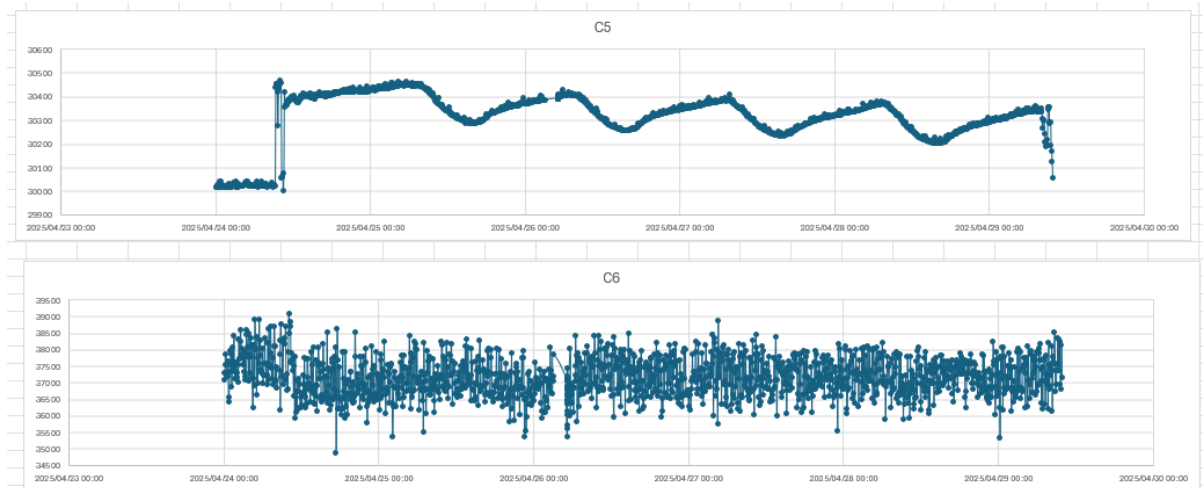
Below are the results of the Open probe XP2, the counter values C2-C6.

The battery voltage recorded is constant due to the Roman outputting 5V to the Probe.

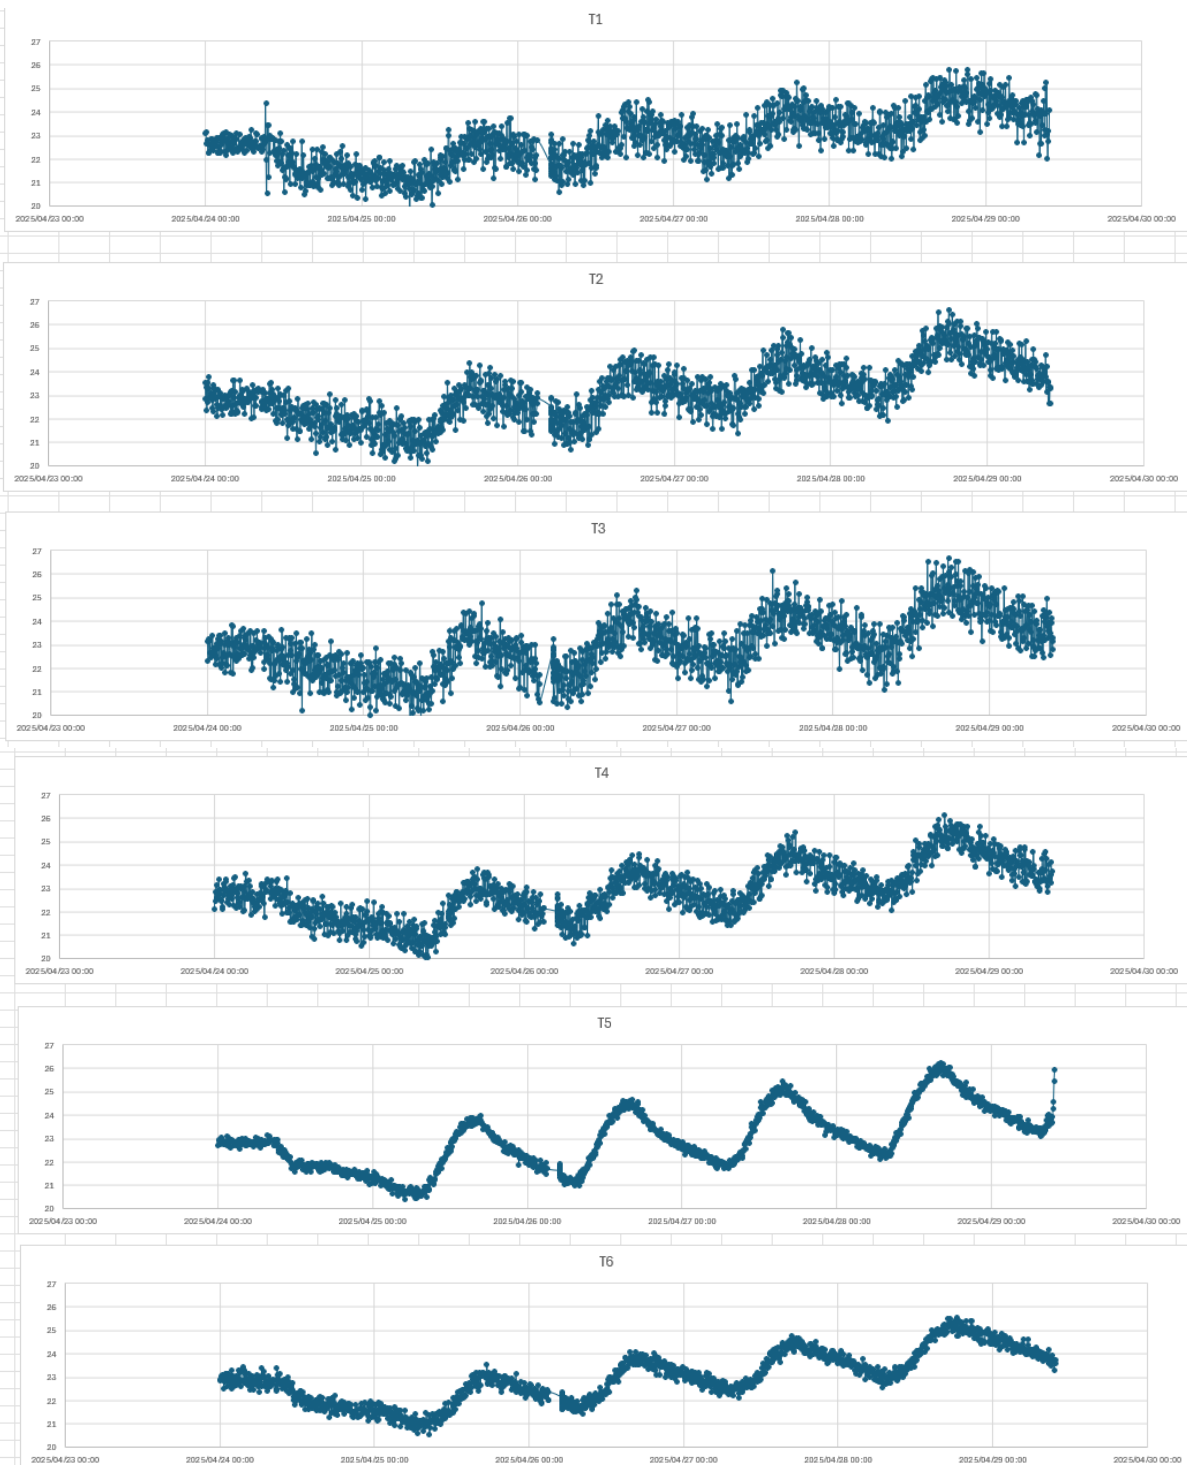
Below are the results of the temperature readings for the past 5 days.

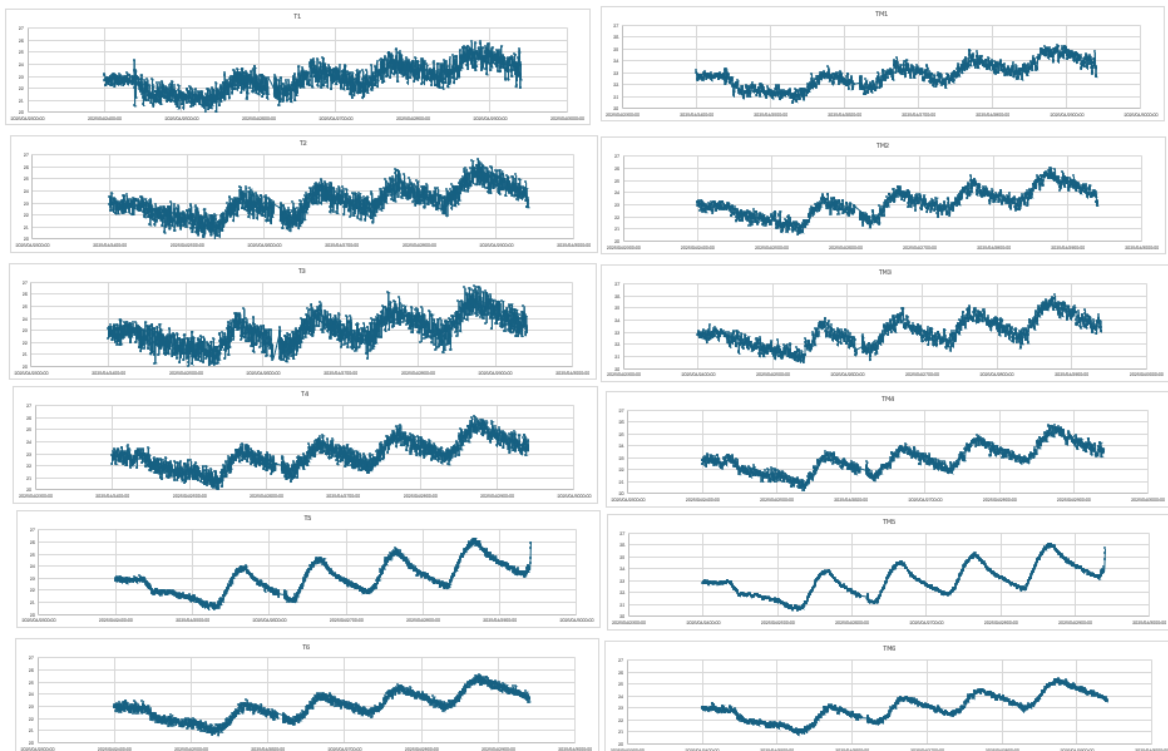
Temperature graphs with a moving average applied:

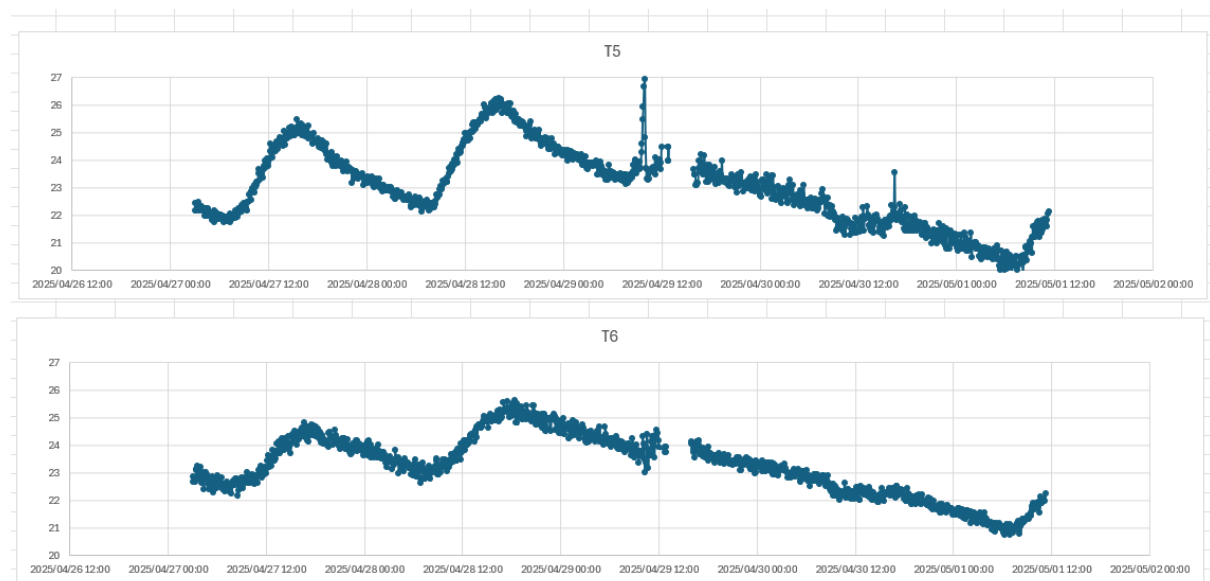
Below are the temperature readings from sense rings 5&6 after simply swapping the cables used between them it can be observed that the accuracy of sensor 6 improved and the accuracy of sensor 5 decreased.

Changing all cable lengths to be the same length as the cable used for sense ring 6 that was plotted above. 01/05/2025 12:00.

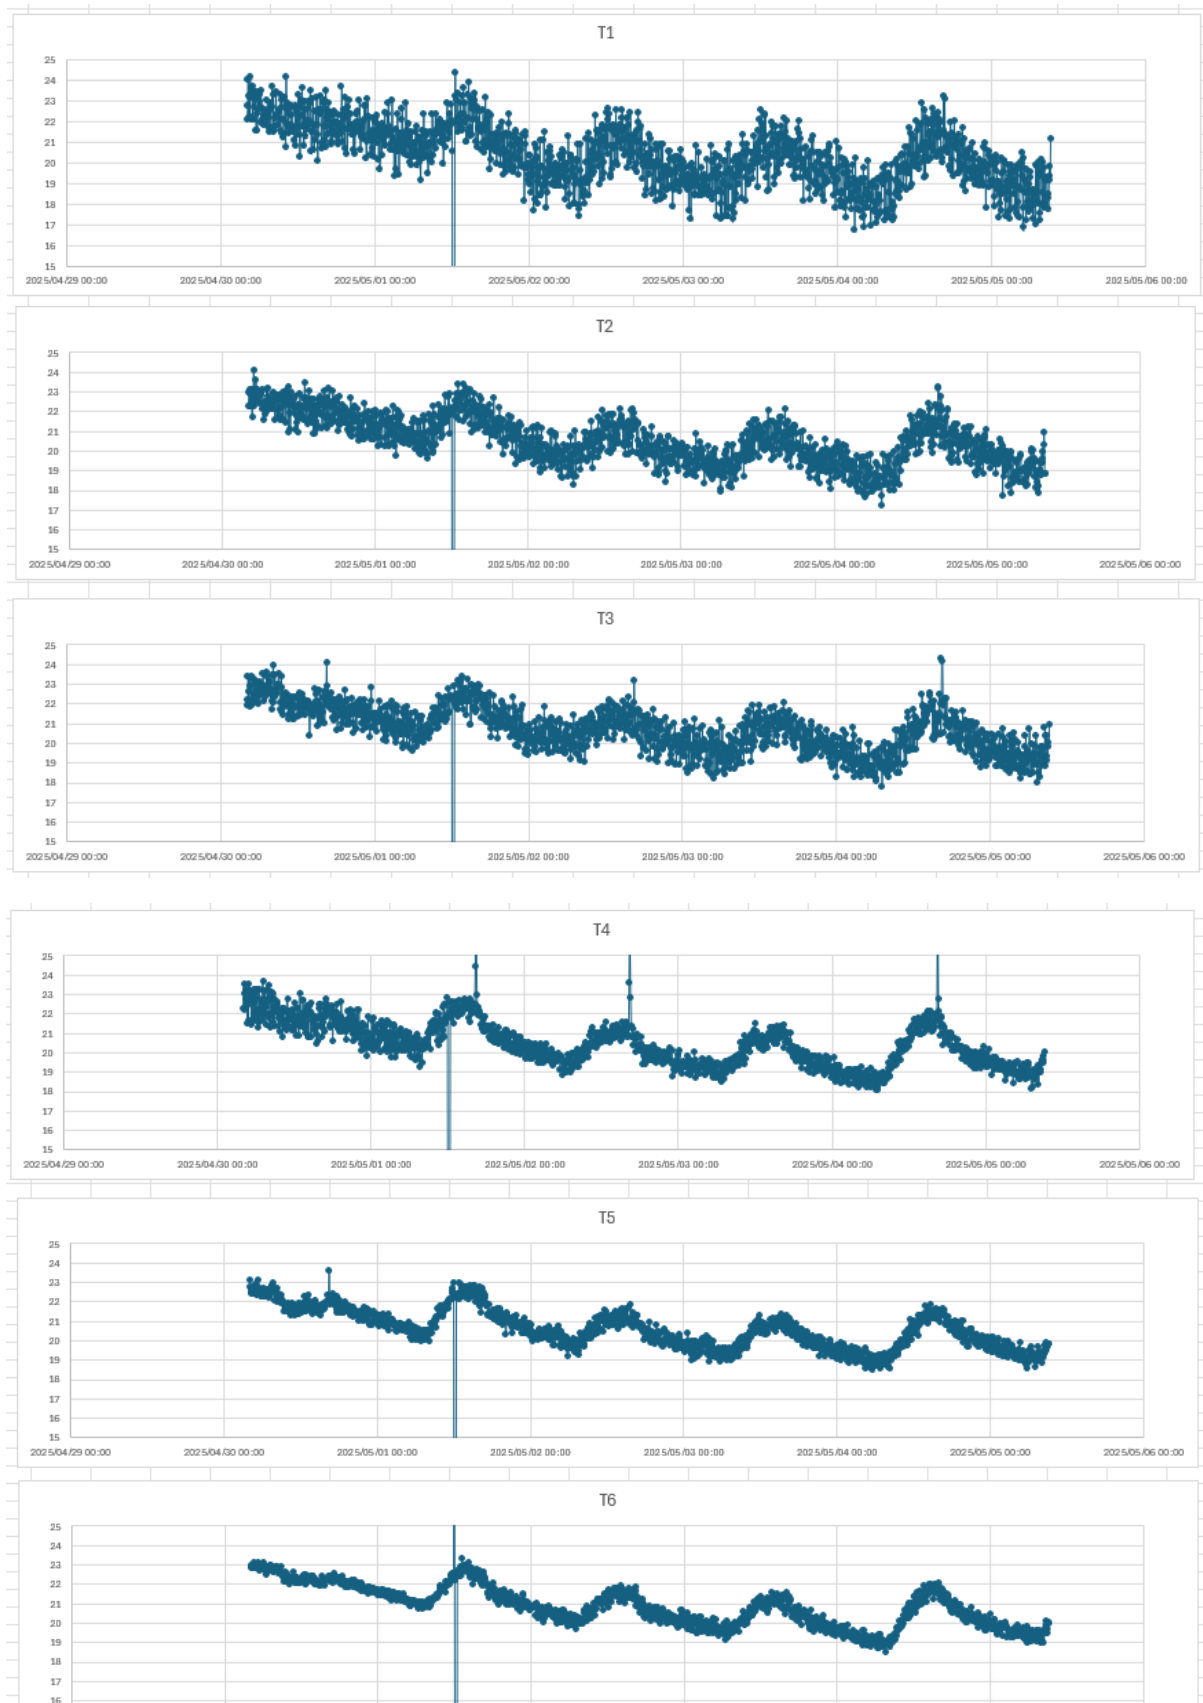
Plotting the data from the 01/05/2025 to 05/05/2025 in the below graphs. This shows that the wire length has a slight improvement influence on Temperature sense board 4, but on the other sense boards it has a negligible effect.
