SOCIETY FOR ECOSYSTEM RESTORATION  
IN NORTHERN BRITISH COLUMBIA

## Restoring Fish Passage in the Peace Region - 2024

PEA-F24-F-3944-DCA

DRAFT Version 0.0.2 2025-03-26

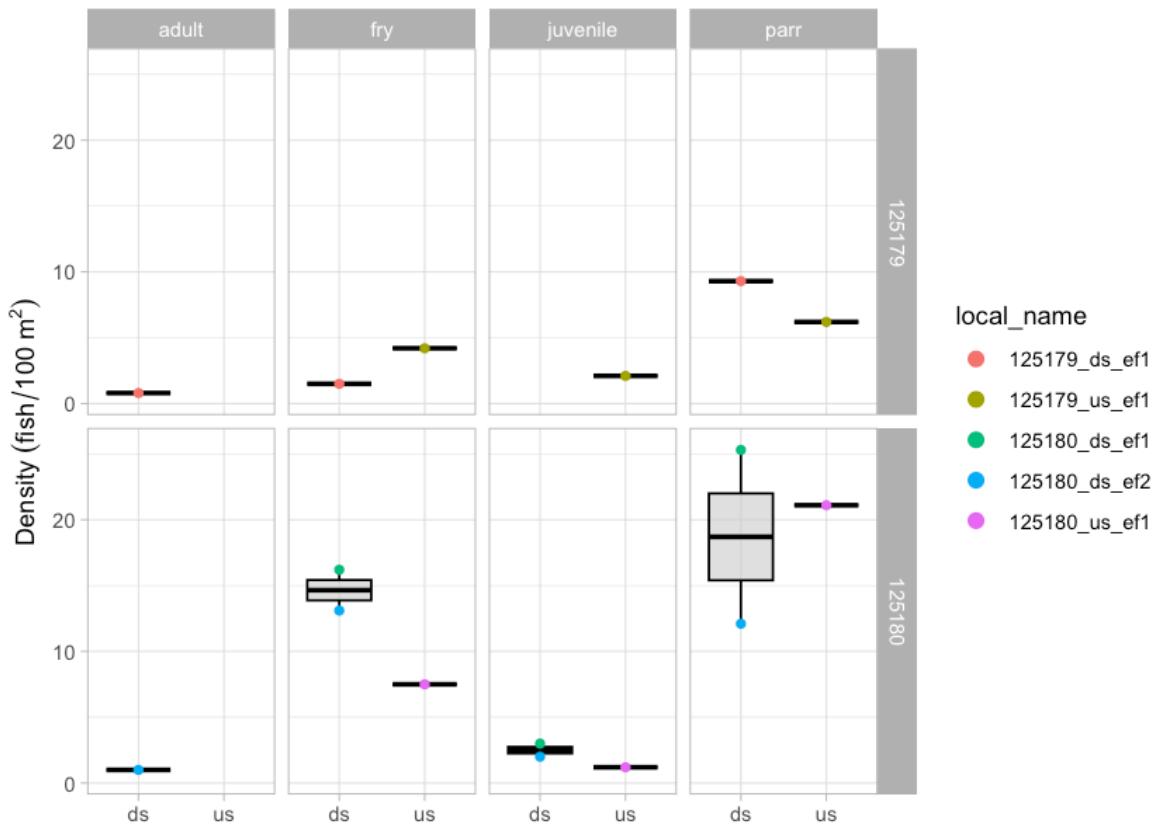
Figure 4.4: Densities of rainbow trout (fish/100m<sup>2</sup>) captured upstream and downstream of PSCIS crossings 125179 and 125180. Note that two sampling events were conducted within the same sampling site on different days - downstream of site 125180
