# **AN 919: Improving Quality of Results with Design Assistant**

**AN-919**

## Improving Quality of Results with Design Assistant

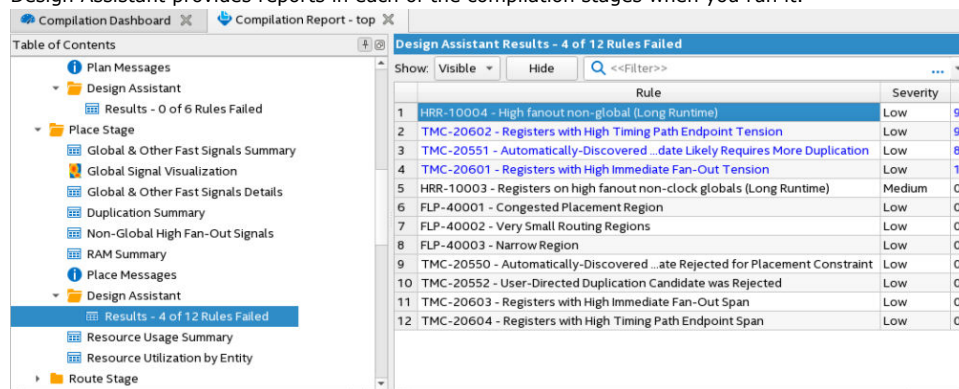
**Figure 1. Design Assistant Report**

Design Assistant provides reports in each of the compilation stages when you run it.

Rule	Severity	Count
1 HRR-10004 - High fanout non-global (Long Runtime)	Low	9
2 TMC-20602 - Registers with High Timing Path Endpoint Tension	Low	9
3 TMC-20551 - Automatically-Discovered ...ate Likely Requires More Duplication	Low	8
4 TMC-20601 - Registers with High Immediate Fan-Out Tension	Low	1
5 HRR-10003 - Registers on high fanout non-clock globals (Long Runtime)	Medium	0
6 FLP-40001 - Congested Placement Region	Low	0
7 FLP-40002 - Very Small Routing Regions	Low	0
8 FLP-40003 - Narrow Region	Low	0
9 TMC-20550 - Automatically-Discovered ...ate Rejected for Placement Constraint	Low	0
10 TMC-20552 - User-Directed Duplication Candidate was Rejected	Low	0
11 TMC-20603 - Registers with High Immediate Fan-Out Span	Low	0
12 TMC-20604 - Registers with High Timing Path Endpoint Span	Low	0
