2025 PVN FME Q1 Work Report

Dept.: BG6-Manufacturing&Operation Management Center.-Vietnam Manufacturing Div.-PVN1 Factory-FME Dept.-Automation Sec.
Name: Andrew Hoang 黃文龍
Date: 2025/03/19

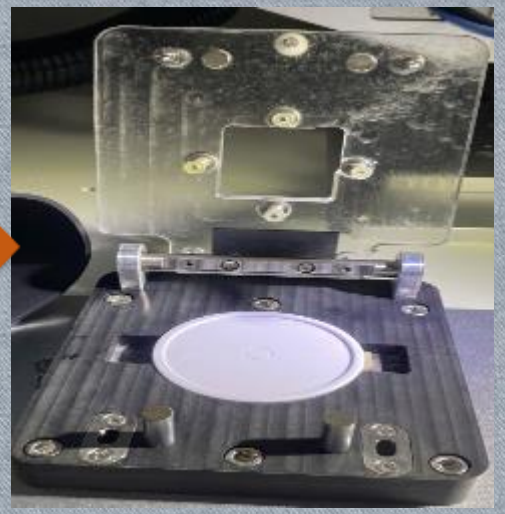
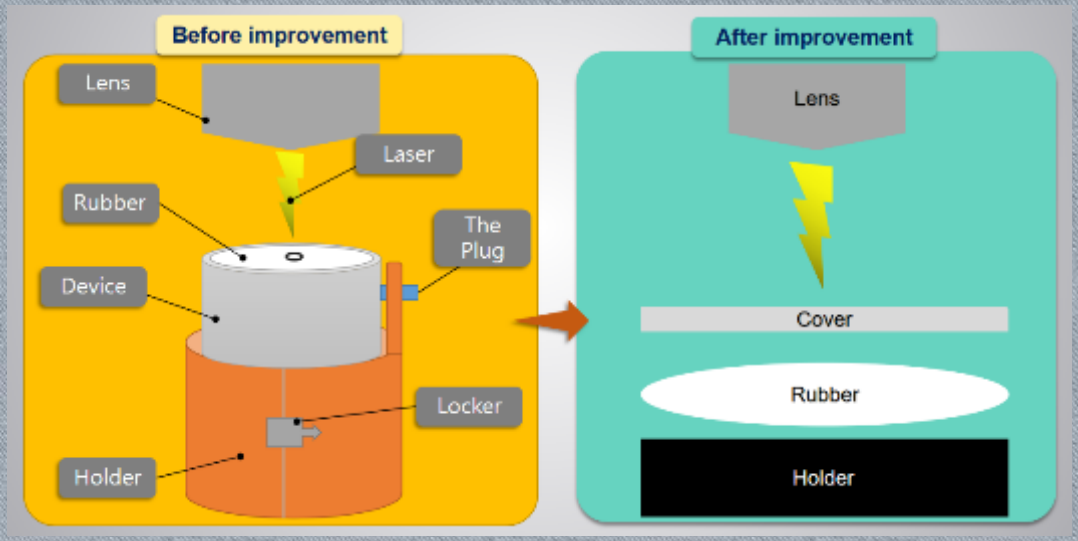
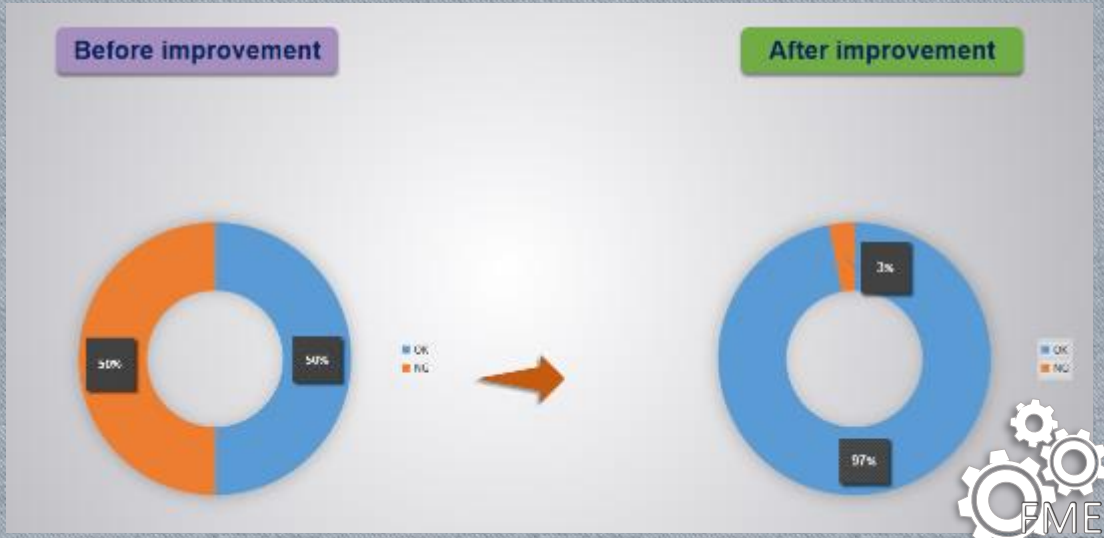
1.Improved UI UDR7 laser engraving machine, top rubber offet engraving.

Have problems with deviation form standard.

The combined tolerance of fixture and assembly will cause the rotation/shift issue of laser artwork.

After changing the Jig, the improvement can be seen immediately. The laser engraving deviation rate is significantly reduced, along with the simple operation of the new Jig, it helps OP get used to it easier and faster, improving productivity.

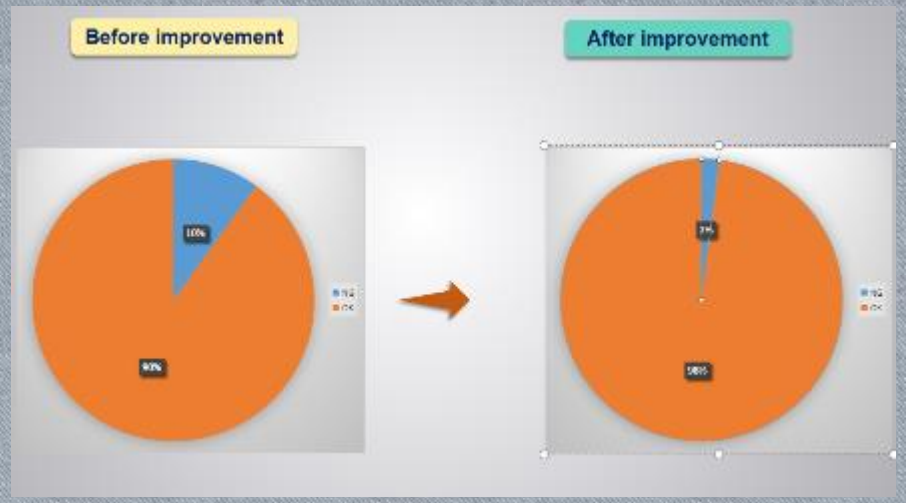
2.Change and setup the laser machine model KD-HDZ200 of the Gucci Pavilion's line.

Due to the discovery that the engraved product has a color that is duller than standard 3C~ 5C.

Because laser head power is insufficient,and the contractor requested to purchase a new laser head.

Because the cost of buying a new laser head is quite expensive and we already have a laser machine model KD-HDZ200, We setup a UV machine model KD-HDZ200(Han's laser) to replaced the old UV machine(Laservall). After setup UPH has been improved from 1400 to 1500.

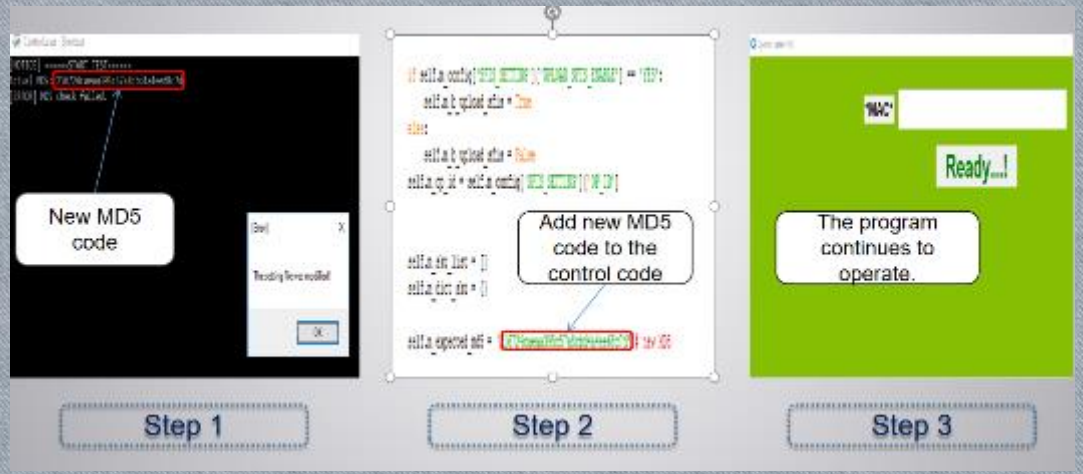
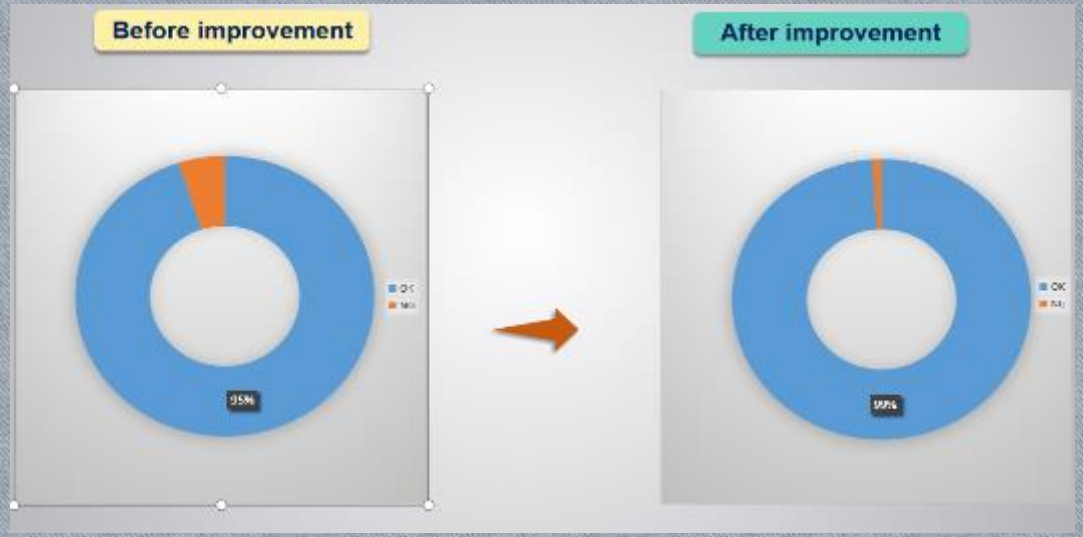
3. Improved laser control program for UI U6-Mesh laser machine report.

Due to the detection of changed setting files, it leads to incorrect engraving.

Because the setting file is not strictly managed, it is easy to change the setting file.

We have added MD5 code to the control program code. When there is any change in the setting file, the program will notify that the setting file has modified and a new MD5 code will be generated. We must change the new MD5 code in the control program code so that the machine can work normally.
