2016.0 RANGE ROVER (LG), 501-25

BODY REPAIRS - GENERAL INFORMATION

BODY EARTH STUD REPAIR

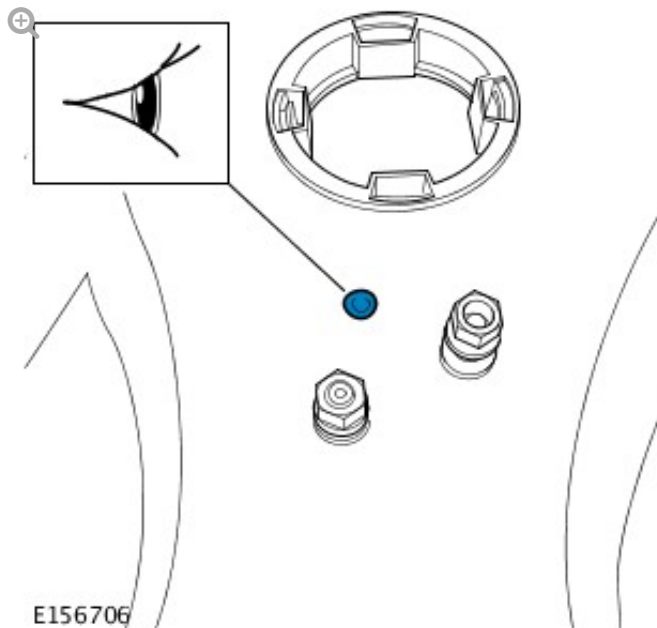
E161219

The plastic earth protection cradle is not compatible with the new stud.

When fitting the repair ground stud please remove the harness cradle from the harness before re-attaching the eyelet to the stud and tightening.

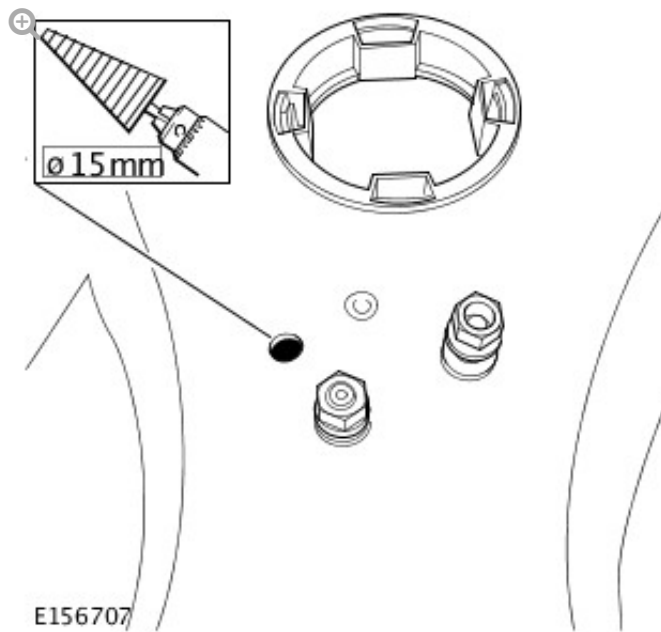
E156706

Locate the broken or cross threaded stud.

3. Dress/file the broken stud to a safe and acceptable repair standard.
