Some problems associated with Injection molding

Top-10 Injection Molding Defects and How to Fix Them

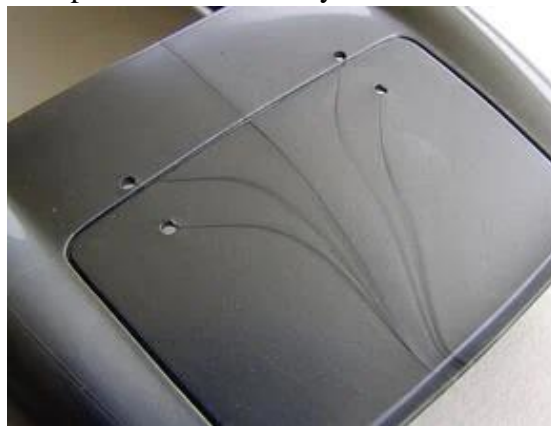
1. Flow Lines

Description: Flow lines are streaks, patterns, or lines - commonly off-toned in color - that show up on the prototype part as a consequence of the physical path and cooling profile of the molten plastic as it flows into the injection mold tooling cavity. Injection molded plastic begins its journey through the part tooling via an entry section called a “gate.” It then flows through the tool cavity and cools (eventually hardening into a solid).

Causes: Flow line defects are caused by the varying speed at which the molten plastic flows as it changes direction through the contours and bends inside the mold tool. They also occur when the plastic flows through sections with varying wall thickness, or when the injection speed is too low causing the plastic to solidify at different speeds.

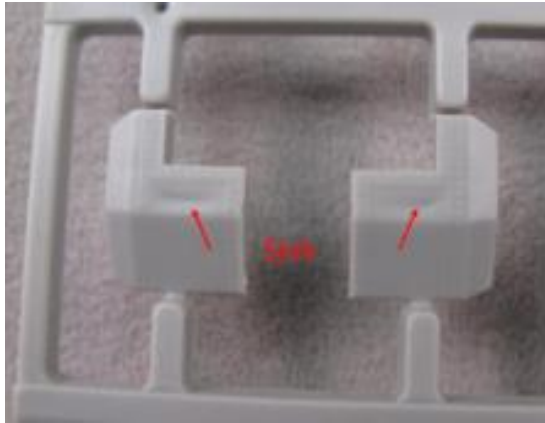
2. Sink Marks

Description: Sink marks are small craters or depressions that develop in thicker areas of the injection molded prototype when shrinkage occurs in the inner portions of the finished product. The effect is somewhat similar to sinkholes in topography, but caused by shrinkage rather than erosion.

Causes: Sink marks are often caused when the cooling time or the cooling mechanism is insufficient for the plastic to fully cool and cure while in the mold. They can also be caused by inadequate pressure in the cavity, or by an excessive temperature at the gate. All else being equal, thick sections of the injection molded part take longer to cool than thin ones and so are more likely to be where sink marks are located.

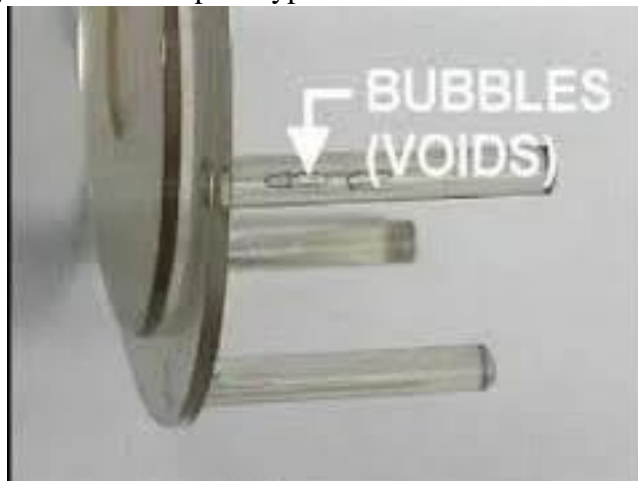
3. Vacuum Voids

Description: Vacuum voids are pockets of air trapped within or close to the surface of an injection molded prototype.

Causes: Vacuum voids are often caused by uneven solidification between the surface and the inner sections of the prototype. This can be aggravated when the holding pressure is insufficient to condense the molten plastic in the mold (and thereby force out air that would otherwise get trapped). Voids can also develop from a part that is cast from a mold with two halves that are not correctly aligned.

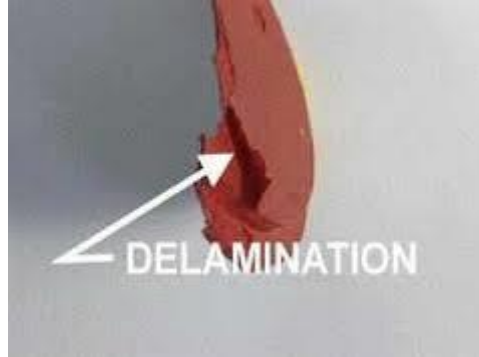
4. Surface Delamination

Description: Surface delamination is a condition where thin surface layers appear on the part due to a contaminant material. These layers appear like coatings and can usually be peeled off (i.e., “delaminate”).

Causes: Foreign materials that find their way into the molten plastic separate from the finished product because the contaminant and the plastic cannot bond. The fact that they cannot bond not only has an effect on the appearance of the prototype, but also on its strength. The contaminant acts as a localized fault trapped within the plastic. An over-dependence on mold release agents can also cause delamination.

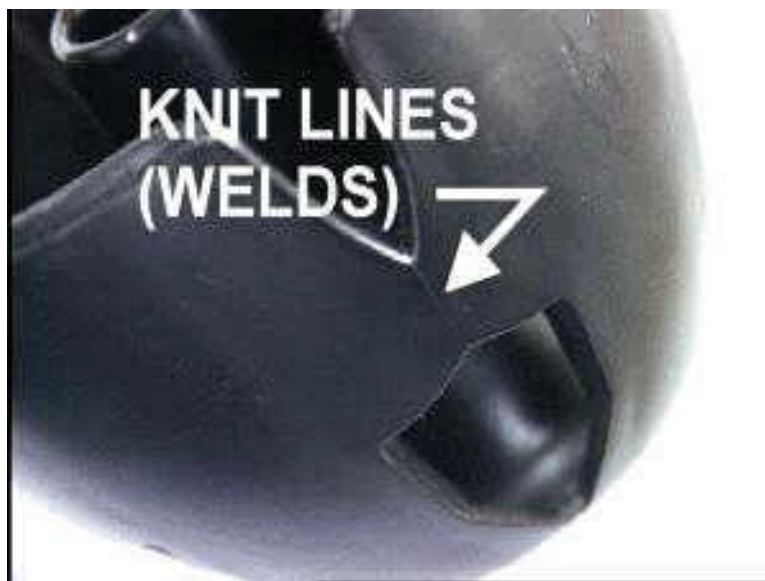
5. Weld Lines

Description: Weld lines are actually more like a plane than a line that appears in a part where molten plastics meet each other as they flow from two different parts of the mold.

Causes: Weld lines are caused by the inadequate bonding of two or more flow fronts when there is partial solidification of the molten plastic.

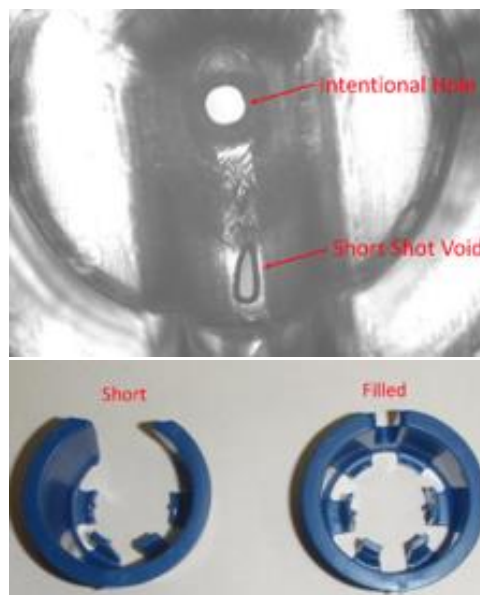
6. Short Shots

Description: As the term implies, short shots can be described as a situation where a molding shot falls short. This means that the molten plastic for some reason does not fully occupy the mold cavity or cavities, resulting in a portion where there is no plastic. The finished product becomes deficient because it is incomplete.

Causes: Short shots can be caused by a number of things. Incorrect calibration of the shot or plasticizing capacities can result in the plastic material being inadequate to fill the cavities. If the plastic is too viscous, it may solidify before fully occupying all the cavities and result in a short shot. Inadequate degassing or gas venting techniques can also result in short shots because air is trapped and has no way to escape; plastic material cannot occupy the space that air or gas is already occupying.

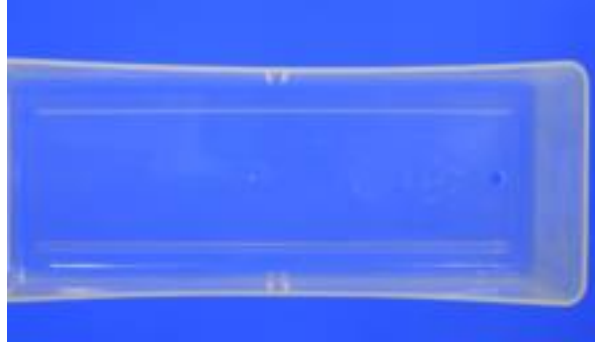
7. Warping

Description: Warping (or warpage) is the deformation that occurs when there is uneven shrinkage in the different parts of the molded component. The result is a twisted, uneven, or bent shape where one was not intended.

Causes: Warping is usually caused by non-uniform cooling of the mold material. Different cooling rates in different parts of the mold cause the plastic to cool differently and thus create internal stresses. These stresses, when released, lead to warping.

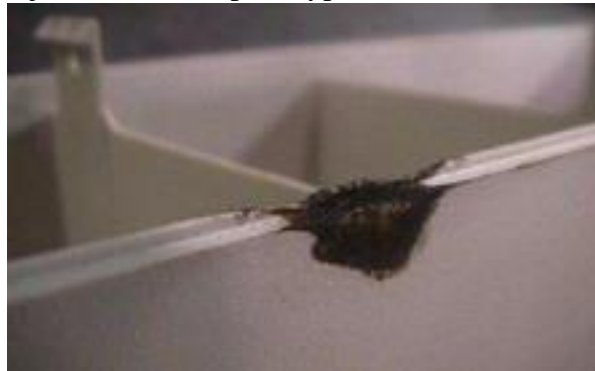
8. Burn Marks

Description: Burn marks are discolorations, usually rust colored, that appear on the surface of the injection molded prototypes.

Causes: Burn marks are caused either by the degradation of the plastic material due to excessive heating or by injection speeds that are too fast. Burn marks can also be caused by the overheating of trapped air, which etches the surface of the molded part.

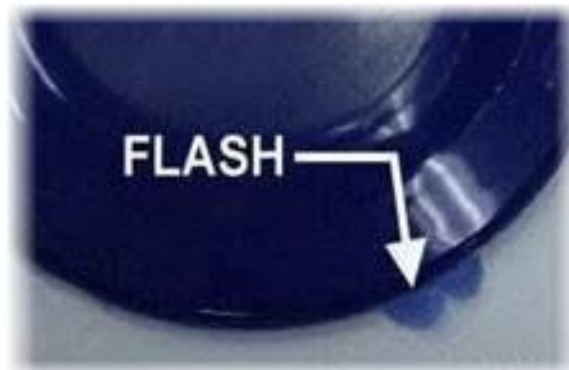
10. Flash

Description: Flash is a molding defect that occurs when some molten plastic escapes from the mold cavity. Typical routes for escape are through the parting line or ejector pin locations. This extrusion cools and remains attached to the finished product.

Causes: Flash can occur when the mold is not clamped together with enough force (a force strong enough to withstand the opposing forces generated by the molten plastic flowing through the mold), which allows the plastic to seep through. The use of molds that have exceeded their lifespan will be worn out and contribute to the possibility of flash. Additionally, excessive injection pressure may force the plastic out through the route of least resistance.
