2016.0 RANGE ROVER (LG), 501-05

INTERIOR TRIM AND ORNAMENTATION

LEATHER TRIM PANEL

DOOR TRIM PANEL NON-MANUFACTURING DEFECT GUIDELINES

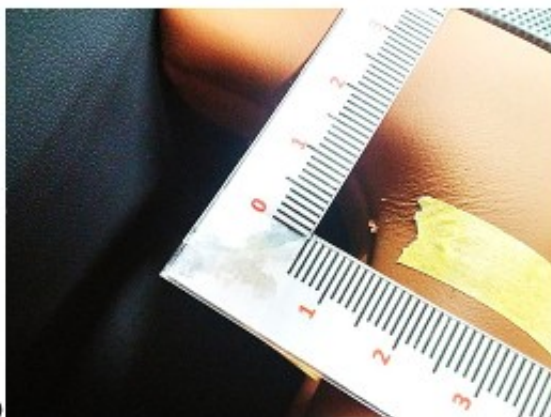
E199586

The examples below show damage such as cuts, tears, scratches scrapes, snags, visual surface burns and indentation marks. These types of damage would not be accepted under the terms of the Jaguar Land Rover warranty agreement (unless damage was noted on pre-delivery inspection).
