1. SUBSYSTEM TITLE PWR	2. NEED DATE	3. TPS NUMBER PAN-TPS-PWR-001-EDU	4. REVISION 001	5. PAGE 1 of 4
---------------------------	--------------	--------------------------------------	--------------------	-------------------

TITLE Install New Piksi Firmware	AUTHOR Stewart Aslan	DATE 9/30/2019
8. PURPOSE Install new Piksi firmware with the GPS COCOM limit removed.	APPROVALS (Printed or Typed and Signed)	
	11.	DATE
	12.	DATE
	13.	DATE

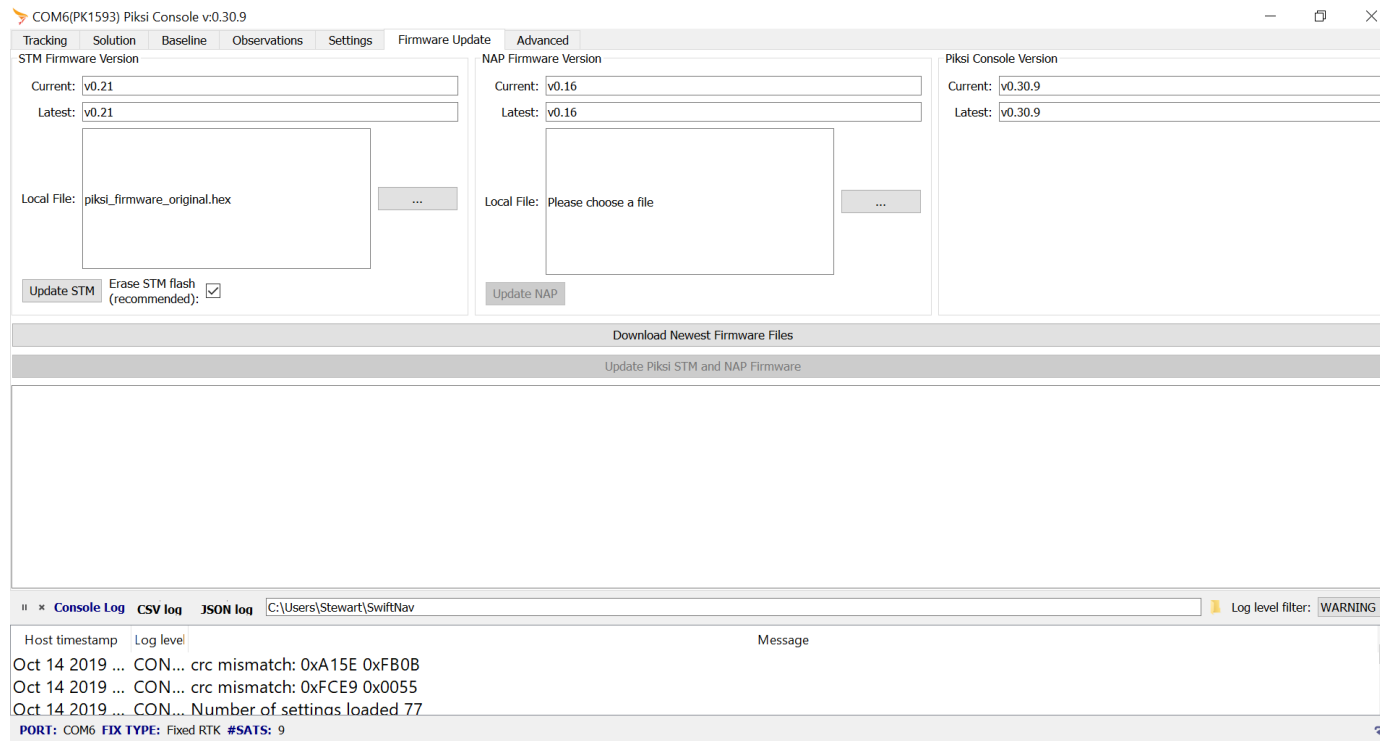
8. Under STM Firmware Version, browse for file and choose the hacked firmware

9. Select “Update STM”
10. Wait for the firmware update to finish. If a dialog box appears asking to update firmware to the newest version, close it.
11. Verify that Piksi is still communicating with the console
12. In the “Settings” tab, scroll down to the “simulator” section and verify that “enabled” is set to “False”
13. Disconnect Piksi from USB
14. Verify that the flight computer can communicate with Piksi
 - a. We plugged in the Piksi to Umbilical harness since we had unplugged it earlier
 - b. Download Test Code Scripts from [here](#)
 - c. Turn the satellite on by removing the RBF pin
 - d. Unzip the test code scripts folder
 - e. Unzip PiksiTest.zip
 - f. Open the Piksi Ping Test arduino script
 - g. Plug in the Teensy to the USB cable with power cut
 - h. Upload the Piksi Ping Test script to the Teensy
