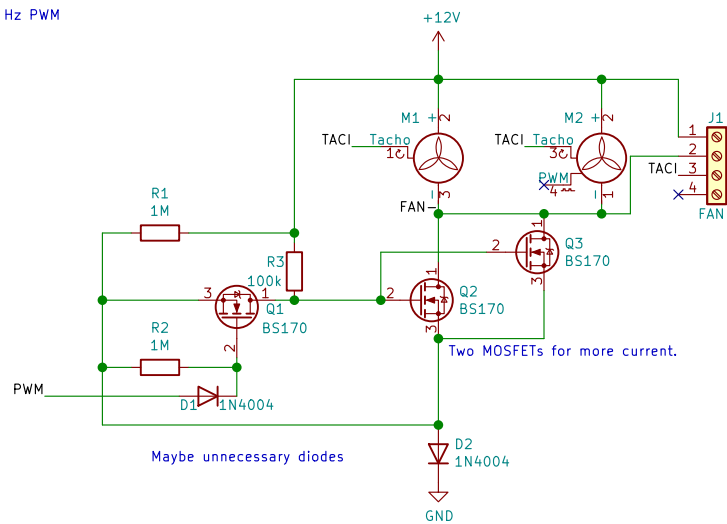
Maybe unnecessary diodes

- TACO is chopped by PWM
- FAN_PWM should be held low while counting TACO
- Two rising edges per rotation
