2016.0 RANGE ROVER (LG), 205-03

# FRONT DRIVE AXLE/DIFFERENTIAL

## DIAGNOSIS AND TESTING

## TCM DTCS P0721-62 OR P0721-64 - DIFFERENTIAL/FINAL DRIVE RATIO CHECKS

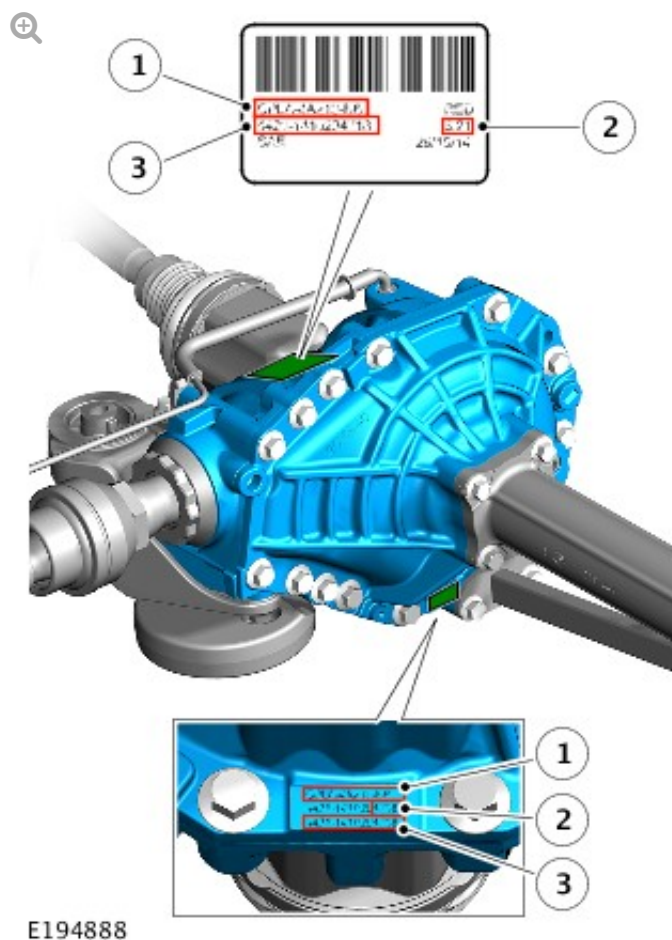
E194888

1 - Land Rover Part Number

2 - Ratio

3 - Serial Number

To check the correct differential units are fitted, cross check the part numbers found on the labels attached to the front and rear differential casings (see illustration above) with the part numbers listed in the tables below:
