Composite Manufacturing Test Logs

Author: Joseph Hayes

Introduction

The following is a list of tests with various composite materials. Each test includes lessons learned, fiber used, matrix used, and overall quality descriptions.

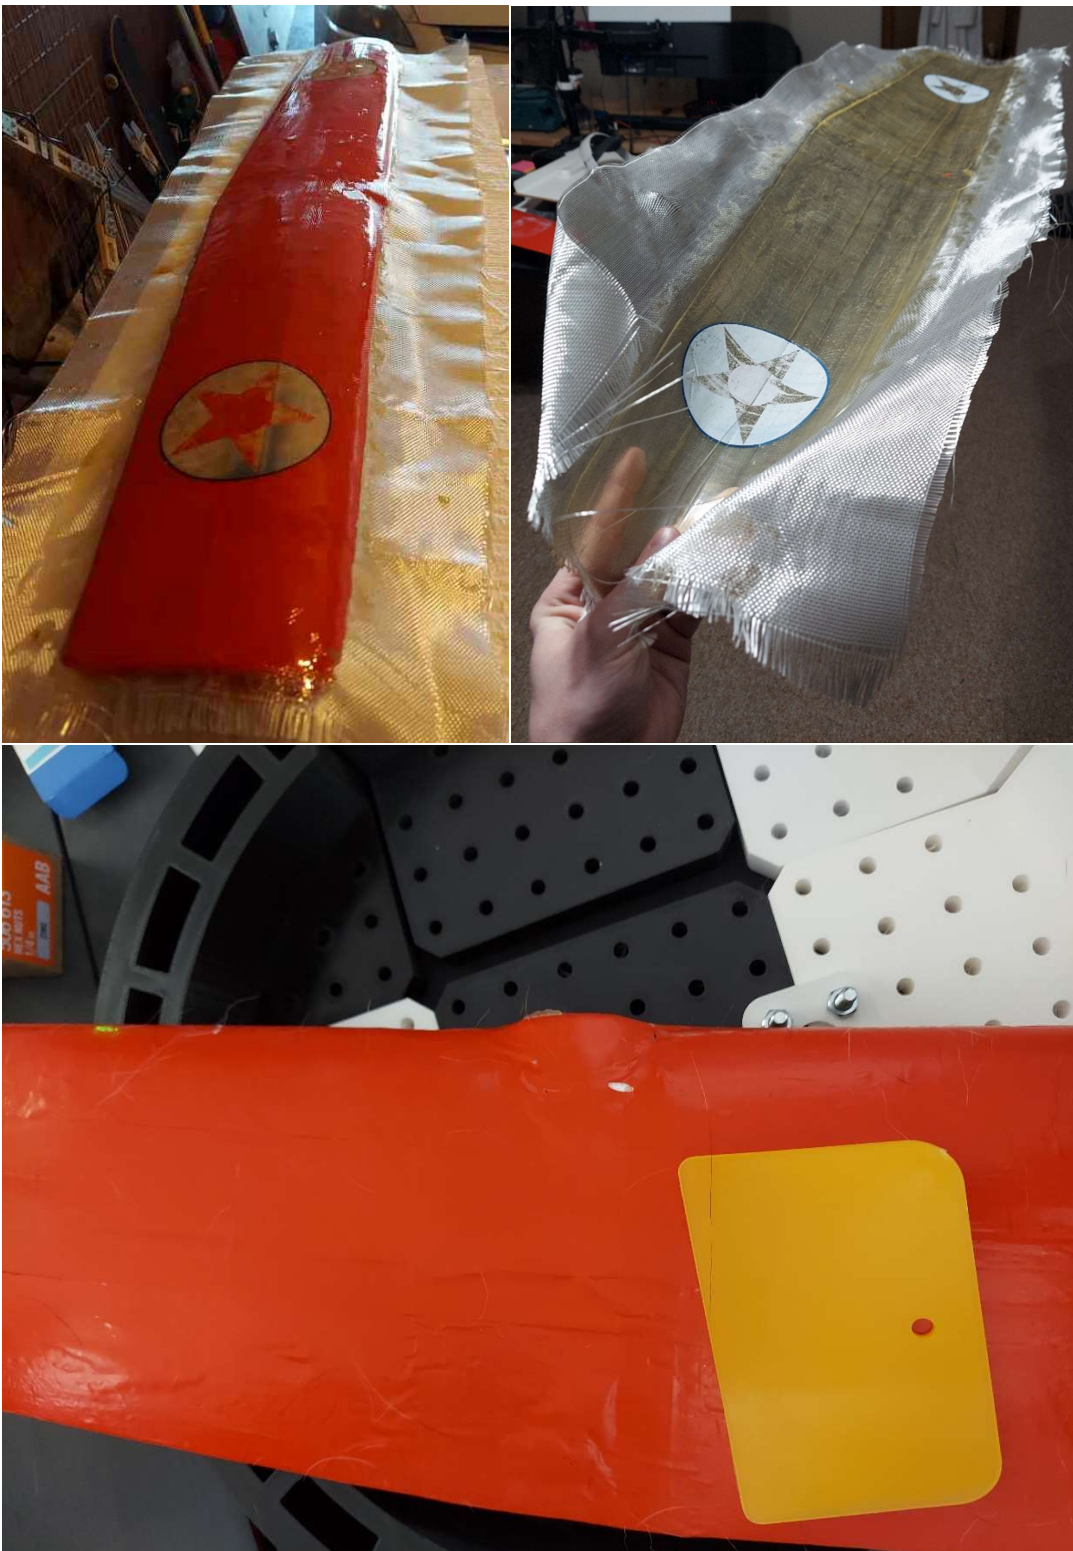
- Extra attention was given to removing small air bubbles that was not given during test 1. Not all bubbles could be removed before the end of the time limit however.

- After 24 hours on the mold after the 2nd coating, the composite was removed.
 - It would be interesting to analyze how peeling off the mold affects durability

- i.e. does this method result in micro fissures in the composite and if so, what do those micro fissures contribute to yield strength and lifespan?
 - After removing this mold minor damage was seen on the tape mold. It is worth noting however, that the age of the mold is unknown and the removal method was not optimal.

- Quality – 5/10
 - Top surface is very smooth considering no post processing was done (with the exception of the occasional bubble).
 - The bottom surface is relatively smooth but would require some post-processing to remove markings left by the tape edges and imperfections covering the mold. For wings only experiencing positive AOA this probably would not affect performance much.

- Test 2 is stiffer than test 1 but not by much. It cannot support its own weight when cantilevered unless occasional wing ribs are in place to keep the surface curved. A sturdy flat wing spar may also allow it to hold its shape, but it doesn't matter much because neither solution is likely to make it flight worthy by itself.
