TECHNICAL SERVICE BULLETIN

Liftgate Mounted Rear Lamp - Child Part Service Procedure

26-2111

Ford 2021-2026 Next-Generation Everest
--

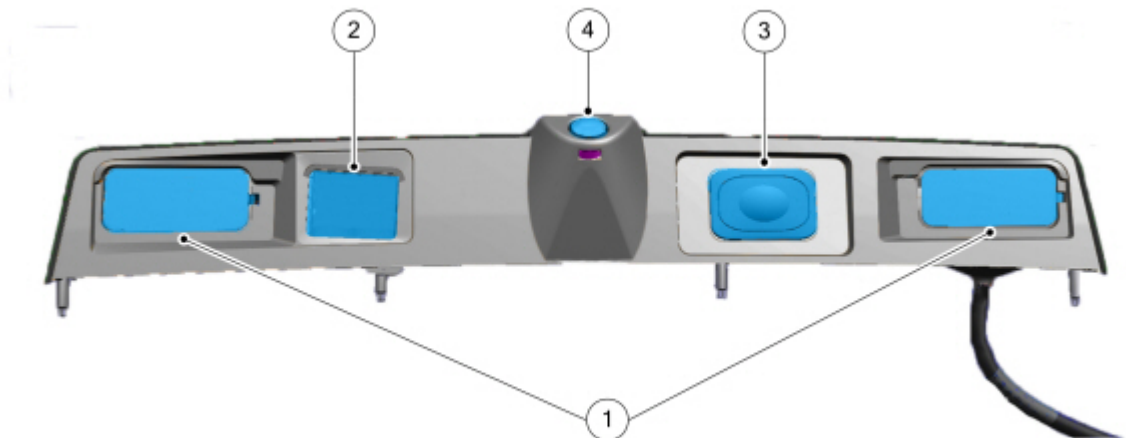
Figure 2

Item	Description
1.	Licence plate lamps
2.	Trailer Backup Assist (TBA)
3.	Liftgate switch
4.	Rear parking aid camera

1. Remove the components from the lamp in the following order (Figure 2). Refer to Steps 2 to 5 below.

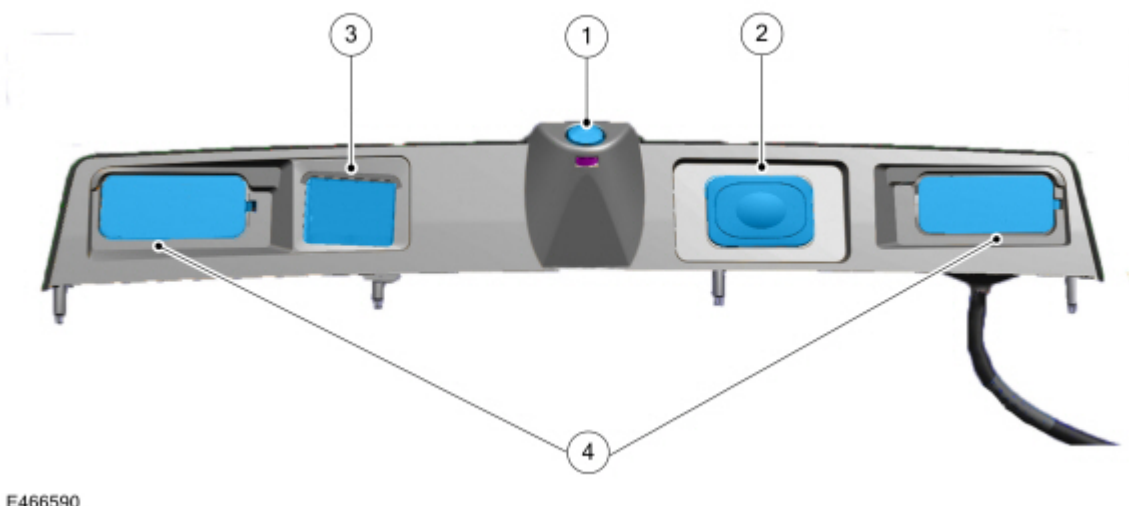
Figure 2

Item	Description
1.	Rear parking aid camera
2.	Liftgate switch
3.	Trailer Backup Assist (TBA)
4.	Licence plate lamps

1. Place the new liftgate mounted rear lamp on a workbench ensuring the plastic wrap remains on to ensure no scratches occur.
2. Install the components into the liftgate mounted rear lamp in the following order (Figure 7). Refer to Steps 3 to 6 below.
