TECHNICAL SERVICE BULLETIN

Vehicles Equipped With A 2.0L (Panther) Engine – Rattle Type Noise From The Transmission Area At Light Accelerator Input

25-2205

30 June 2025

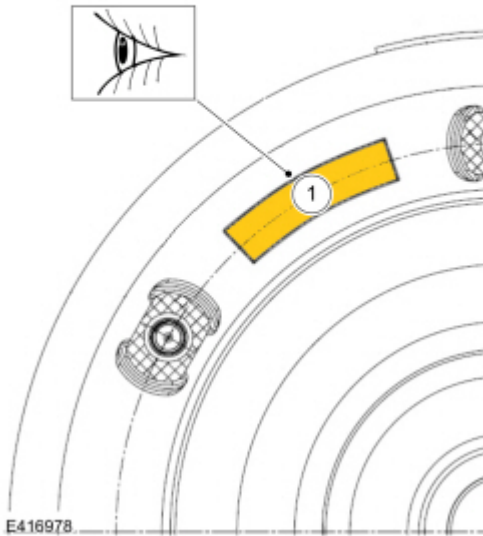
Figure 1

Callout 1: Ford Part Number Prefix and Suffix 3mm Max High Here

7. Remove the transmission and verify the torque converter part number Prefix and Suffix. Ensure the torque converter part number is JB3P-(7902)-JD or later. If the part number is JB3P-(7902)-JC or earlier, then replace the part with a new torque converter (JD or later). (Figure 1)
