GE Canada Electronic Products Repair

Test Instructions for

4006L6500 ALL GROUPS

Drive Control Card

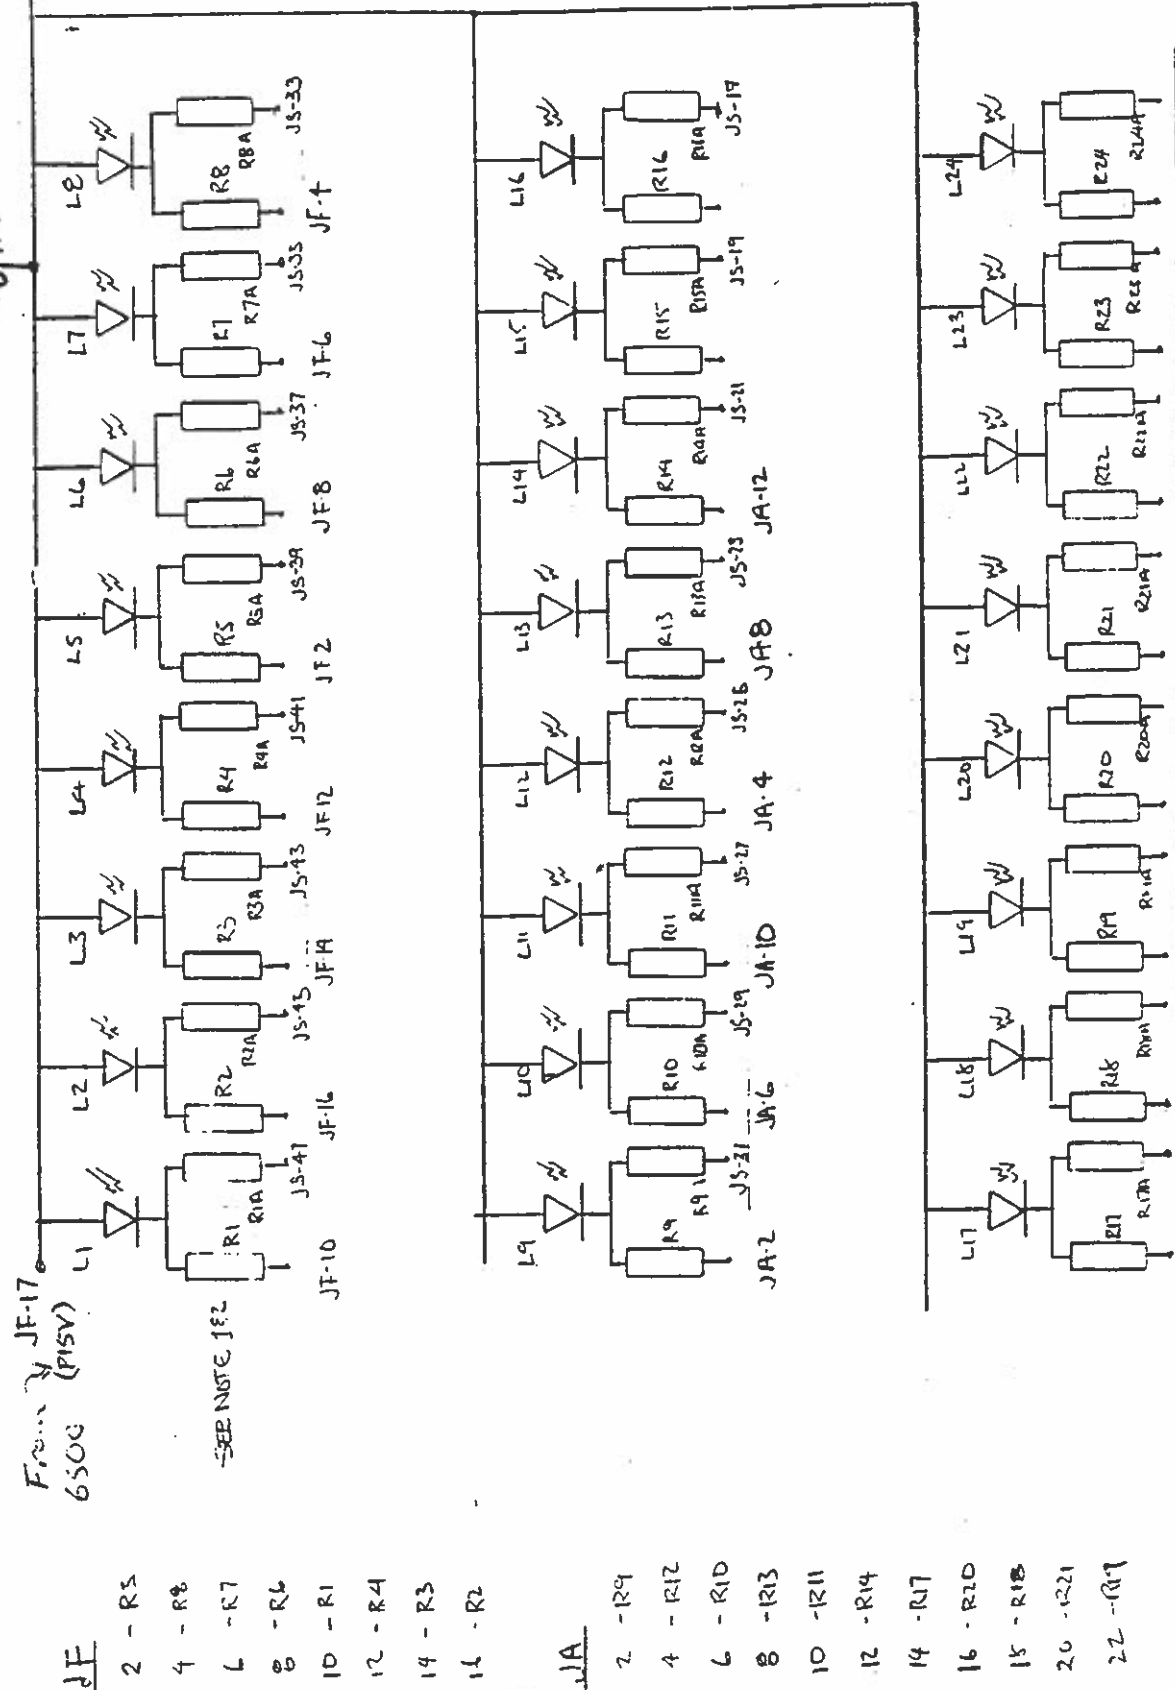
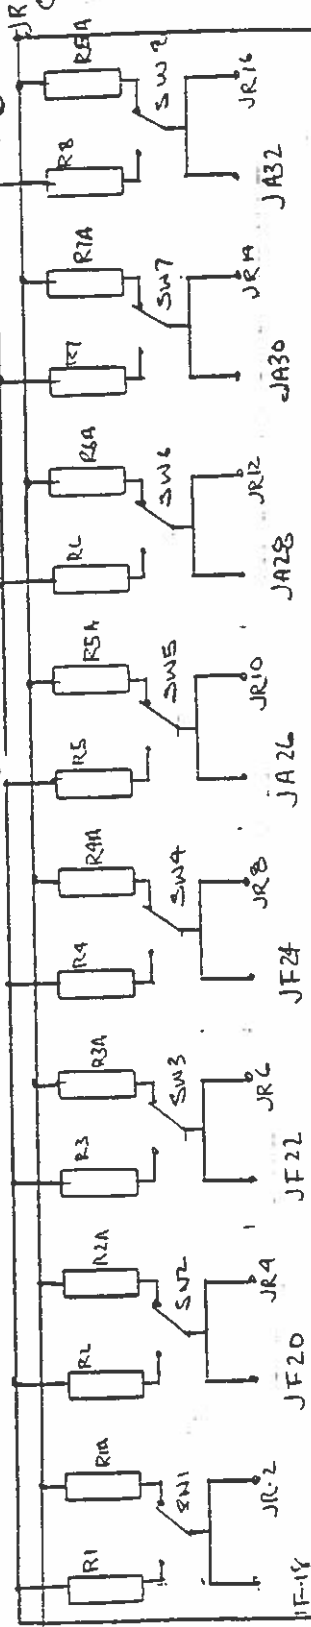
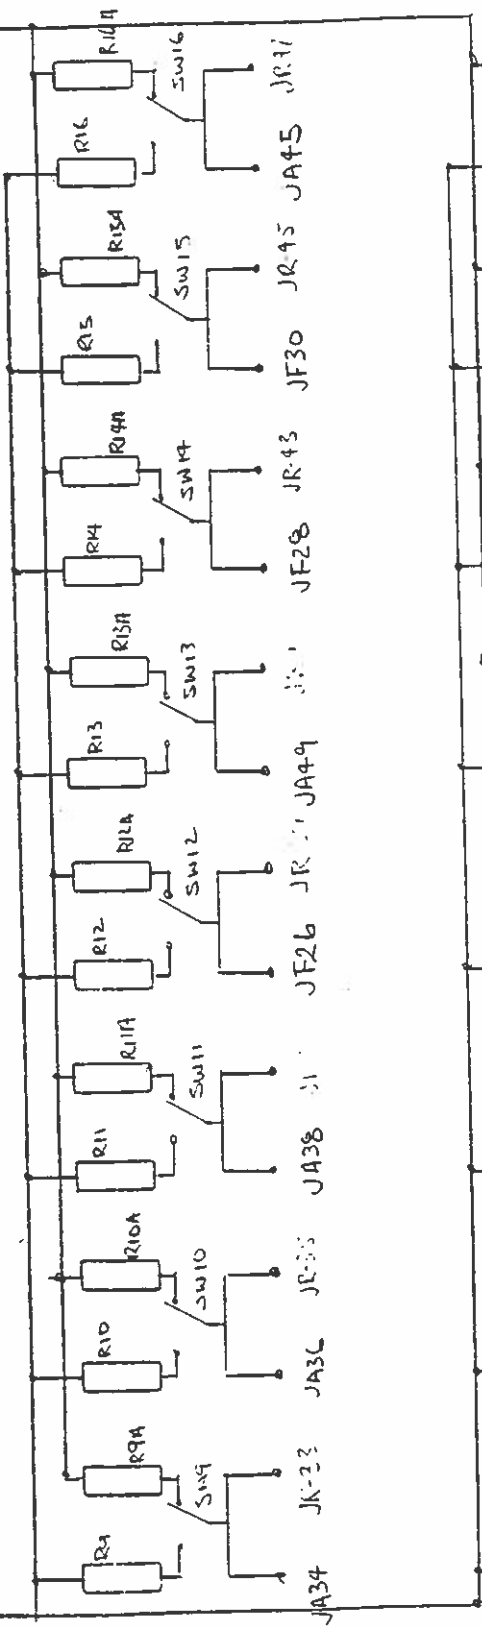
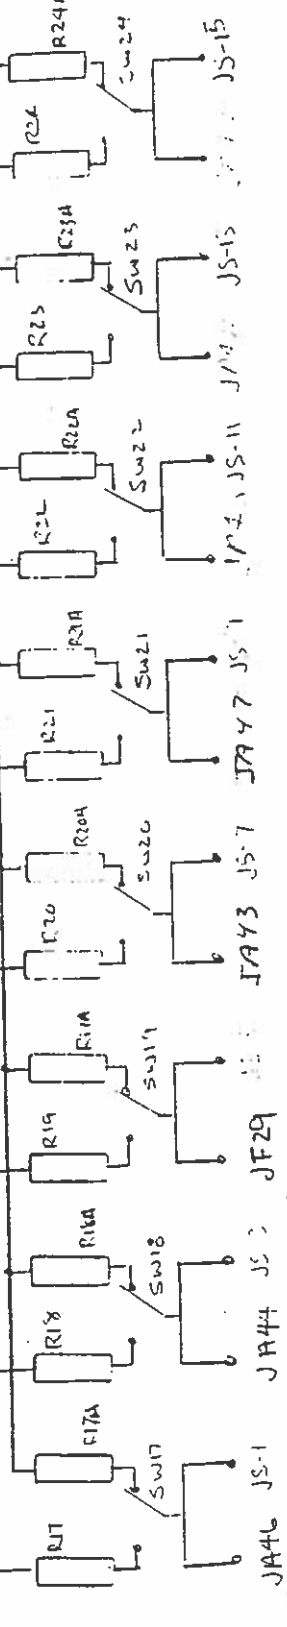
TEST BOX - SP32

4. JF-34 PIN CONNECTION
5. JA-50 PIN CONNECTION

- 1K - SW1
- 20 - SW2
- 22 - SW3
- 24 - SW4
- 26 - SW12
- 28 - SW14
- 29 - SW19
- 30 - SW15

- 26 - SW15
- 28 - SW16
- 30 - SW17
- 32 - SW18
- 34 - SW19
- 36 - SW10
- 38 - SW11
- 41 - SW18
- 45 - SW16
- 46 - SW17
- 49 - SW13
- 48 - COM
- 42 - COM
- 43 - SW20
- 44 - SW21
- 47 - SW21

1. DRIVE CONTROL DOES NOT REQUIRE PSV TO RESISTORS.
2. JR - 50 PIN CONNECTION
3. R1 - R8 = 300Ω 1/4W - (17A1457 - P36)
4. R9 - R24 = 100Ω 1/4W (17A1457 - P25)

- a. Connect the ribbon cables from JA and JF on the SP3200 Test panel to the JA and JF respectively on the card under test.
- b. Connect the 26pin cable from JI to CP1 to CP6 respectively.
- c. Pull switch (+15) on the Test panel away from the 34pin connector.
- d. Connect Lambda to 120VAC supply.
- e. Connect the Lambda power supply to the card under test.
- f. Connect +5VDC and Com to the Test Panel.
- g. Remove CPU (U1) and connect the pod to the U1 CPU socket. If the socket is the old style, it may need to be shaved down in order for the pod to be connected. If it is the CMOS style, a CPU adapter is required.
- h. The technician should verify if the customer, CASCADES BOXBOARD INC, wants G007 firmware installed. This applies to this customer only.
