FSA 25S82

Safety Recall 25S82 *Reissue* - **Final Repair**

Certain 2023-2025 Model Year F-150 Vehicles Equipped with 9.75" HD

Rear Axle Half-Shaft and Hub Assembly Replacement

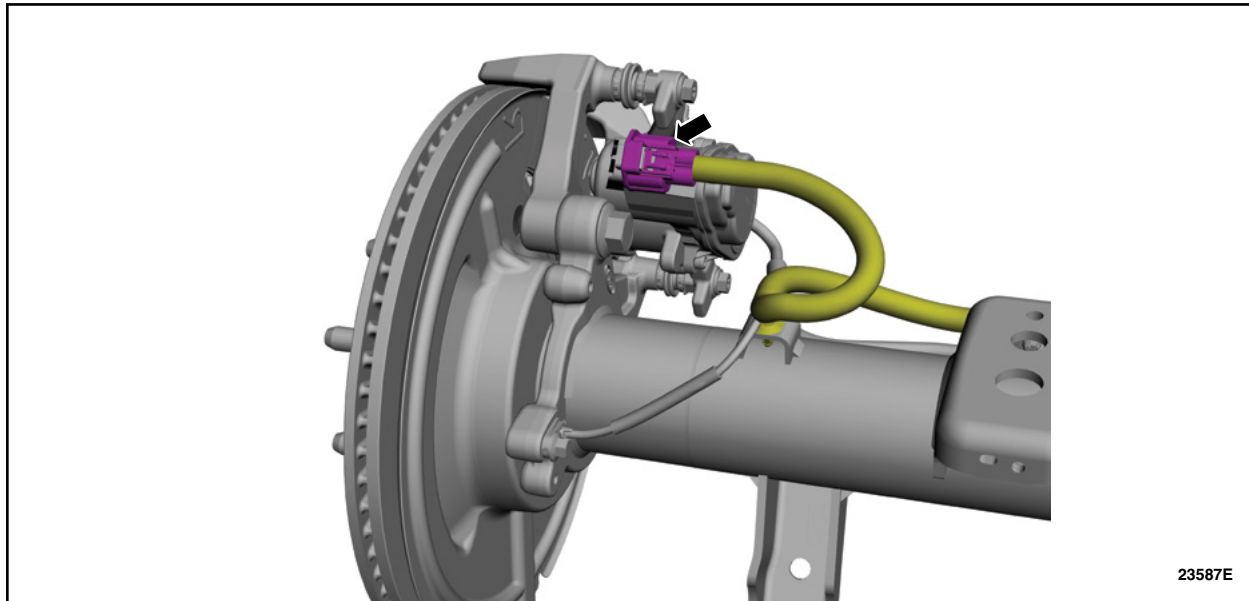
FIGURE 1

5. On both sides, disconnect the Electric Parking Brake (EPB) actuator motor electrical connector and position aside the wiring harness. See Figure 1.

11. On both sides, position back the wiring harness and connect the Electric Parking Brake (EPB) actuator motor electrical connector. See Figure 1.

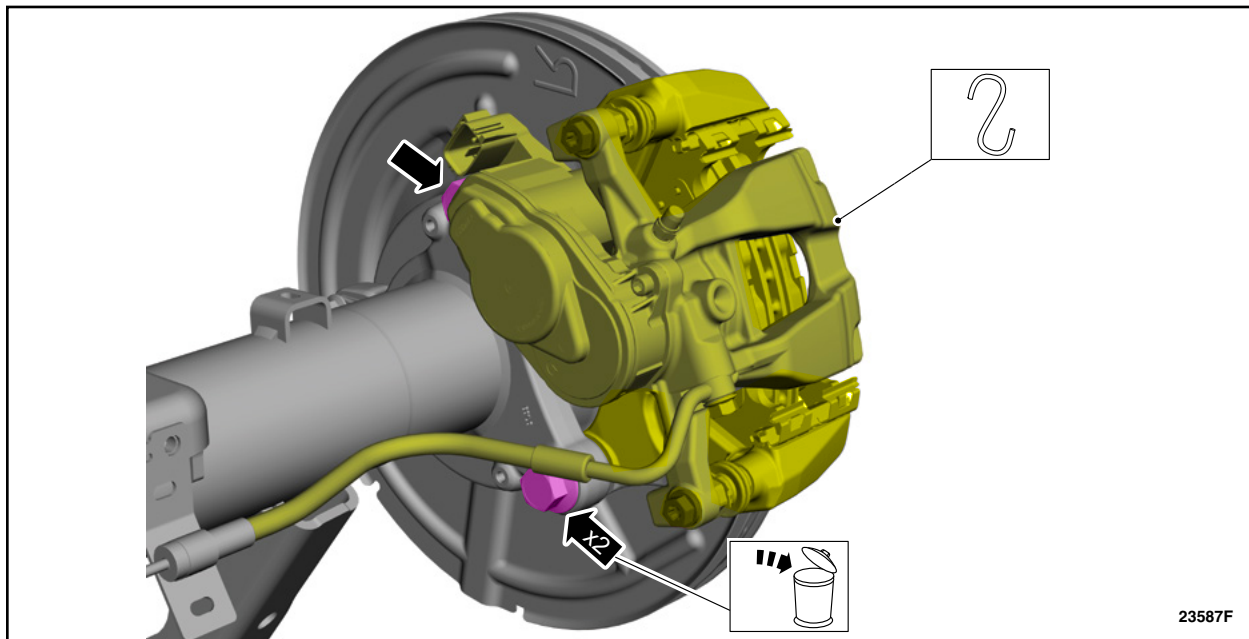
FIGURE 2

6. On both sides, remove and discard the two (2) anchor plate bolts and position aside the brake caliper and anchor plate assembly. See Figure 2.

10. On both sides, position back the brake caliper and anchor plate assembly and install the new bolts. See Figure 2.

- The anchor plate bolt is an M18, torque each bolt to 258 lb ft (350 Nm).

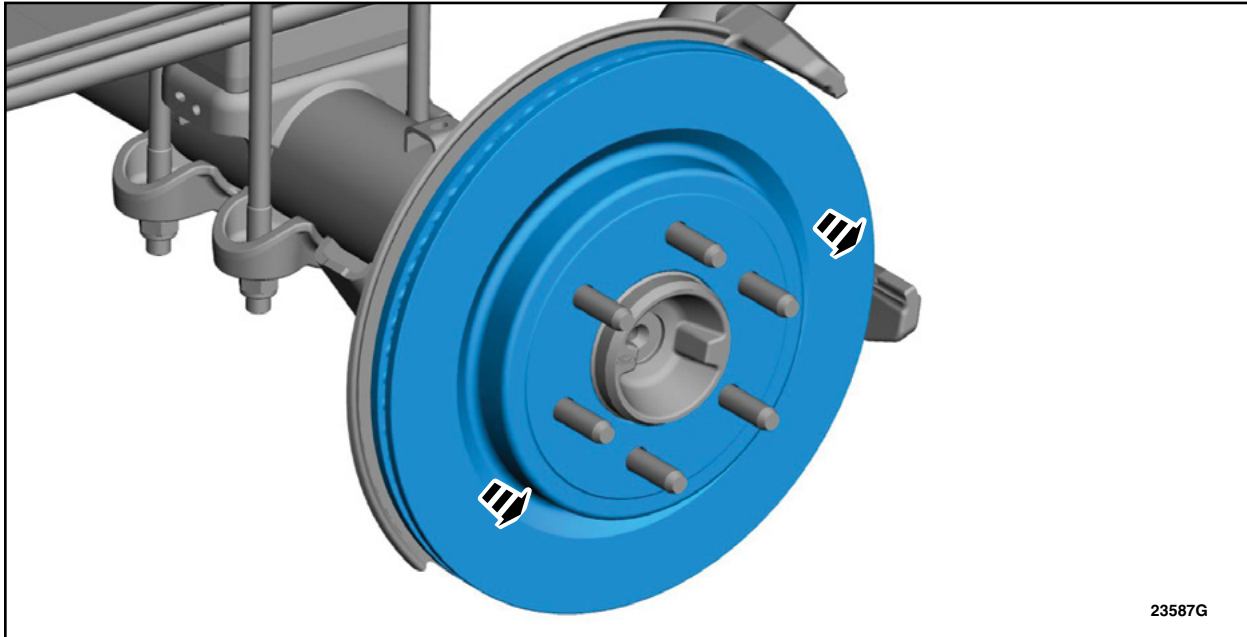
FIGURE 3

7. On both sides, remove the brake disc. See Figure 3.

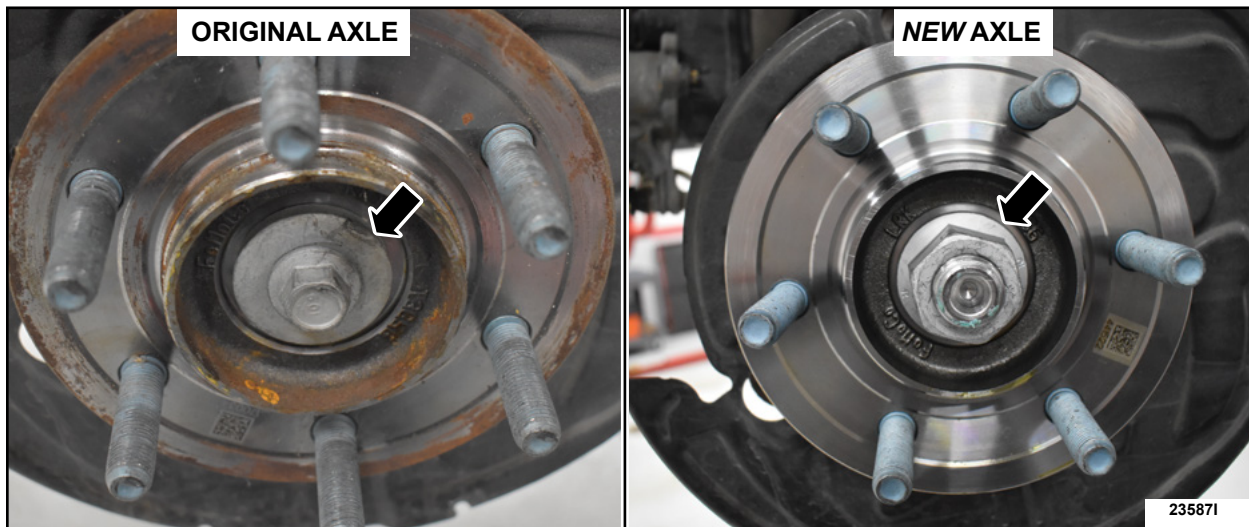
FIGURE 4

NOTE: The original axle has a bolt in the center to secure the hub to the axle shaft, the new axle is threaded and secured with a nut. See Figure 4.

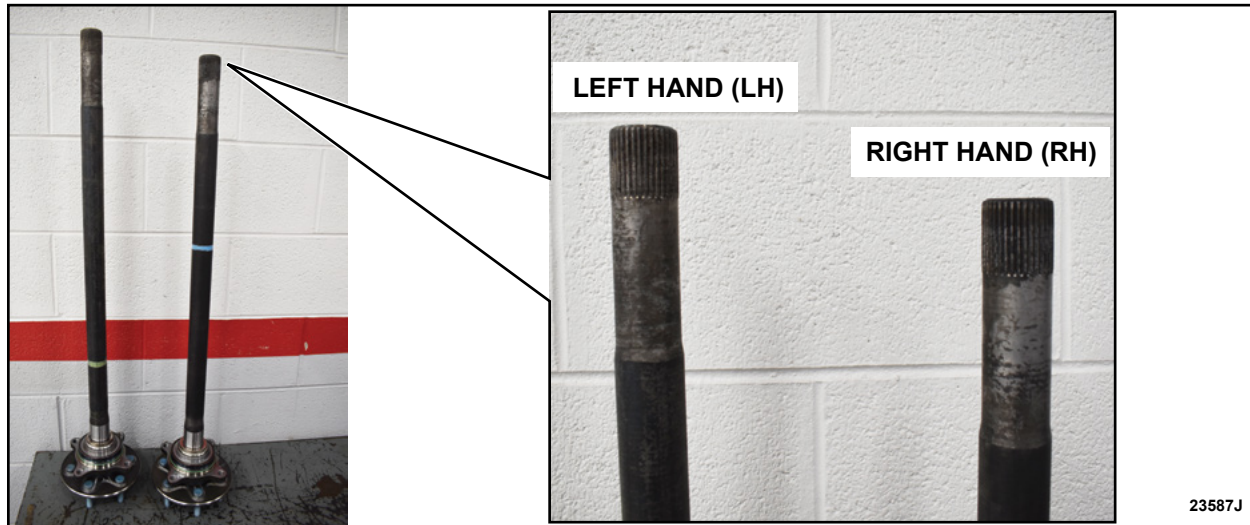
FIGURE 5

NOTE: The Right Hand (RH) side axle is shorter than the Left Hand (LH) side axle. See Figure 5.

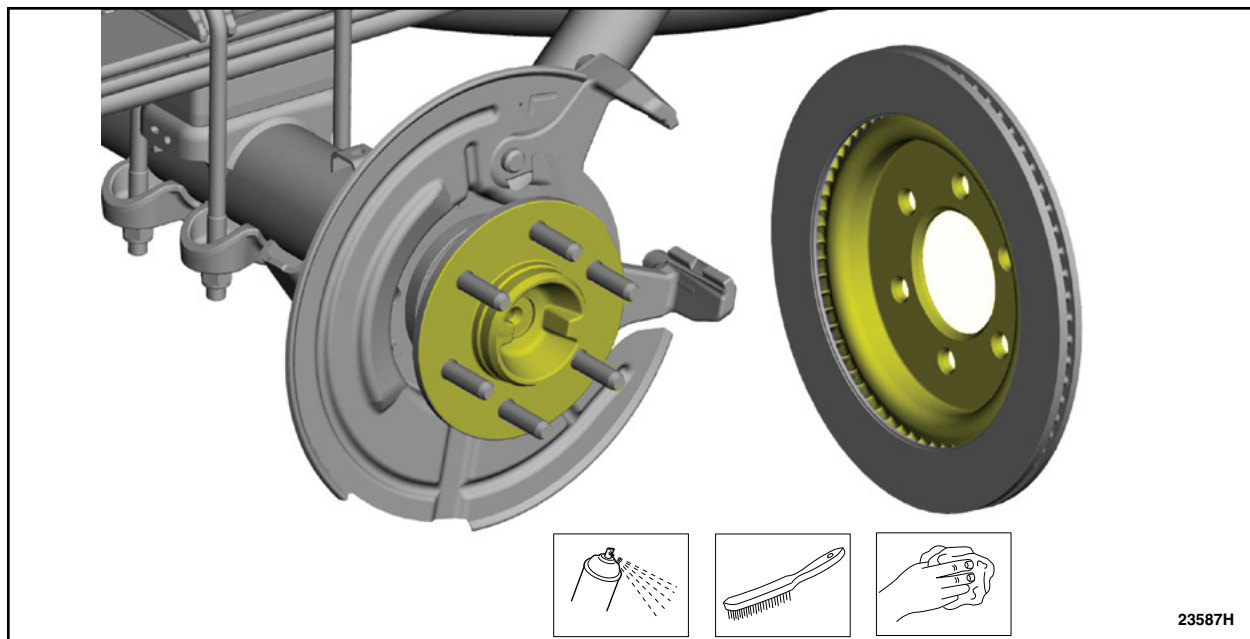
FIGURE 6

8. Starting on Step 2 of the WSM procedures in Section 205-02B, replace one or both rear axle shaft assemblies depending on the results found in Step 1. Then, continue to the next Step below.
9. On both sides, clean the brake disc mating surfaces using a wire brush and the specified material. See Figure 6. Material: Motorcraft® Metal Brake Parts Cleaner / PM-4-A, PM-4-B.
