**Thomas C. Turney**  
*Consulting Engineer*

## MEMORANDUM

Subject: Property at 316 East Buena Vista

Date: August 27, 2008

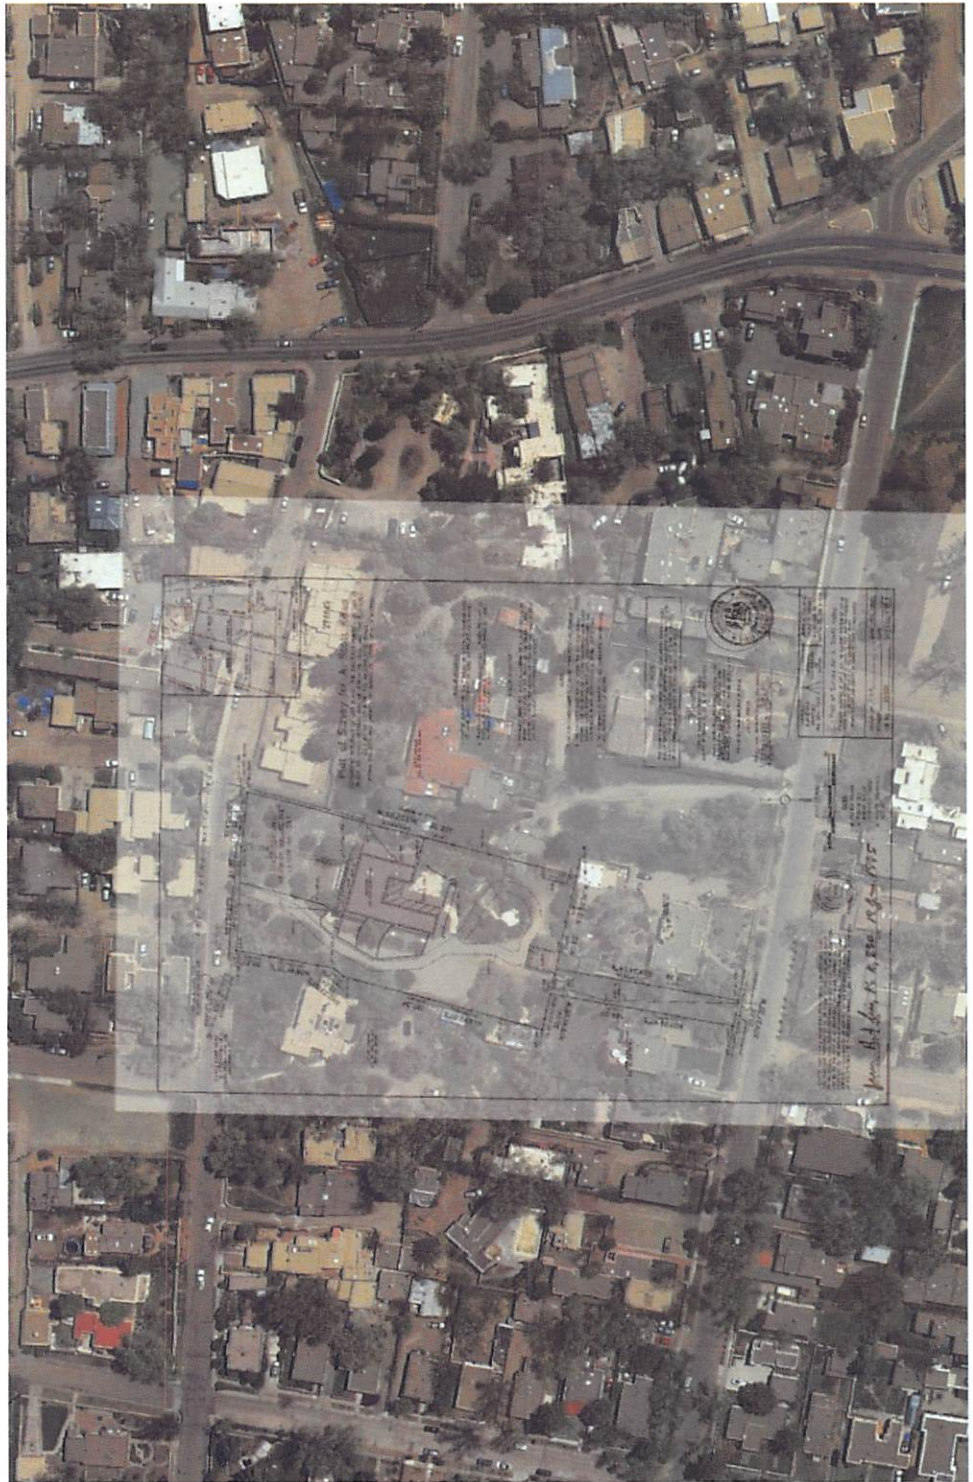
**Figure 1**  
Juan Flores 1995 Survey of the 316 East Buena Vista Street property over a 2005 aerial photograph

I met with you and Fran on August 8, 2008 to discuss the use of an old well, as well as water right issues relating to a parcel of property you are proposing to acquire. Figure 1 shows a 1995 survey of the property over a recent aerial photo. The property is located at 316 E. Buena Vista Street. I will summarize my findings and research to-date.

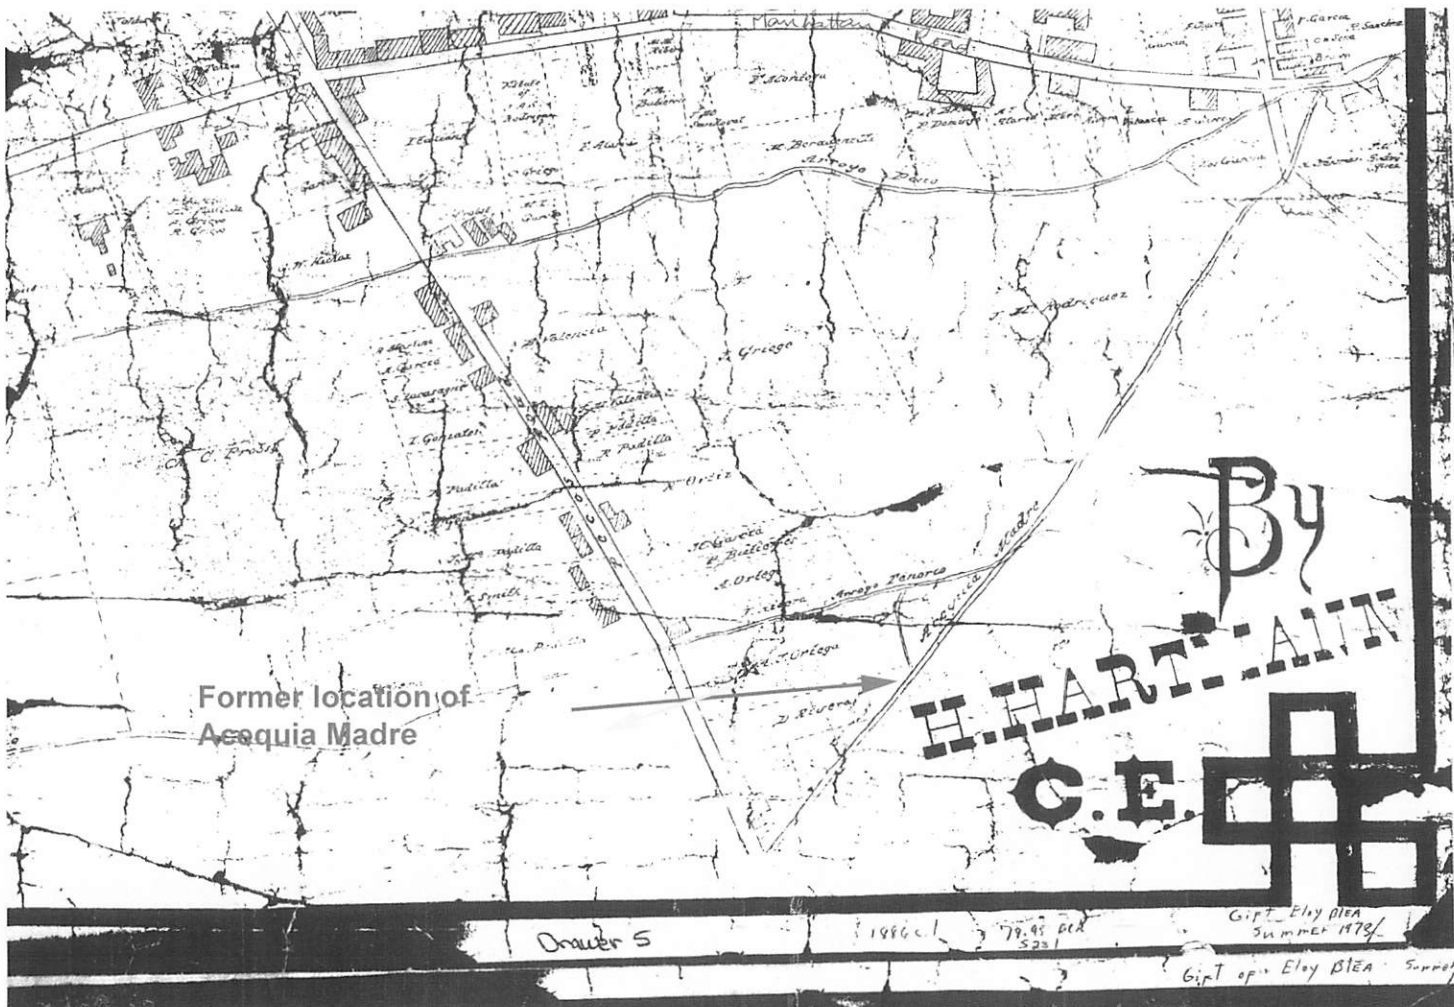
Figure 2

1886 Map showing early location of the Acequia Madre. The Acequia Madre was located approximately along the current alignment of the Arroyo Tenorio Street

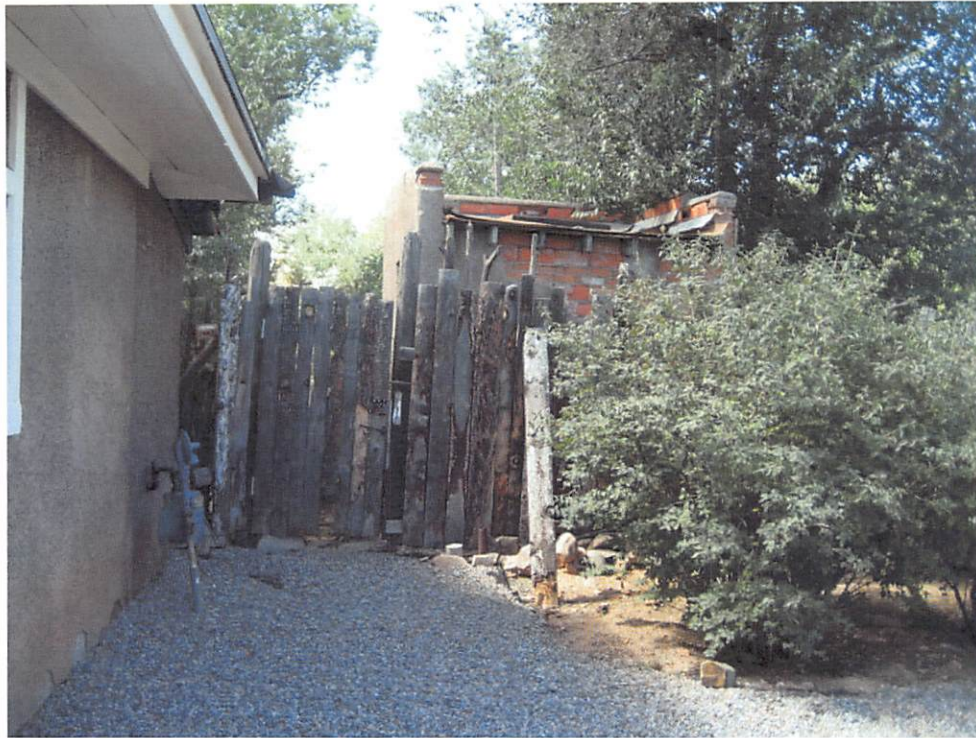
**Figure 7**

Well house behind house. Well house is accessed through wooden gate. Note reddish colored structural clay tile brick used to construct well house.

My belief that the well is a pre-basin well is based on a number of facts. Photographs taken in August 2008 show a well house around the well. The well house is constructed of a type of structural clay tile brick which was probably manufactured no later than the mid-1940's.
