TECHNICAL SERVICE BULLETIN

Accelerated Wear Of The Rear Inner Brake Pads Or Scraping And Grinding Noises

26-2274

Ford 2021-2026 Next-Generation Ranger

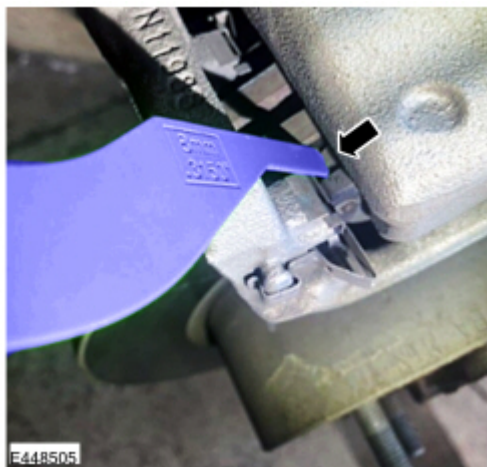
Figure 1 - Brake pad friction material thickness measurement with a gauge

6. Remove the rear wheels. Refer to WSM Section 204-04.**7. Measure the rear brake pad friction material thickness on the inner and outer brake pads on the Right Hand (RH) and Left Hand (LH) side. (Figure 1)**

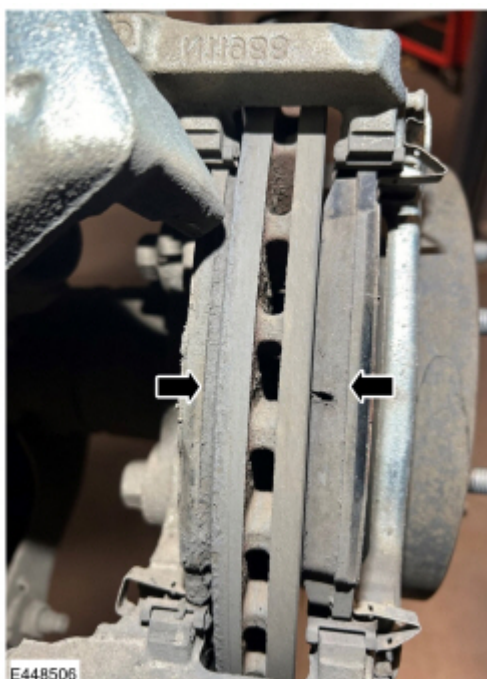
8. Is the inner and outer brake pad thickness difference 3mm or greater on the RH or LH side AND any pad thickness 1.5mm or less?

Figure 2 – this TSB applies. The wear difference is more then 3mm and the inner pad is worn out

9. Remove the brake disc shield bolts and brake disc shields on both sides. Retain the bolts. Discard the brake shield. Refer to WSM Section 206-04.

10. Replace the rear pads using the service pad kit. Refer to WSM Section 206-04.

11. Install new brake dust shields with the original bolts. Refer to WSM Section 206-04.

Torque: 9 Nm

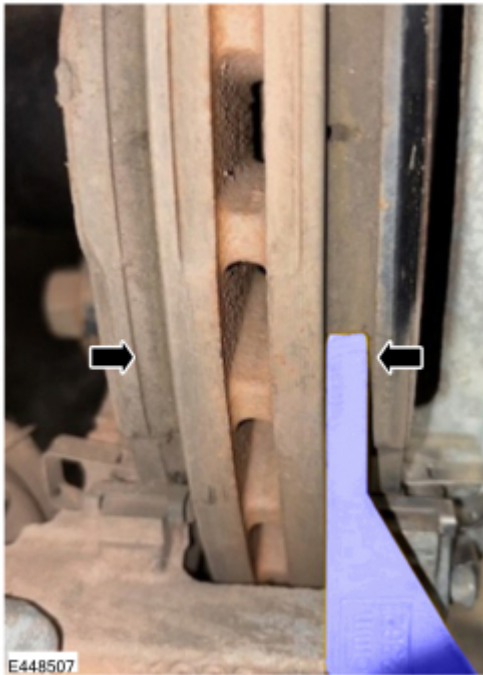
Figure 3 – this TSB does not apply. The wear difference is more than 3mm and plenty of pad material remains
