COUNTERFEIT IC DETECTION REPORT

VERDICT	LIKELY AUTHENTIC
AUTHENTICITY SCORE	76.1/100
TIMESTAMP	2025-12-08T00:46:52

Part Number	ATMEGA32U4-AU
Manufacturer	Atmel (now Microchip Technology Inc.)
Package Type	TQFP
Pin Count	44

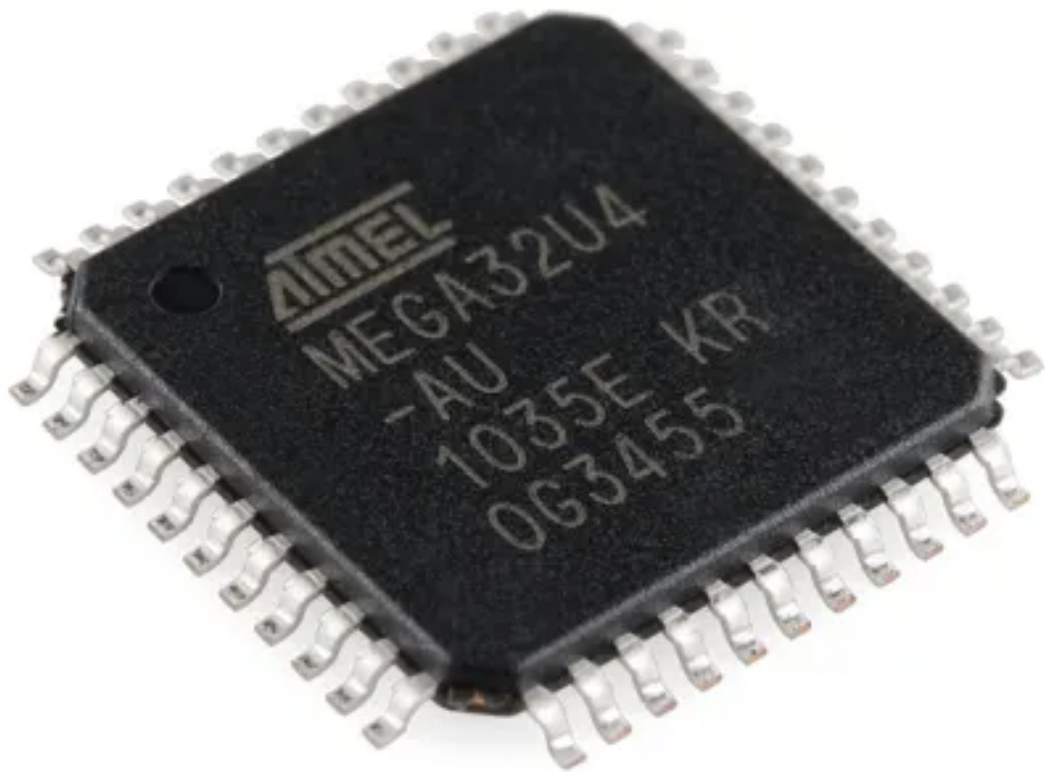
INPUT IC IMAGES

Markings appear crisp and well-defined. Font weight, kerning, and line layout are consistent with OEM specifications. No signs of erosion or tampering detected.

The IC has 44 pins, which matches the datasheet specification. Pin count is correct.

Package type (TQFP) matches the datasheet specification. Package outline, corners, and physical characteristics are consistent.

- The IC is a 44-pin Quad Flat Package (QFP), visually consistent with a Thin Profile Plastic Quad Flat Package (TQFP) as specified in the datasheet.
- Pin count of 44 pins matches the datasheet for ATMEGA32U4-AU (44ML package).
- Pins appear well-formed, uniformly spaced, and show no signs of bending, corrosion, or irregular manufacturing. Pin pitch is consistent with the specified 0.8mm.
- The pin-1 indicator is a clear circular dot located in the top-left corner, which matches the standard orientation and pinout diagrams in the datasheet.
- Markings include the 'Atmel' logo, 'MEGA32U4', '-AU', '1035E KR', and 'OG3455'. All markings are sharp, clear, and appear to be laser-etched with consistent font style, weight, and kerning.

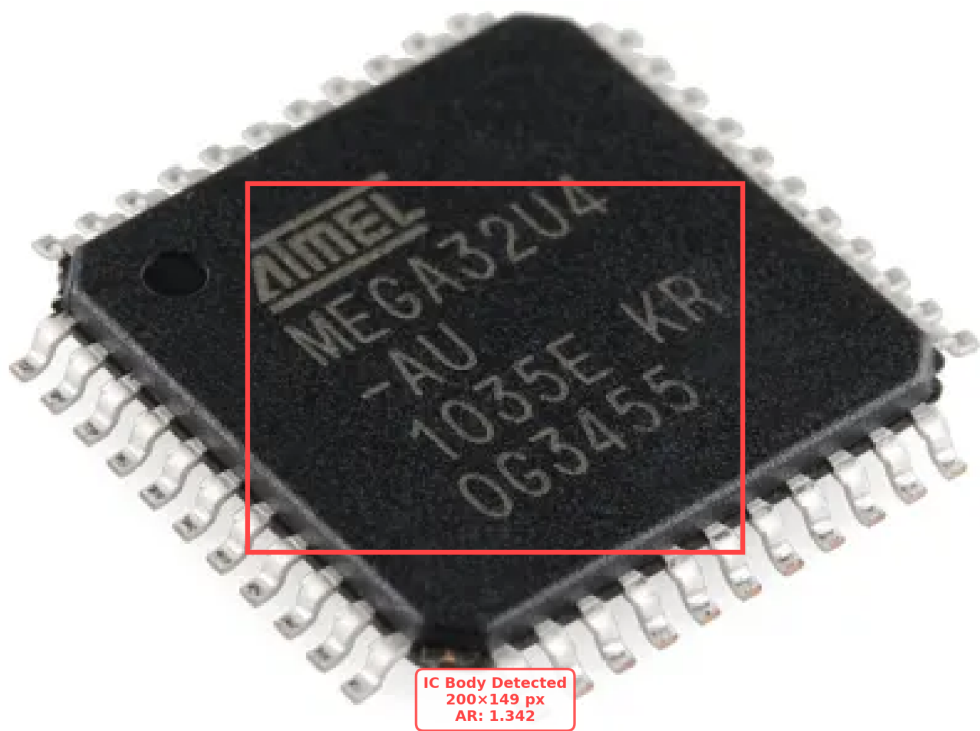
Dimension Analysis - Detected IC Body

✗ Package dimensions show significant deviation. Measured aspect ratio (1.342) differs from expected (1.000) by 34.2%. This indicates potential counterfeiting.

Parameter	Value
Measured Aspect Ratio	1.342
Body Width (px)	200
Body Height (px)	149
Expected Aspect Ratio	1.000
Expected Length (mm)	10.0
Expected Width (mm)	10.0
Dimension Source	gemini_extraction
Aspect Ratio Match	NO X
Dimension Score	48.7/100
Verdict	MISMATCH

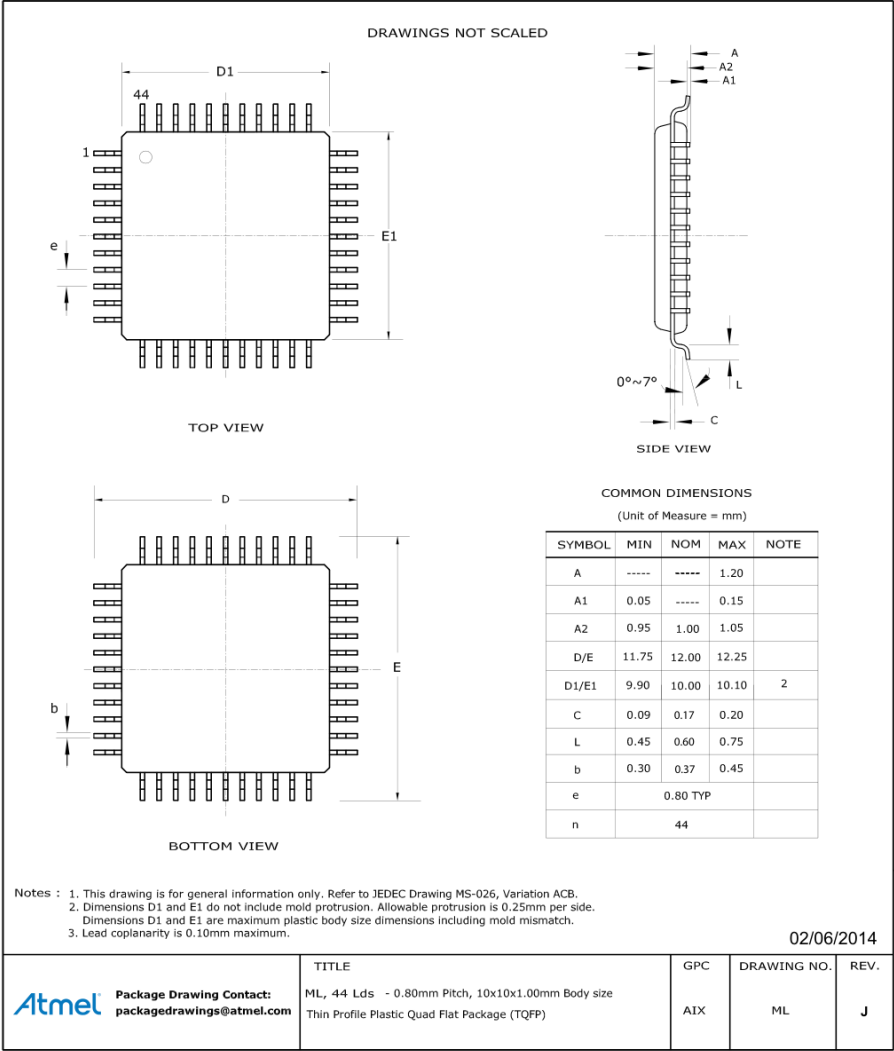
7.1 TQFP44

Parameter	Value
Height/Thickness	1.2 mm
Pin Count	44
Pin Pitch	0.8 mm
Package Type	TQFP
