Top Sheet, Repro update
Altair CPU-A with 8085A/80C85B

8/18/2026 to 9/30/2026 rev 1.05, correcting the ERRATA from 1.04.2 panel

VALIDATION: RESET, SYSTEM CLOCK & PSYNC

VALIDATION: THERMAL IMAGES

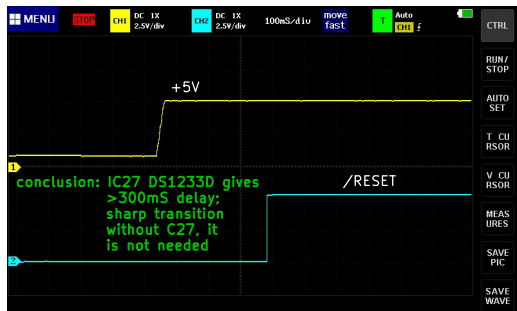
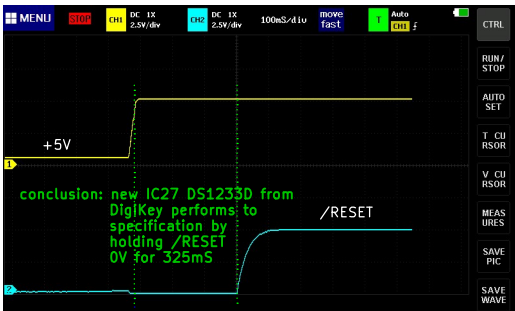
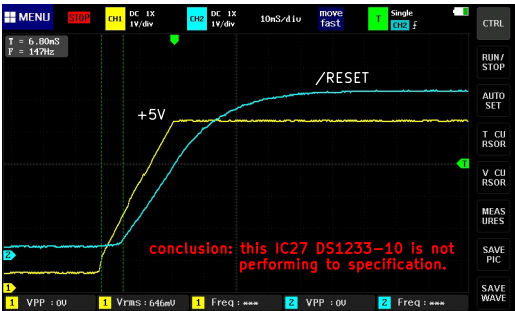
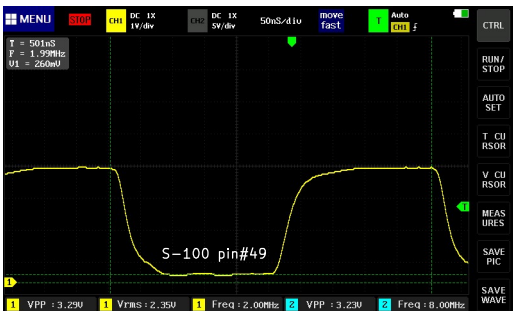
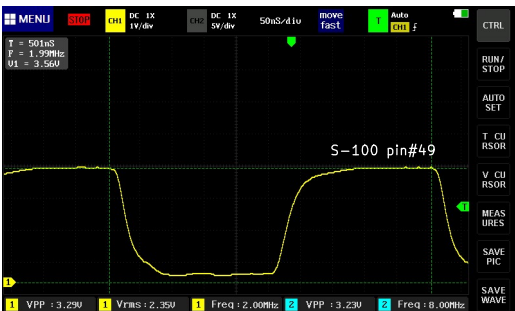
This page was created because when I first powered up the sample CPU85 panel... nothing happened and the POJ stayed illuminated (not a good sign).

DEBUGGING and OBSERVATIONS:
11) (FIXED) Found 3 folded under PDIP pins on logic ICs... this happens even to me.
12) (FAIL) (FIXED) CPU stuck in RESET... IC12-36 stuck at Logic 0. IC12-36 resistance to VR1-2 Ground = 9 Ohms.
removed C27, nope IC12-36 to Ground still 9 Ohms. Removed IC27, OK IC12-36 to Ground is 10K Ohms. New DS1233-10 installed, but 350mS delay from DS1233 is not happening.
Only 6.8mS Vcc power up delay not 350mS & no Vcc=4.5V threshold to RESET release is occurring. New DS1233D from DigiKey (9/5/2026) works to specification, desired >300mS /RESET delay.

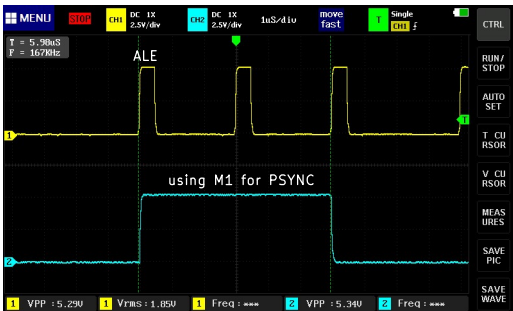
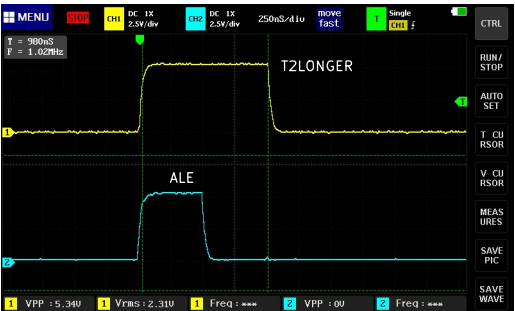
14) (PASS) PSYNC source waveforms, M1, ALE and extended ALE; ALE is normal with 2MHz XTAL input; T2LONGER is expected 2xALE duration; but I did not expect M1 to last while collecting immediate oprand byte(s).

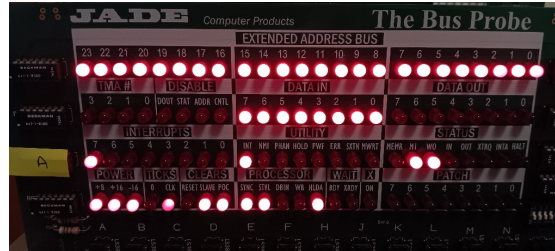
15) (PASS) Since my PCS80/30 does not have multiple CPUs or card(s) using the DMA function, there is no activity on HOLD_TYPE1 and HOLD_TYPE2 signals, thus no difference in selection performance in my system.

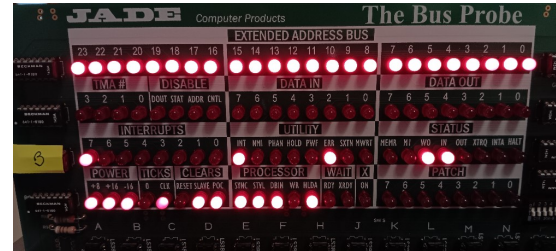
16) (PASS) BUS IDLE (RST or TRAP) State with sM1, U23 Rev3

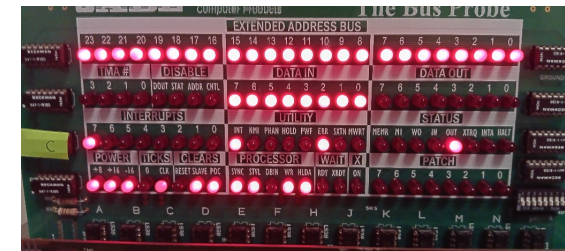
17) (PASS) sINP (Input Read) State, U23 Rev3

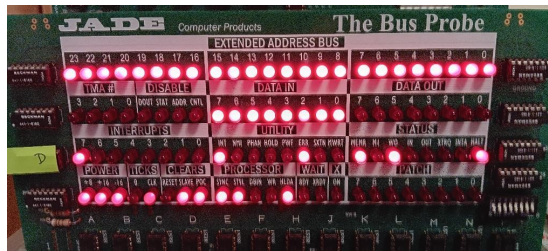
18) (PASS) sOUTP (Output Write) State with sWO OFF, U23 Rev3

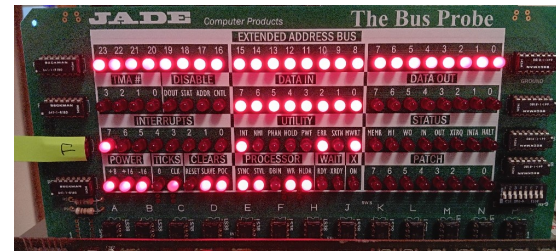
19) (PASS) sHLTA (HALT) State with MEMR, U23 Rev3

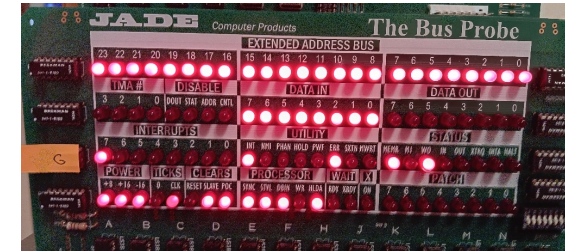
20) (PASS) sMWRT (Memory Write) State with sWO OFF, U23 Rev3

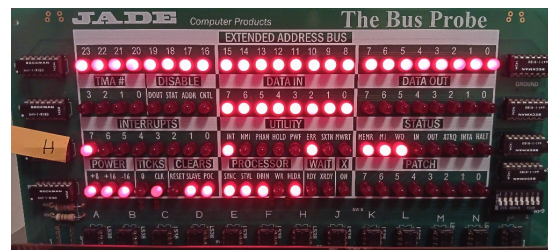
21) (PASS) sMEMR (Memory Read) State, U23 Rev3

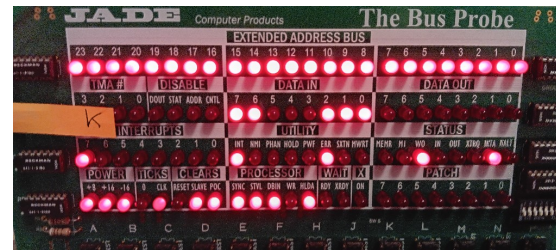
22) (PASS) sM1 (Op Code Fetch) State with sMEMR, U23 Rev3

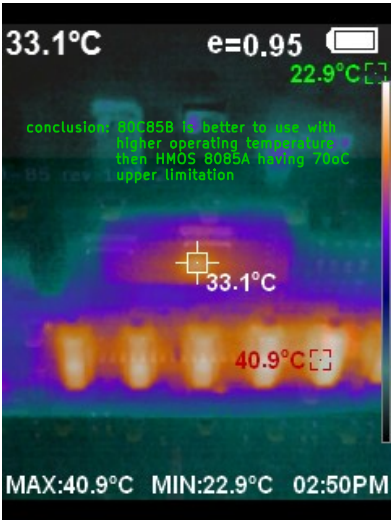
DEBUGGING and OBSERVATIONS:
24) (PASS) The thermal images are to verify no parts are over heating or being over stressed >30 (was 25) degrees above ambient. Y2 = 16MHz for maximum toggling using 80C85B. Y2 = 12MHz for maximum toggling using 8085A-1.
