SUMMER INTERNSHIP REPORT

TATA STEEL LTD. JAMSHEDPUR, JHARKHAND INDUSTRIAL TRAINING REPORT DEPARTMENT OF MECHANICAL ENGINEERING

OFFICE – NEW BAR MILL, TSL

TOPIC – INCREASE IN THE RELIABILITY OF BRAKING PINCH ROLL ASSEMBLY IN NEW BAR MILL.

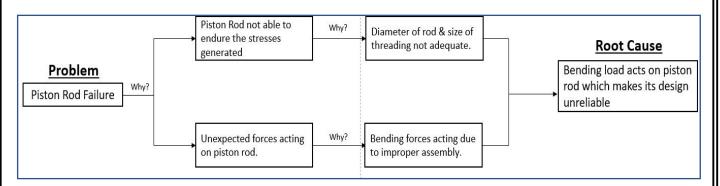
- On analysis of the fractured surface of piston rod it was revealed that the mode of failure was fatigue mode.
- According to design calculations the piston rod should not fail for the theoretical loading condition and have a life of more than 106 cycles.
- However, due to the presence of bending load on the piston rod, it failed prematurely.

Fig 4: Location of Failure of Piston Rod

- Improve Assembly Procedure One of the possible reasons for increased bending load can be improper alignment of cylinder. Hence the assembly process needs to be checked to minimize the bending load acting on the piston rod.
- Increase Piston Rod Diameter If the diameter of the rod is increased size of the threading at the ends also increases. This reduces the stress generated at the minor diameter of the thread thereby increasing the life of piston rod.
- New Piston Rod Inspection Dye penetrant inspection and ultrasonic inspection of new piston rods should be done to identify any surface or internal cracks which can lead to sudden failure of piston rod.

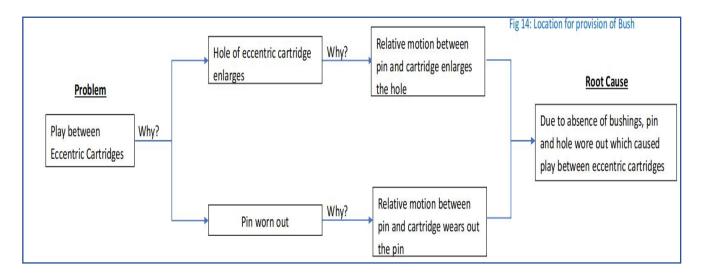
- If play exists between the eccentric cartridges of the pinch roll assembly then the gap between the pinch rolls will not be uniform which will result in inefficient braking of rebars.
- On close examination of the pinch roll assembly it was observed that the reason for this play is the wear and tear of the pin about which the eccentric cartridges pivot.
- Wearing of pin reduces the MTBM cycle of the pinch roll unit.

Fig 18: Location for provision of Bush

- By using a bush we can ensure that the pin won't wear and hole of the eccentric cartridge won't enlarge.
- Replacement of the bush would also be more convenient and cost efficient as compared to replacement of pin.
- Therefore, overall downtime of the mill will be reduced and the monetary losses incurred would also be minimised.
- The material of the bushings is: UNS F13101 (ASTM A48)
