QCA8075

Device Revision Guide

80-Y9112-3 Rev. C

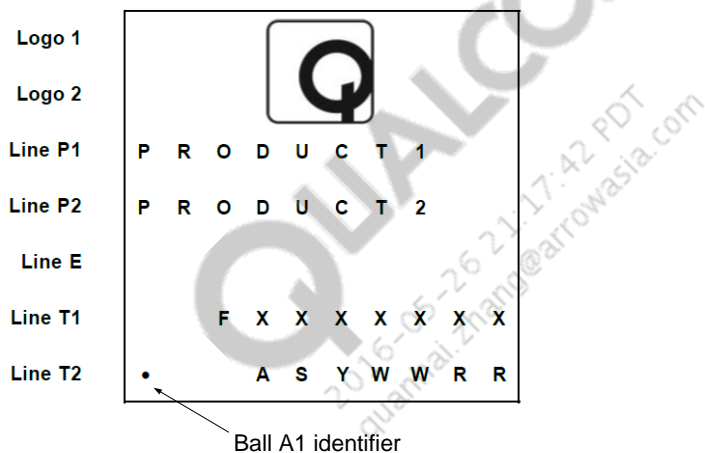
Figure 1 Device marking (top view, not to scale)

The QCA8075 device can be identified by the markings on its top surface and by the contents of an identification register; these identification techniques are described in Section 2.1 through Section 2.2.
