Affected Systems: STAR Micronics Thermal Receipt Printer

Summary

On 5/17/2026, a STAR Thermal Printer at [Business Redacted] printed unauthorized pages containing automated internet scan logs, raw command syntax, and a "I hacked you!" message.

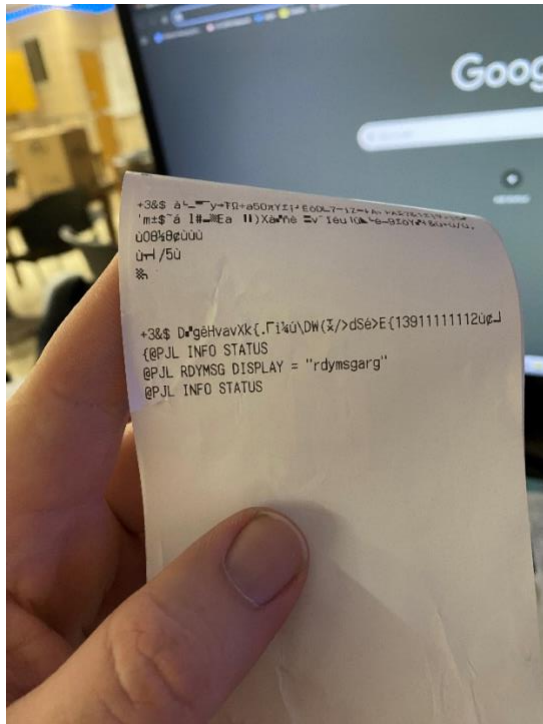
The commands were sent via Printer Job Language (PJL) as shown by queries (@PJL INFO STATUS (essentially “Do you have paper, are you on?”), @PJL RDYMSG DISPLAY = “rdymsgarg” (This tells the screen to print “rdymsgarg”))

Figure 1 Printed receipt showing the P/JL commands
