# VisualMotion 9 Multi-Axis Motion Control using GPP and GMP Firmware

**R911292841**  
Edition 02

## Troubleshooting Guide

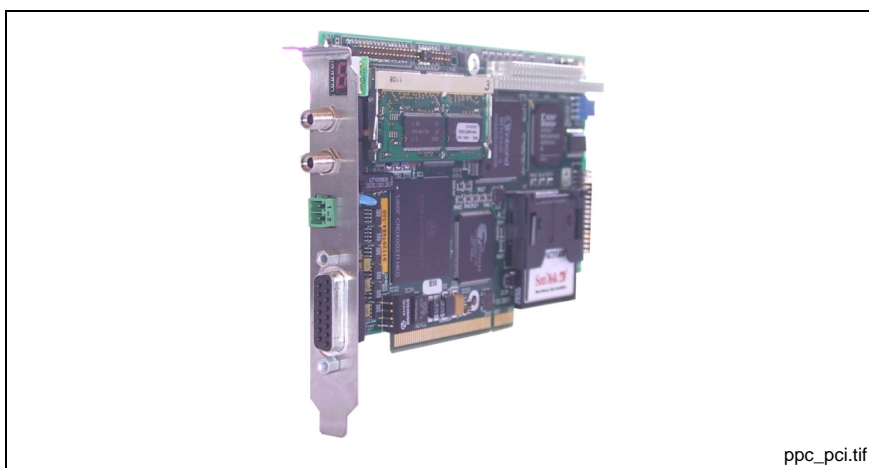
Fig. 1-2: PPC-P (PCI-version) Motion Control

The PPC-P11.1 (PCI-version) is a PC-based stand-alone multi-axis motion control. The GMP 9 firmware used with the PPC-P is designed to work as a complete motion control solution. A host PC containing a Logic Controller (SoftPLC) handles the system logic, fieldbus and Ethernet communications.

Just like the PPC-R, the PPC-P supports Bosch Rexroth DIAX04 and ECODRIVE03 digital servo drives. Communication between the control and digital servo drives is performed via the SERCOS fiber optic interface.
