Rudy's Retro Intelligence

Commodore Super PET - SP9000

2 Board Version Diagnostics Manual

Version 2.8 Created in September 2024

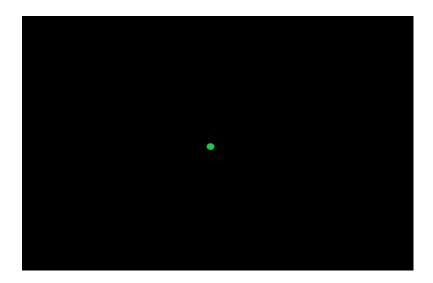
Symptoms: SuperPET boots up but hangs and no keyboard input. Both 6809 and 6502 show the following screen.

Diagnoses: Check\replace U12 - 74LS123, U20 - 74LS367, U18 - 74LS367 and\or check\replace U40 - 6551-11
