Date	PC APP software:	BOB Firmware:	Donlight Firmware:	Github hash
07/07/2022	1.3.2 +Gerderland detup	+1.00.06	2.0.0	9c5dd7e6e79d4a42567d73da661bcd3da96c2c06

Donlight Changelog 10/10/2022

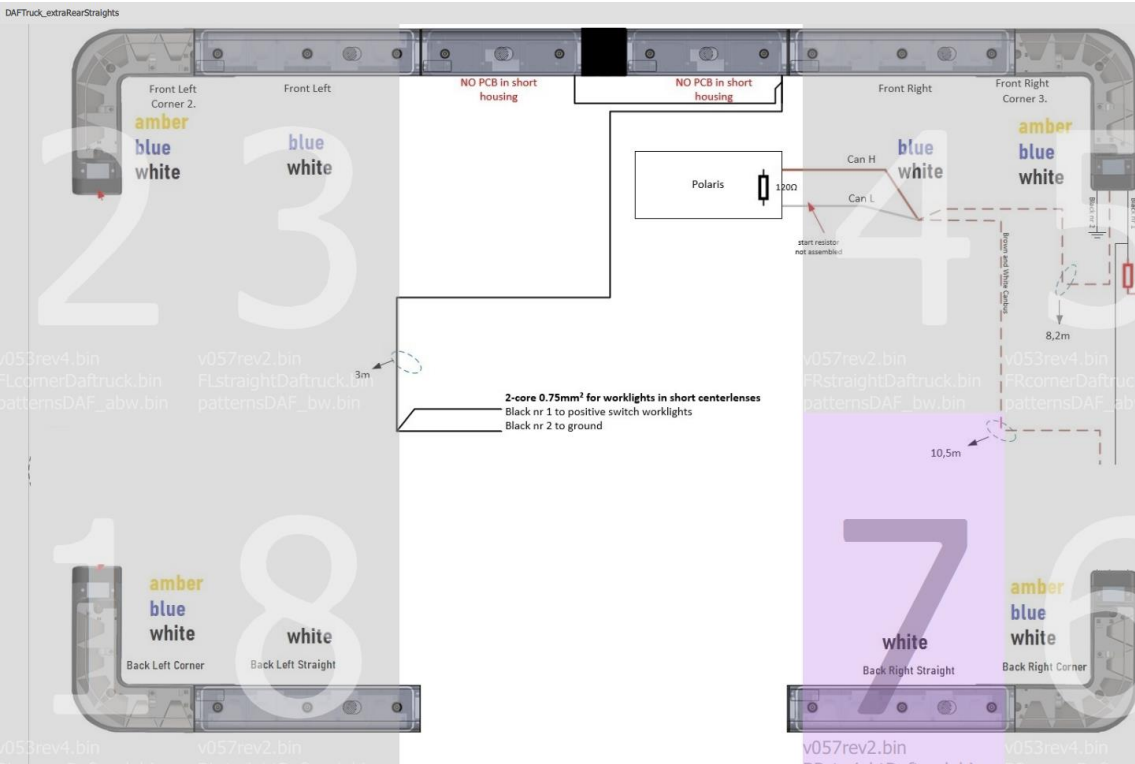
After Wesley’s request:
Added DAFTruck_extraRearStraights setup, based on DAFTruck_amberbluewhite setup with two extra white straights on the rear.

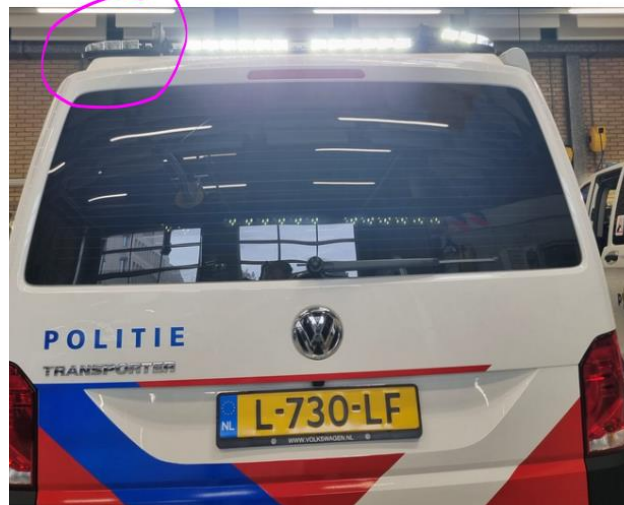
After reviewing one by one this are the specific configs fixed that were deaf to polaris commands.

- Box-body MB Sprinter
 - BLcorner
- sprinter6
 - BLcorner
 - FL55blue
 - FR55blue
- sprinter6_fixedcolours
 - BLcorner
 - FL55blue
 - FR55Blue
- sprinter6_fixedcolours_blue_white_fronts
 - BLcorner
 - FL55Blue
 - FR55Blue
- sprinter6RearWithArrow
 - BLcorner
- sprinter8_fixedcolours
 - BLcorner

Date	PC APP software:	BOB Firmware:	Donlight Firmware:	Github hash
10/10/2022	1.3.3 + Multiple config files updated, containing typo in Polaris canbus addr.	1.01.01(ping)	2.0.2(ping)	f0844f333ca651 35439bb0eb6315 2379dd5a80e3
