# Rudy's Retro Intelligence

Commodore Super PET - SP90002 Board Version Diagnostics Manual

### Version 2.4 Created in September 2024

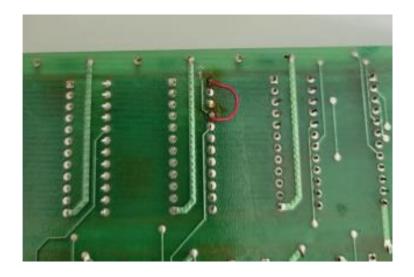
Verify\Install a wire from **U46** – Blank ROM socket Pin 24 to 21.

\*This jumper wire <u>is</u> required on the REV A board **ARTWORK NO. 9000017 REV. A**

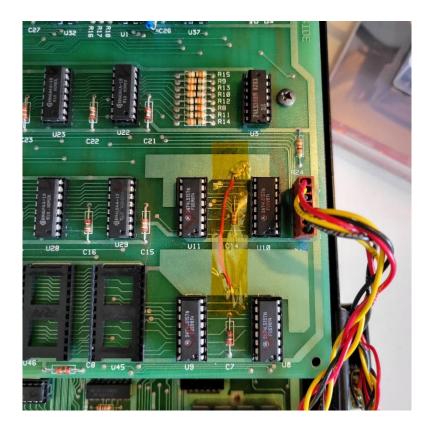
Verify\Install a wire from the 2 locations as per above picture as there are no markings on the daughter board as to where exactly to install this jumper wire.

\*This jumper wire is not required on the REV A board ARTWORK NO. 9000017 REV. A

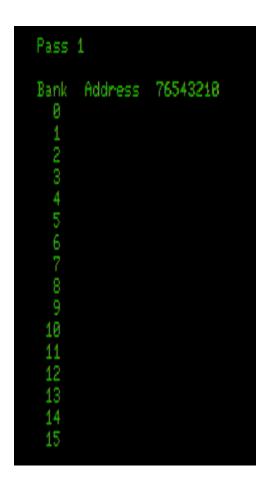
**Symptoms:** When running the SuperPET memory test software, you see "X" s on the screen.

Pass	1	
Bank	Address	76543210
0	36867	Х
1	36867	Х
1 2 3 4 5	36867	X
3	36867	Х
4	36867	X
5	36867	X
6 7	36867	Х
7	36867	X
8	36867	Х
9	36867	Х
10	36867	X
11	36867	X
12	36866	X
13	36866	X
14	36866	X
15	36866	X

In the above screenshot, the "X" indicates memory issue at U22 which is shown in column "0"

The column with "76543210" indicates the location of the bad RAM IC. Here is the list for all the other RAM failures:

An X in column 0 = Bad RAM in U22

An X in column 1 = Bad RAM in U25

An X in column 2 = Bad RAM in U24

An X in column 3 = Bad RAM in U25

An X in column 4 = Bad RAM in U26

An X in column 5 = Bad RAM in **U27**

An X in column 6 = Bad RAM in U28

An X in column 7 = Bad RAM in U29

Multiple "X" s means there are several bad RAM ICs. Replace bad RAM with 4164 as they can be used. Ensure that the replacement RAM ICs are the same speed or faster.

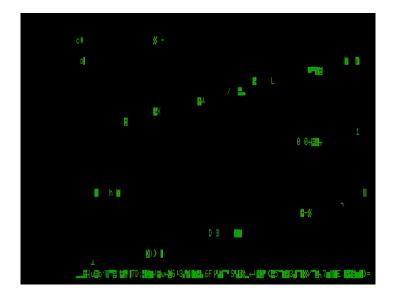
**Symptoms:** No programming language loads. 6502 and 6809 appears to be working and language file is on the diskette (or SD card). System tries to load the program but is never successful. 6809 mode appears suck and 6502 mode is working.

Here is an example trying to load FORTRAN language.

**Diagnoses:** Check\replace **U41** – 6702. This IC is required to load any development language. When testing, the language software does take a while to load.
