Donlight Changelog 24/11/2022

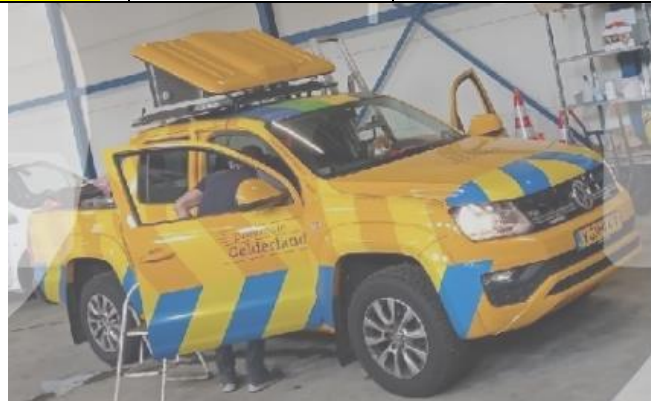
After spending 3hours with Richard at Gerderland and connecting the turning signals from the vehicle to an oscilloscope, we noticed this vehicle had a delay between turning signals of 9ms. As the BOB was set to tolerate delays up to 5ms between received turning signals the lights were glitching when the hazard was on.

13000003500_rev01_BOB_V01_00_05_hazarddelaytoleranceUpto11ms is build on top of v01_00_04 with increased tolerance to delay in turning signals.
