Technical Information, Projects and other Research & Development, >
Hardware technical information > Wireless and Bluetooth >
Broadcom BCM4350 cards under High Sierra/Mojave/Catalina

BROADCOM BCM4350 CARDS UNDER HIGH SIERRA/MOJAVE/CATALINA

By Hervé, February 10, 2019 in Wireless and Bluetooth

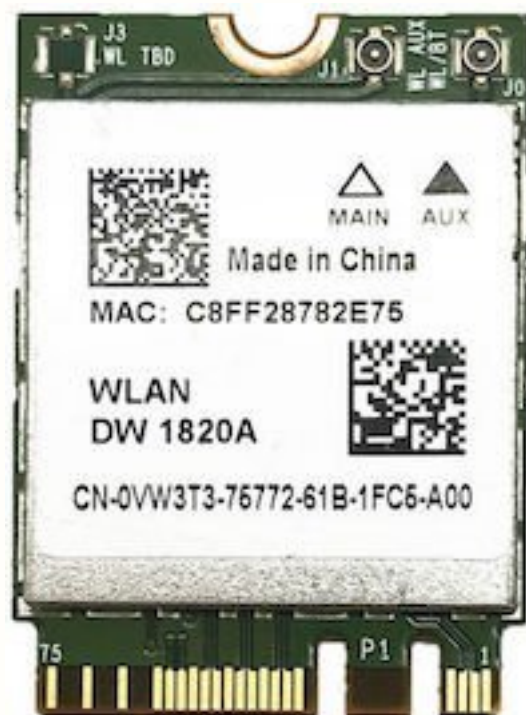
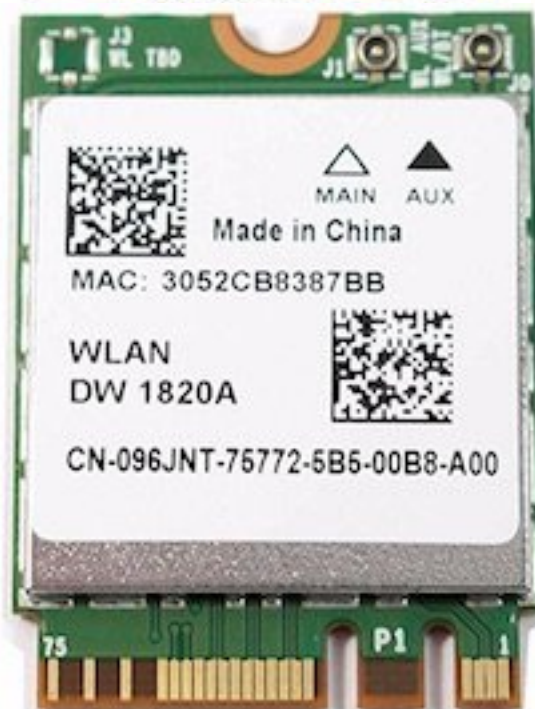
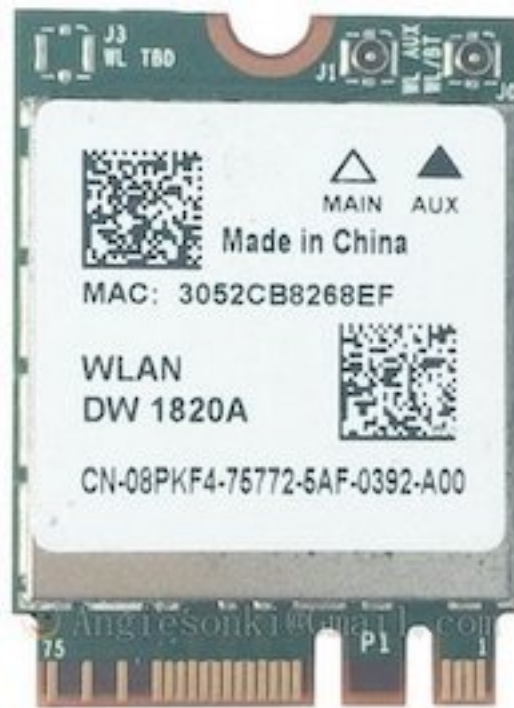
Dell DW1820A:

DW1820A is a pretty good combo card providing 2.4/5GHz 802.11ac wireless at 867Mbps + Bluetooth 4.1. As stated at Wikidevi, there appears to be a few different models of the card. Whilst they all carry the same Broadcom id 14e4:43a3, they each carry a different subsystem id/part #:

- 1028:0021 (part # CN-0VW3T3) -> 100% Ok with ASPM disabled (originally tested 100% Ok on my Latitude 7490 without ASPM tuning)
- 1028:0021 (part # CN-096JNT) -> 100% Ok with APSPM disabled
- 1028:0022 (part # CN-096JNT) -> 100% Ok with APSPM disabled
- 1028:0023 (part # CN-0VW3T3) -> 100% Ok with APSPM disabled
- 1028:0023 (part # CN-08PKF4) -> 100% Ok with APSPM disabled

According to Wikidevi, DW1820A are manufactured by Lite-On with part # WCBN808B. I was not able to verify this for certain and could not find any specific info for a Lite-On WCBN808B card but this number is printed at the back of my Dell DW1820A 0VW3T3 cards.

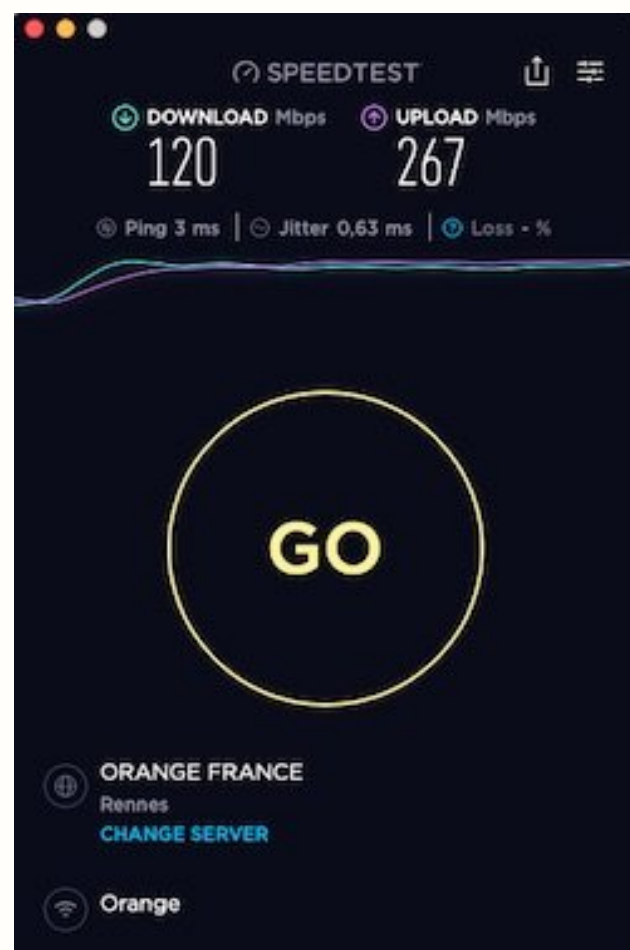
- with country code set to FR (for France), I would not connect at 80MHz on my 5GHz Wireless network, only to 40MHz which resulted in a local wireless connection limited to 400Mbps (vs. 867Mbps) and reduced my overall Internet RX rate by about 60% and TX rate by about 10%:

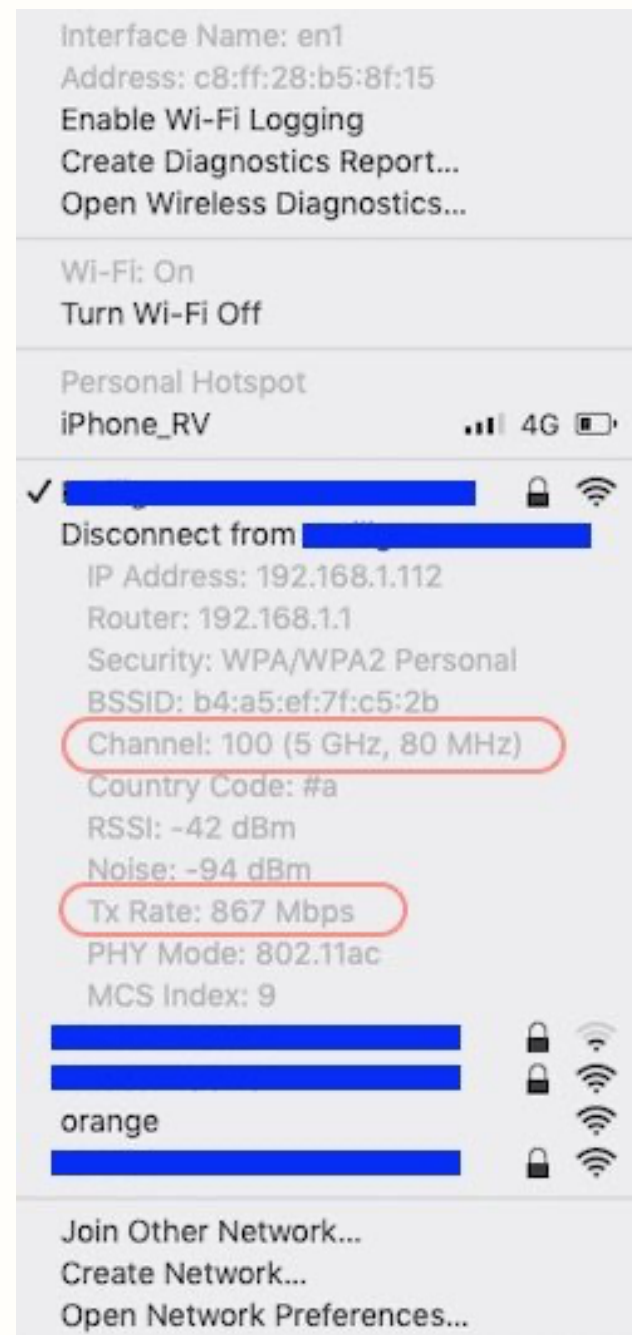
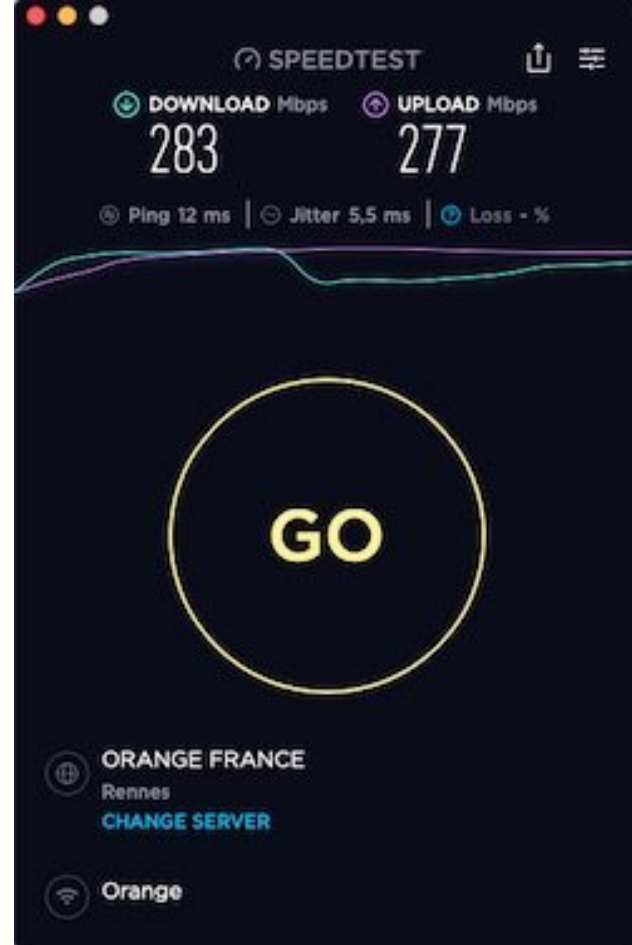
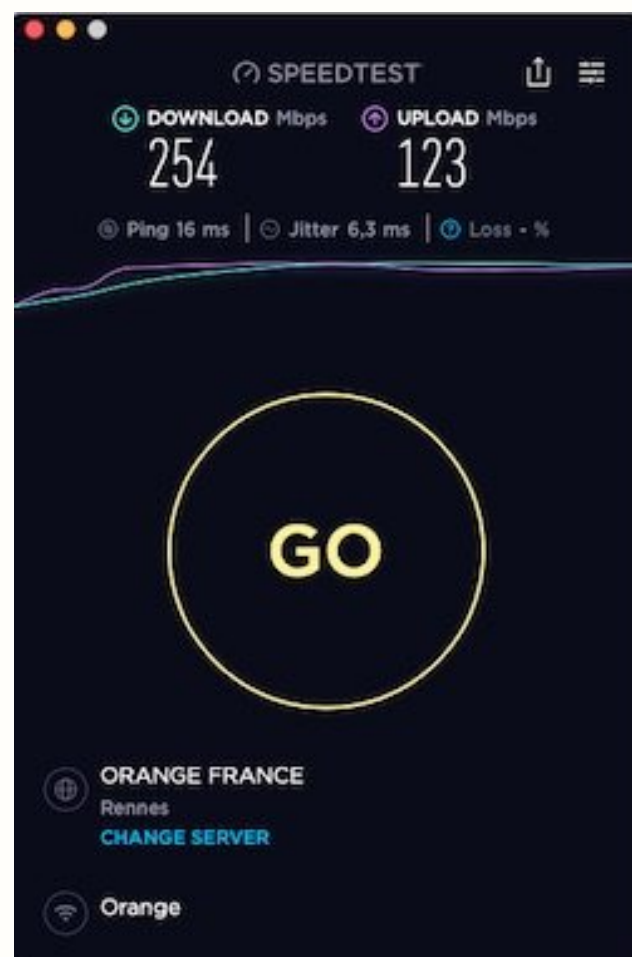
80MHz connection), I could not obtain DFS channel mode to my local router and I noticed fluctuating/unstable RX/TX rates:

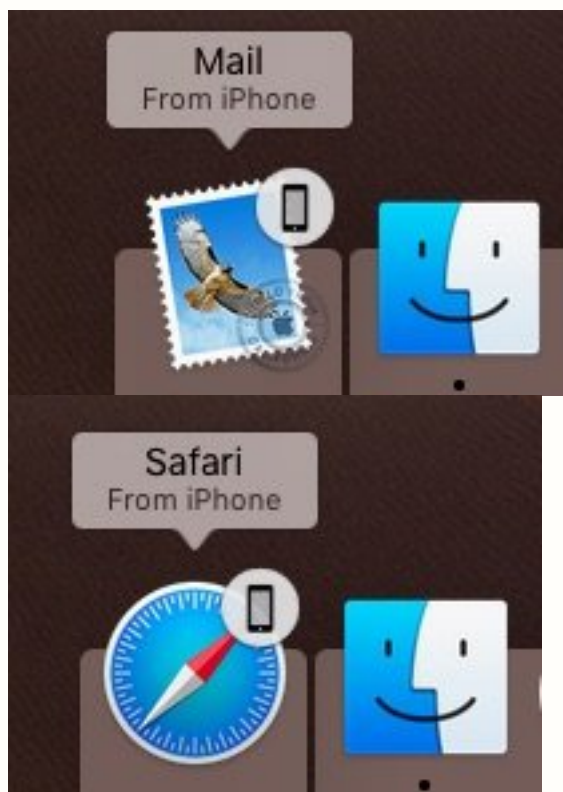
On the Bluetooth side, once the usual Rehabman's Broadcom firmware patching kexts are installed (*BrcmFirmwareRepo* + *BrcmPatchRAM2*), the BT4.1 module will be fully operational and capable of supporting AirDrop and Handoff!

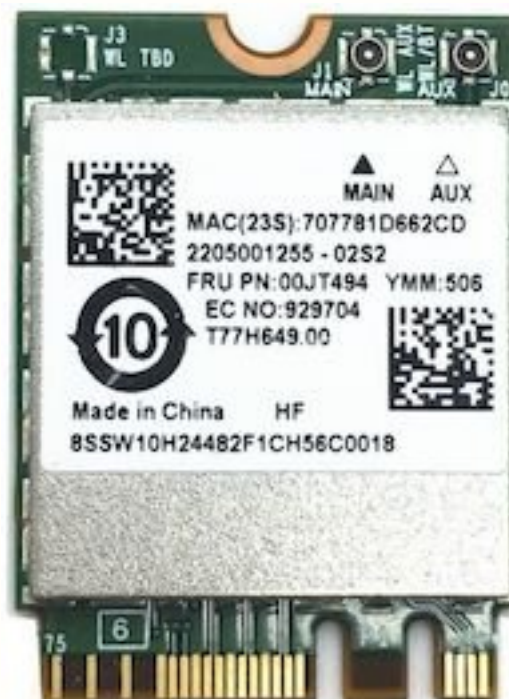
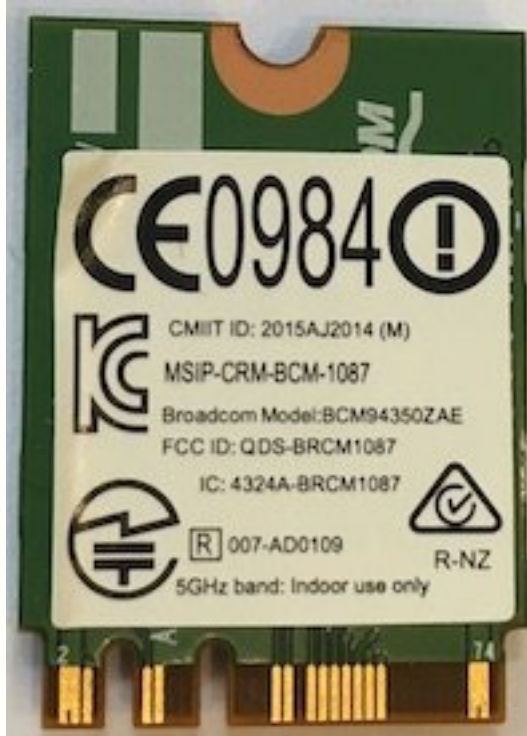
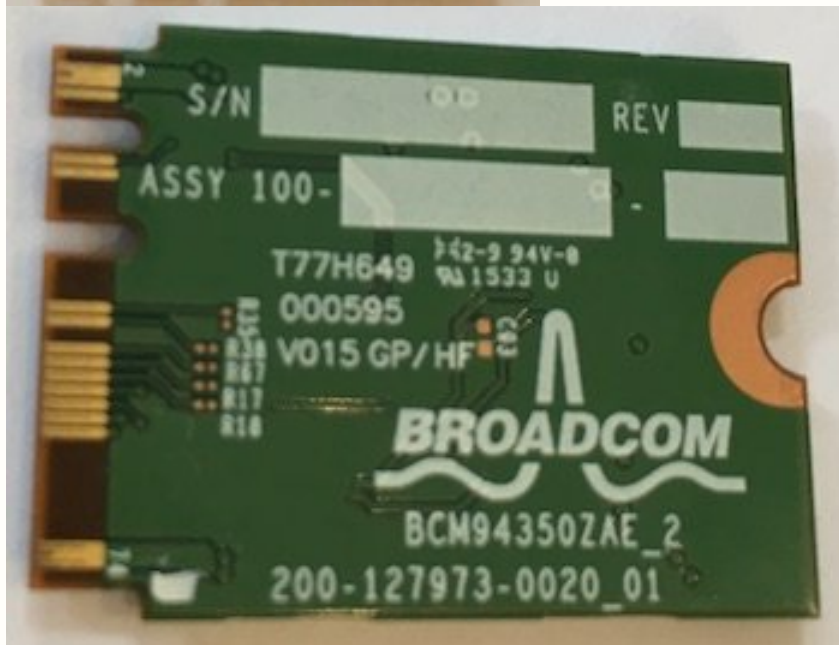
Foxconn T77H649.00:

Foxconn T77H649.00 appears mostly offered with Lenovo laptops and carries Lenovo FRU (i.e. part #) 00JT494. The cards carries the usual Broadcom PCI id 14e4:43a3 and subsystem id 17aa:075a.

Updated with freshly found ASPM disabling property injection that fixes all outstanding stability issues. DW1820A #096JNT and Foxconn T77H649 now tested 100% Ok. DW1820A #08PKF4 should be just the same.

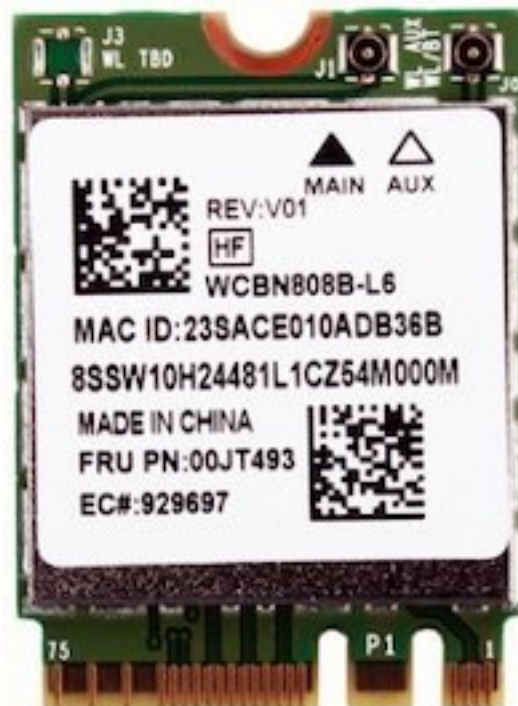
I also found a Lenovo card (FRU 00JT493) carrying that WCBN808B reference on its front label. That card is definitely based on BCM4350 chipset. Afaik, it's not been tested yet but I'll try to get one too.
