PAM Detector Module 005

Test Report and Datasheet

Built and tested February-March 2026 by Jay Frothingham.

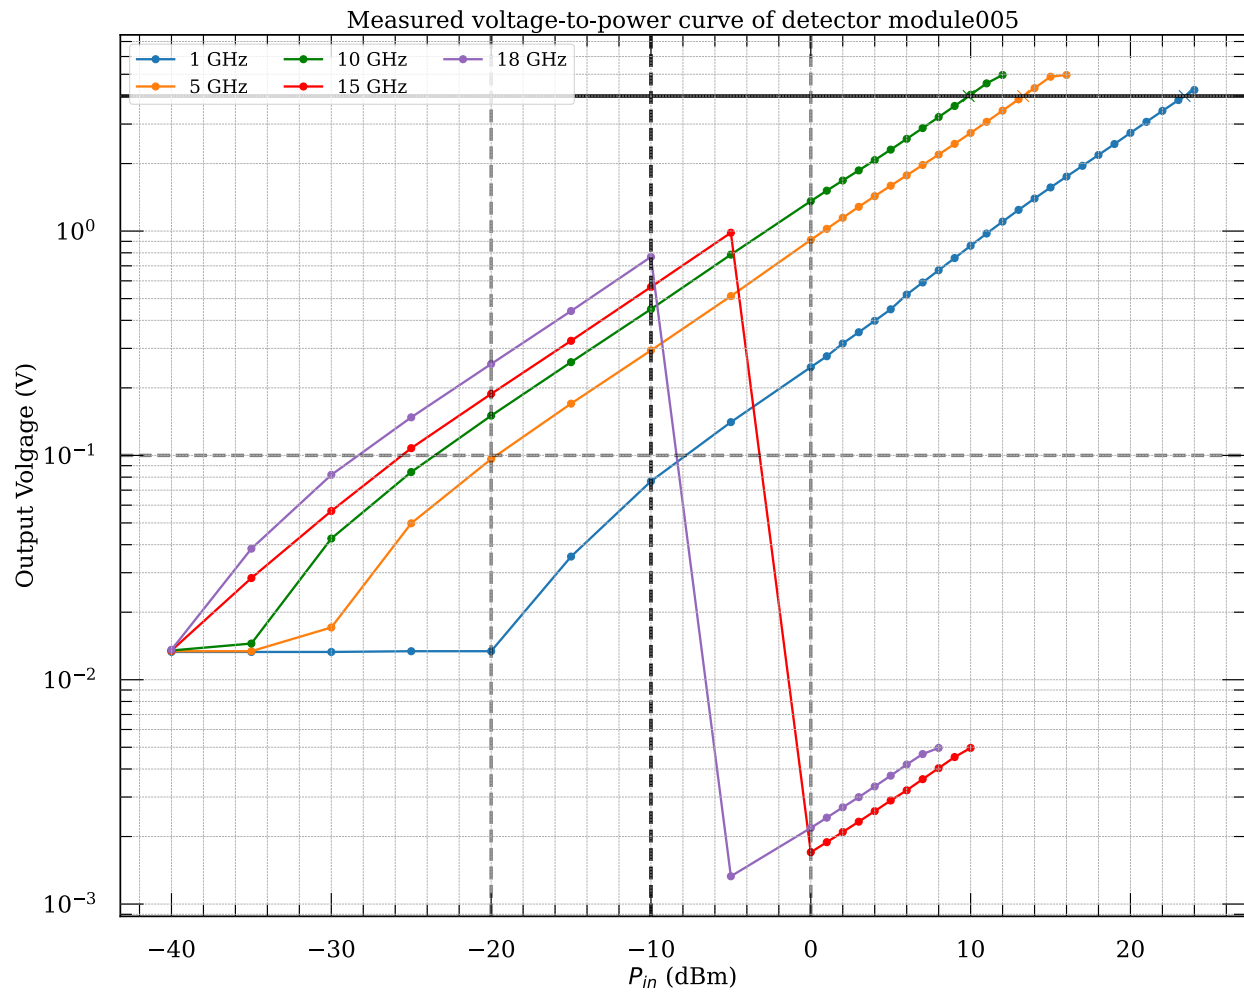
First build failed due to impedance mismatch and voltage drop. Success after rework.

Reworked module P-V curve

First build P-V curve

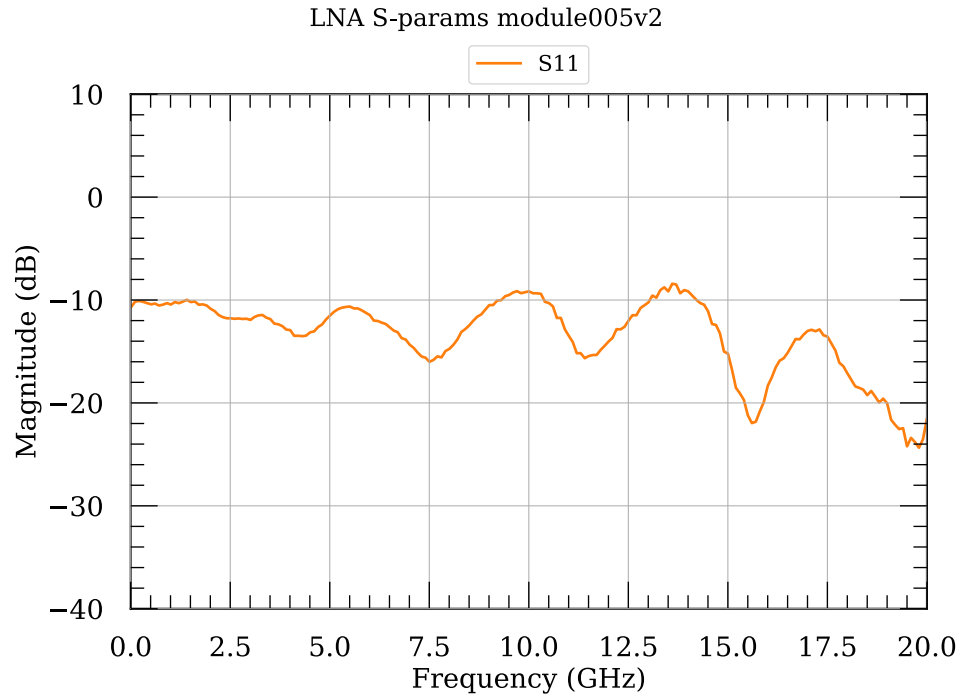
Reworked module S-parameters

S-parameter measurement with the VNA (N5230C).

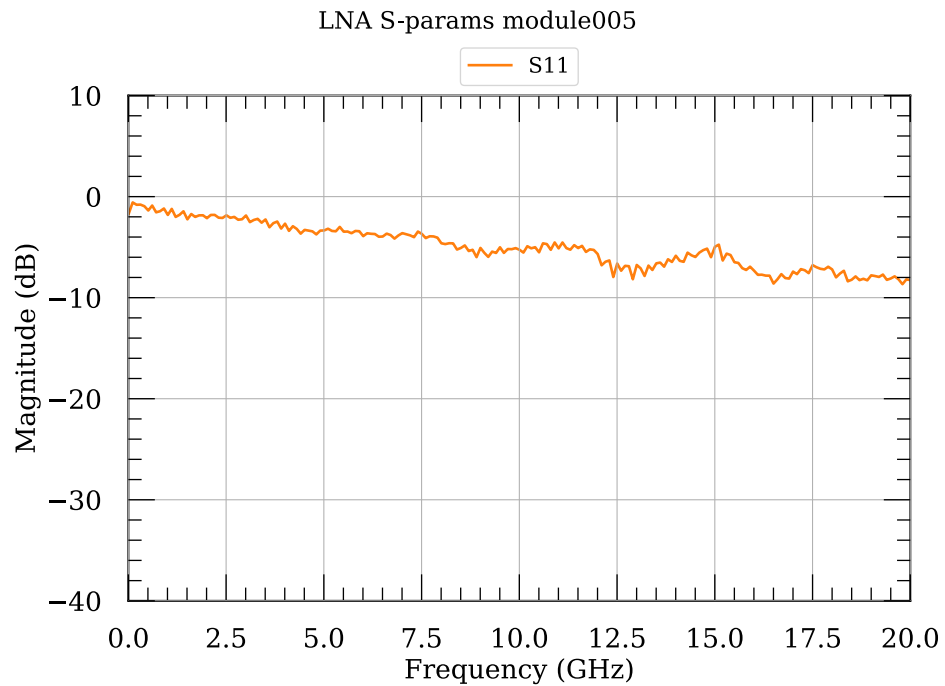
First build S-parameters
