PAM Detector Module 012

Test Report and Datasheet

Built and tested March 2026 by Jay Frothingham.

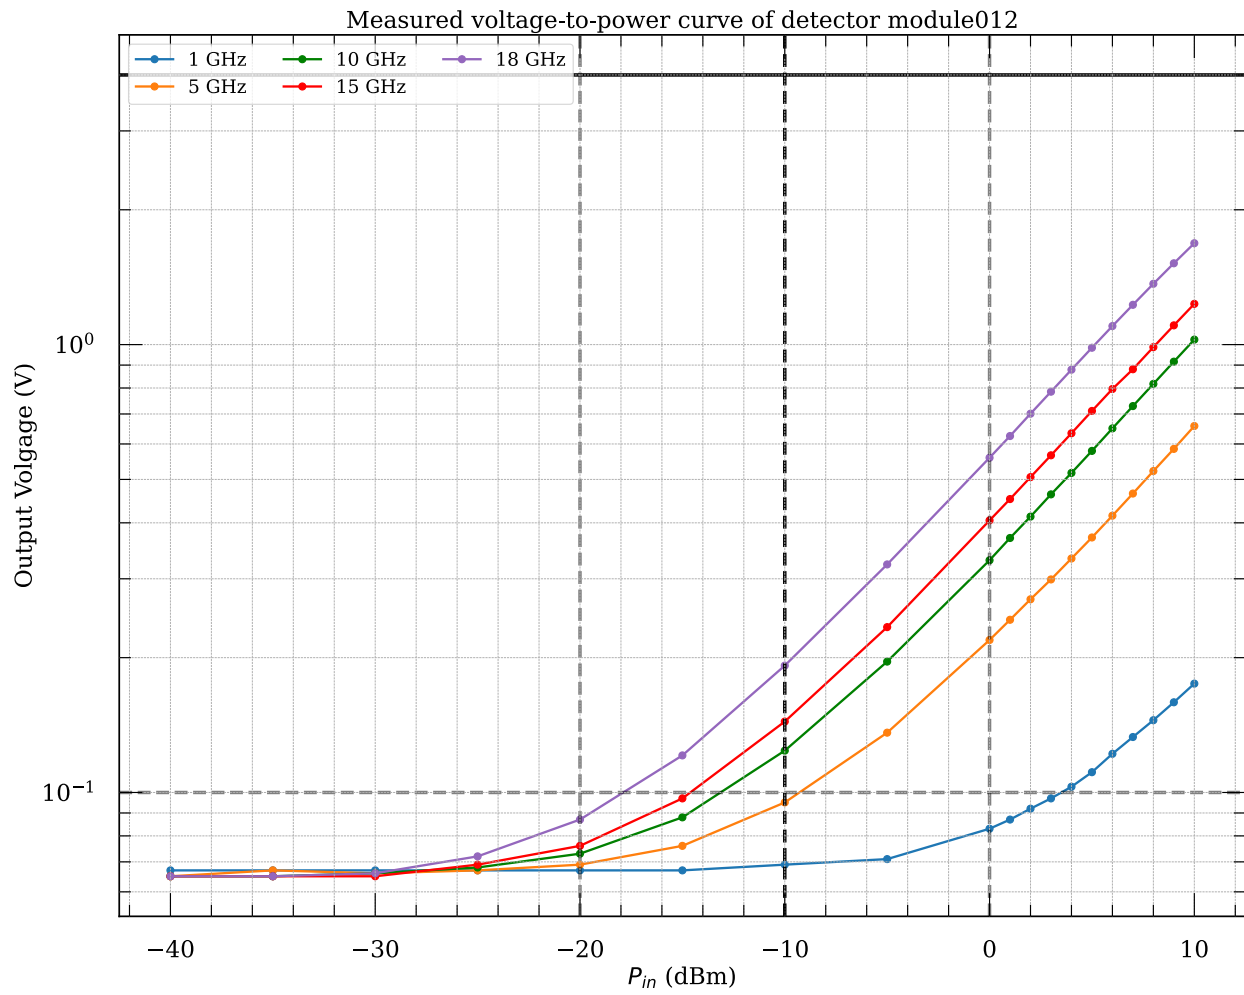
Voltage-to-power Curve

First build failed due to impedance mismatch. Success after rework.

Reworked module P-V curves

First build P-V curves.

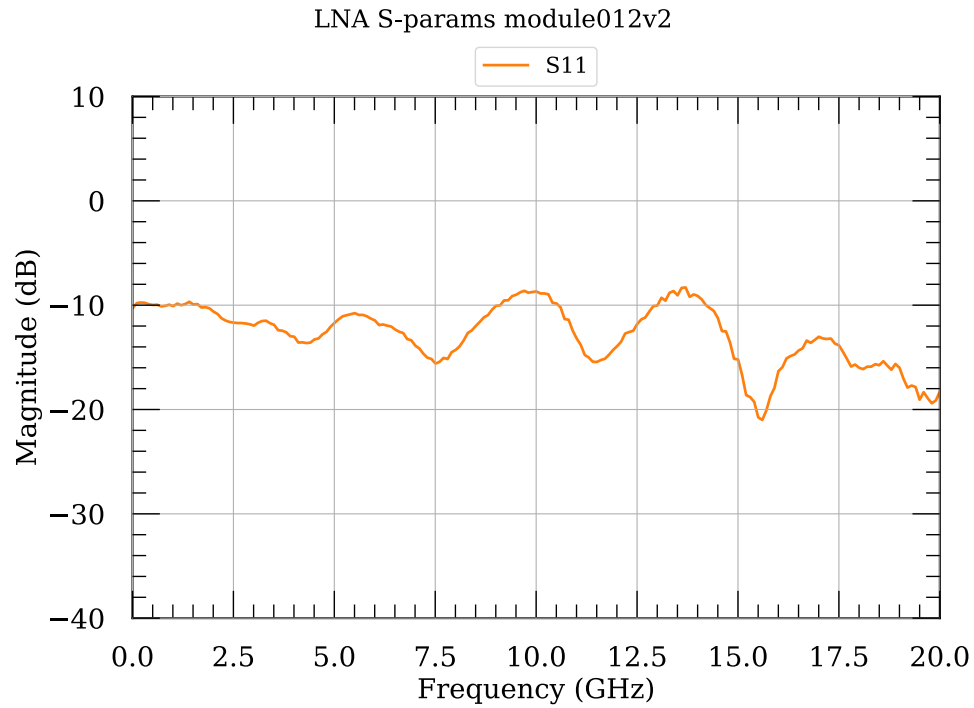
Reworked module S-parameters

S-parameter measurement with the VNA (N5230C).

First build S-parameters
