Figure 7.1: Detection of sewer defects using YOLOv8.

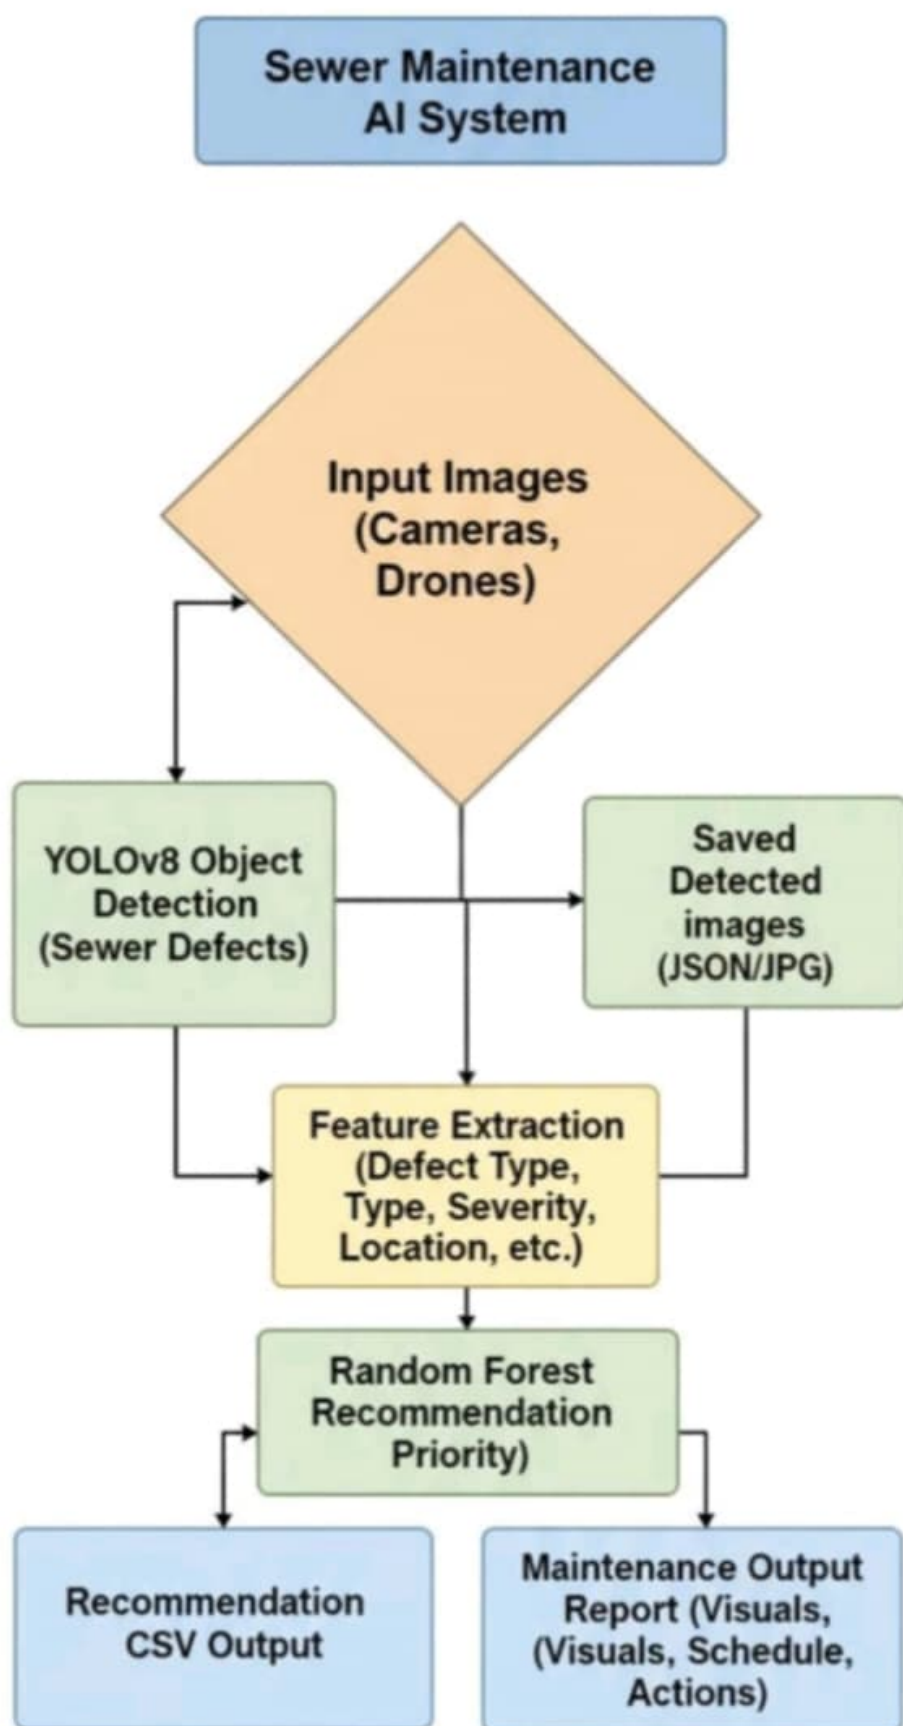
Figure 6.2: YOLOv8 workflow for detection

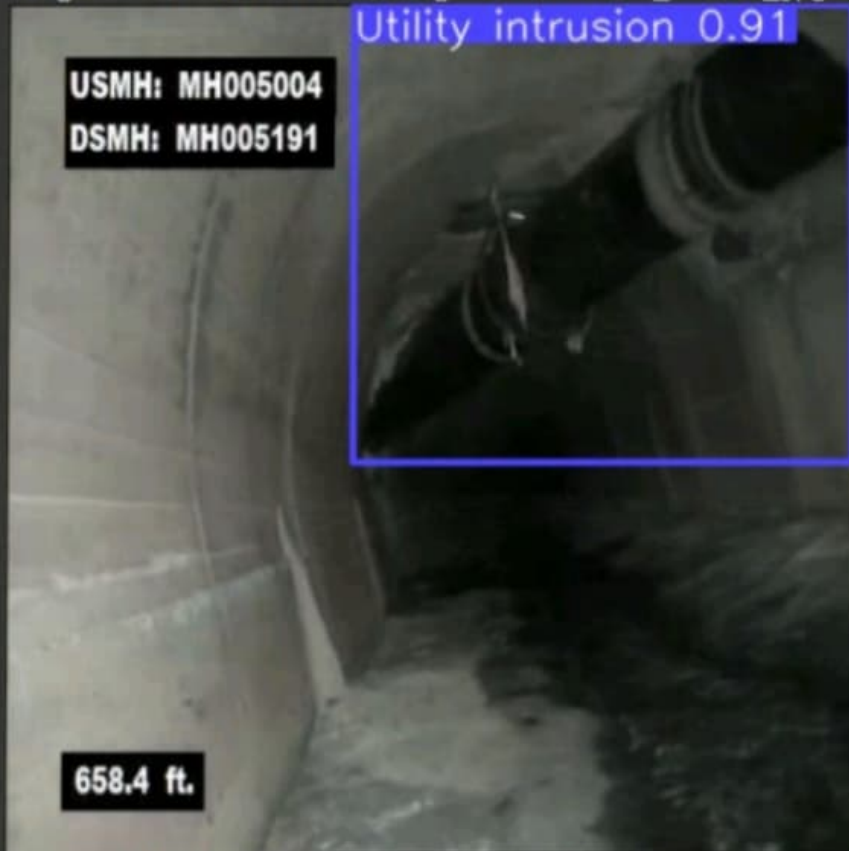
Image 39: /content/test/images/PI010523-a_f13620_jpg.rf.f5e6c7f9dc9356fe0d250aa40440358d.jpg

Detected fault class: 6 (Name: Utility intrusion)

Confidence: 0.9053 | Box Area: 54719

RF Recommendation: Urgent action: notify utility/excavate.

(Original Intensity Check: HIGH)

Figure 7.4: Utility image combining detection and recommendation output.

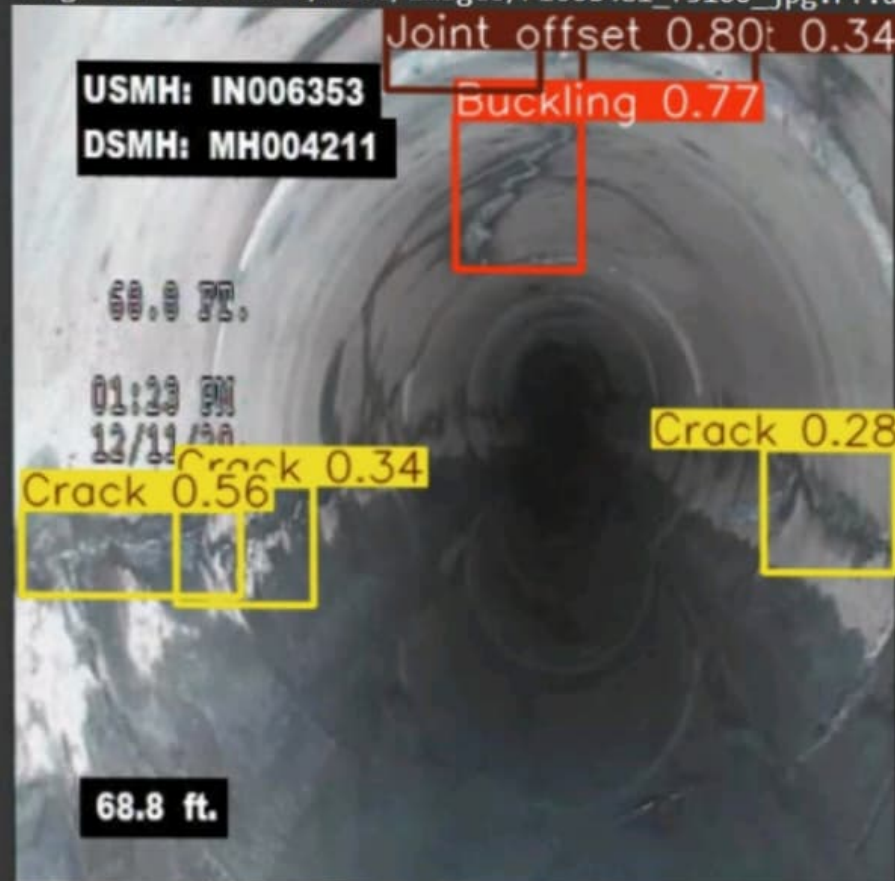
Image 21: /content/test/images/PI008481_f5160_jpg.rf.df7b0d13b6c46909eb0cf98ee481851a.jpg

Detected fault class: 4 (Name: Joint offset)

Confidence: 0.7973 | Box Area: 2756

RF Recommendation: Plan adjustment for joint offset.

(Original Intensity Check: MEDIUM)

Detected fault class: 0 (Name: Buckling)

Confidence: 0.7720 | Box Area: 4254

RF Recommendation: Schedule inspection for buckling.

Figure 7.5: Detection of multiple sewer defects and respective recommendations.

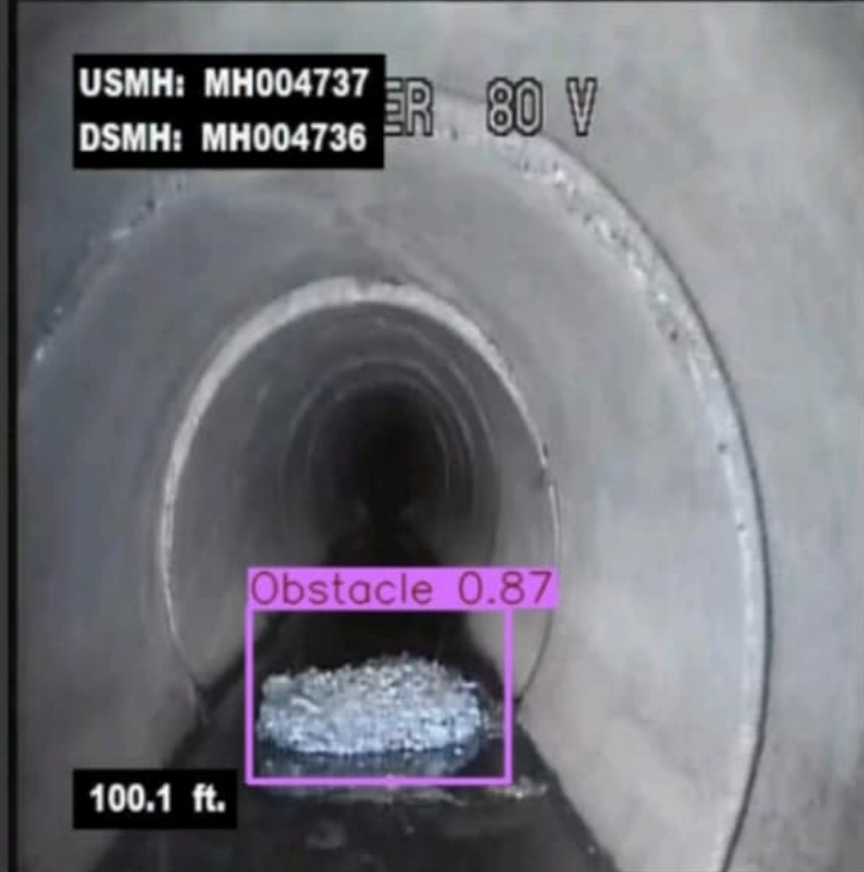
Image 22: /content/test/images/PI008708_f2100_jpg.rf.017b368c13d113e2578a89df69692405.jpg

Detected fault class: 5 (Name: Obstacle)
Confidence: 0.8696 | Box Area: 10341
RF Recommendation: Immediate removal required.
(Original Intensity Check: HIGH)

Figure 7.6: Detection of obstacle and generated maintenance recommendation.
