PAM Detector Module 024

Test Report and Datasheet

Built and tested March 2026 by Jay Frothingham.

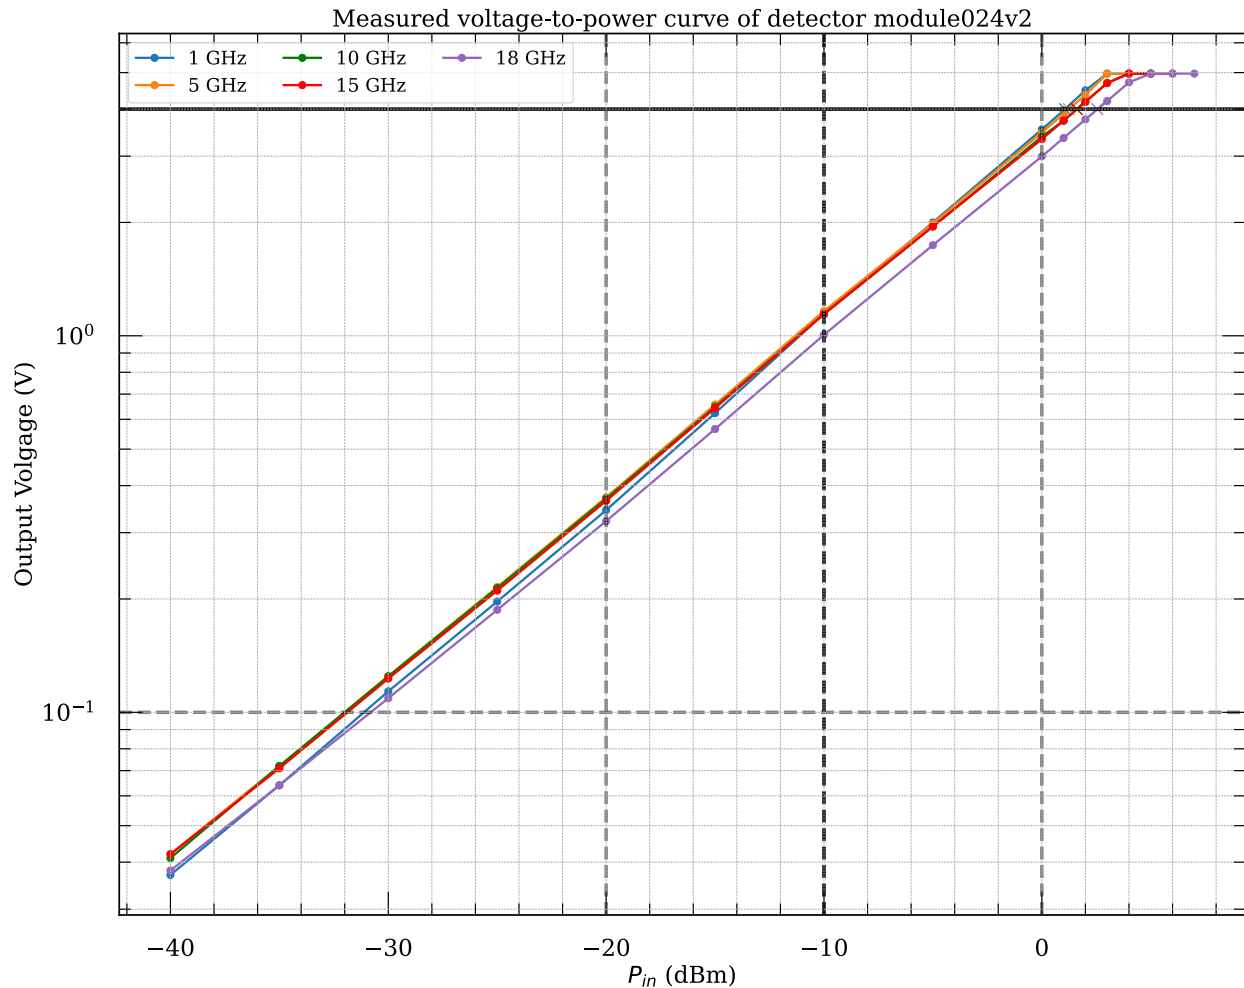
First build failed due to impedance mismatch. Success after rework.

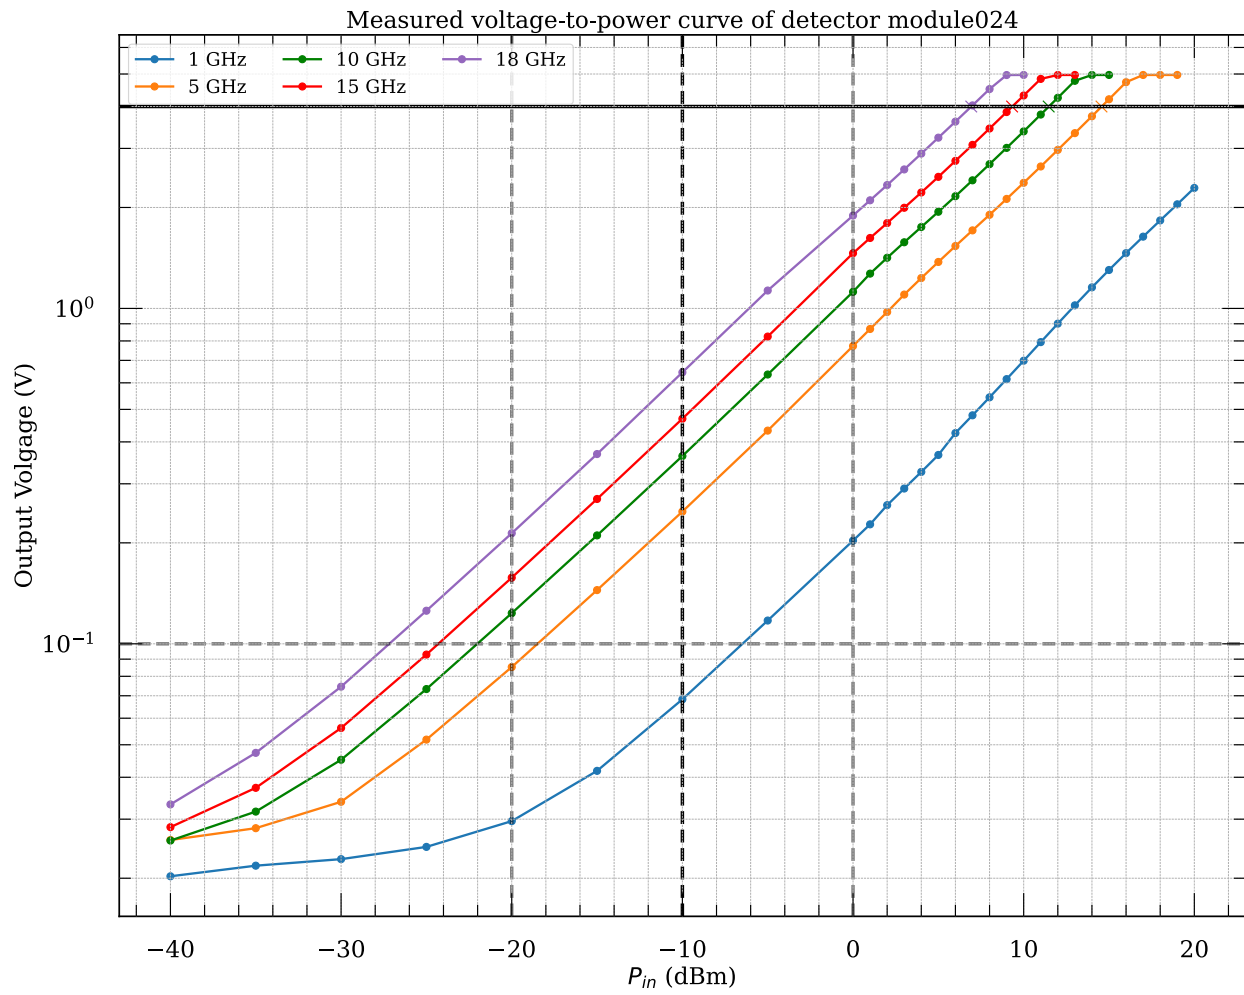
Voltage-to-power Curve

Reworked module P-V curves

First build P-V curves.

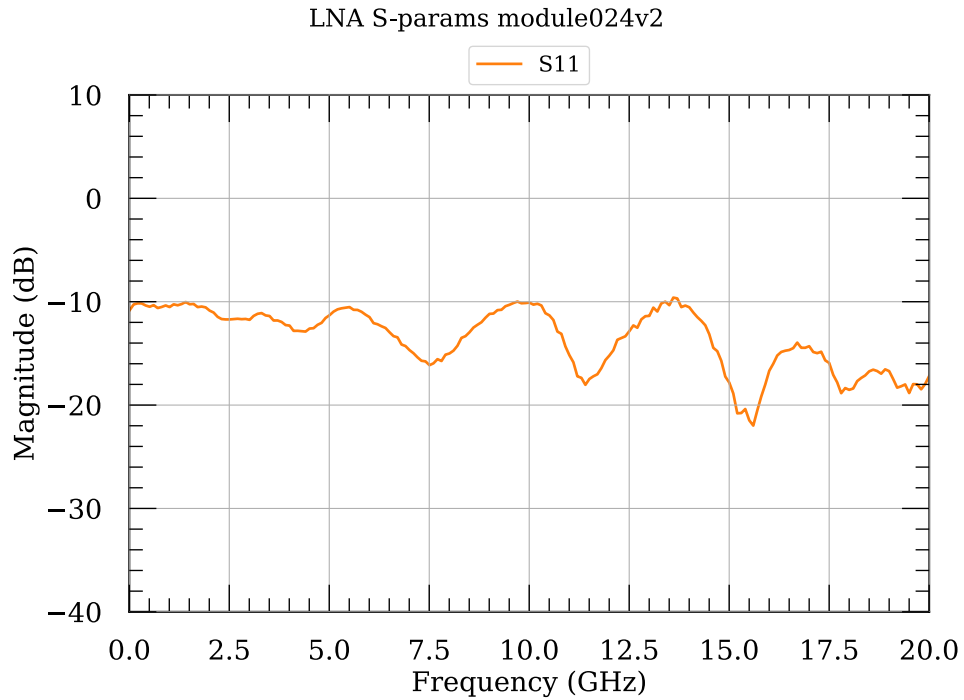
Reworked module S-parameters

S-parameter measurement with the VNA (N5230C).

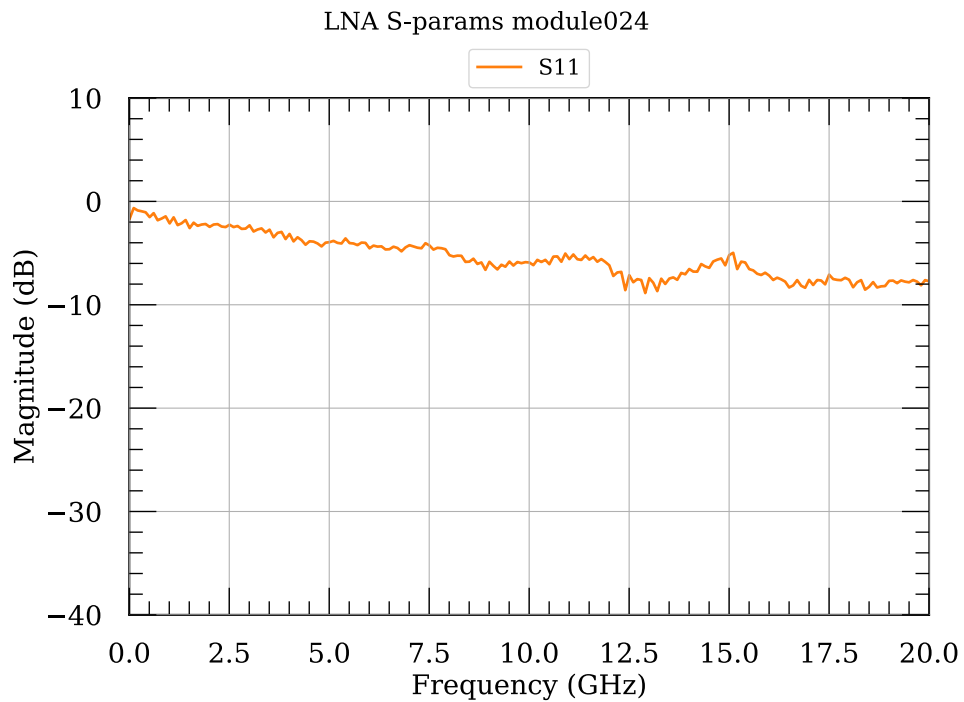
S-parameter

First build S-parameters
