TLS-3XX Series Consoles

Troubleshooting Guide

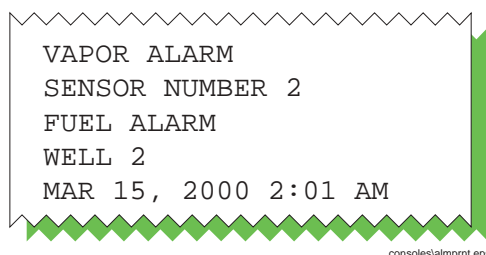
Consoles equipped with a printer will generate an alarm report when a warning or alarm condition is detected. This report will show the type and location of the warning or alarm and the date and time it occurred. An example alarm report is shown below:
