PAM Detector Module 027

Test Report and Datasheet

Built and tested March 2026 by Jay Frothingham and Colin Rush.

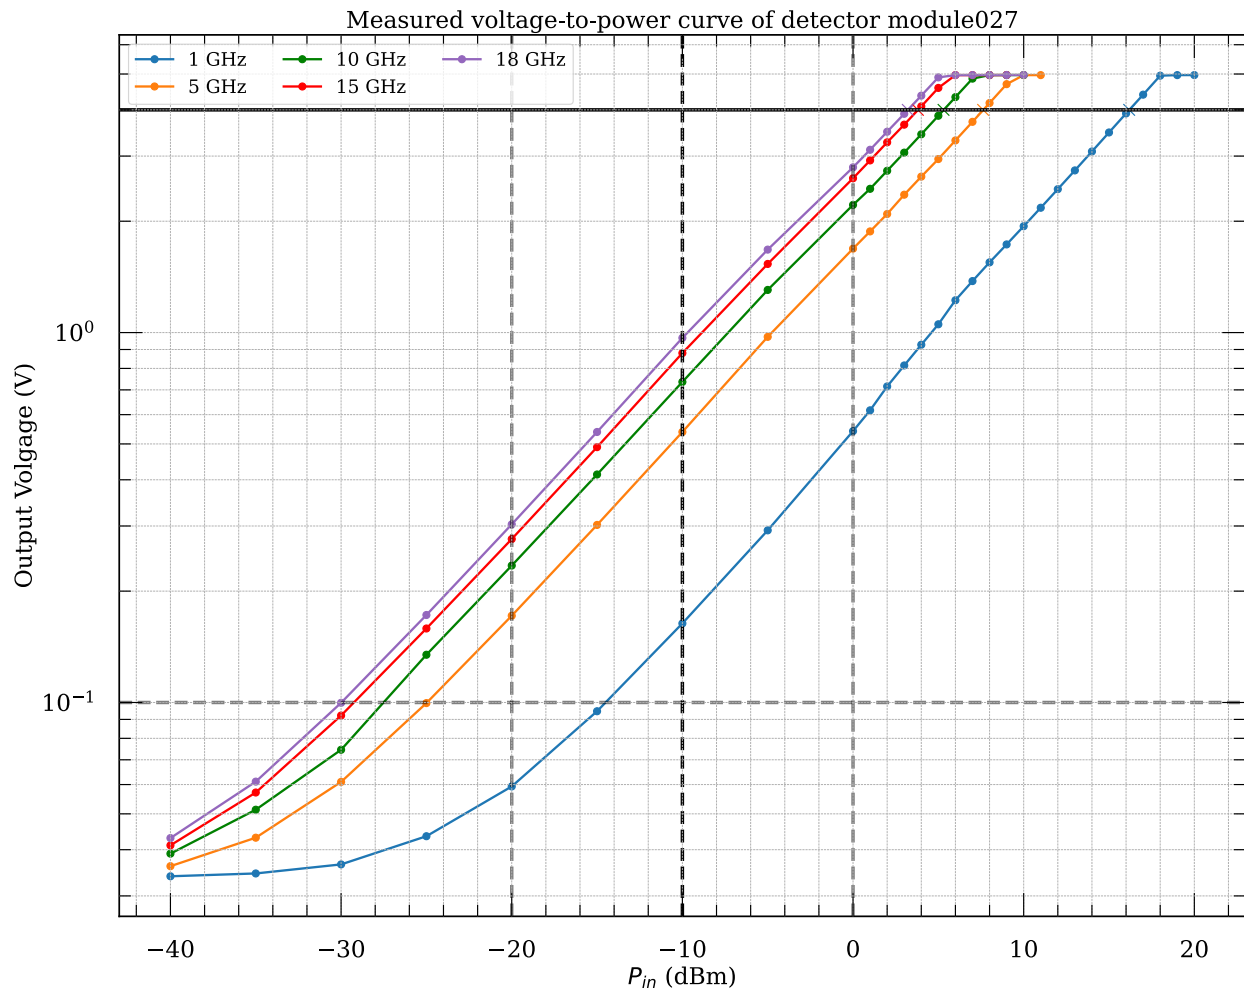
First build failed due to impedance mismatch at low frequencies. Success after rework.

Reworked module P-V curves

First build P-V curves.

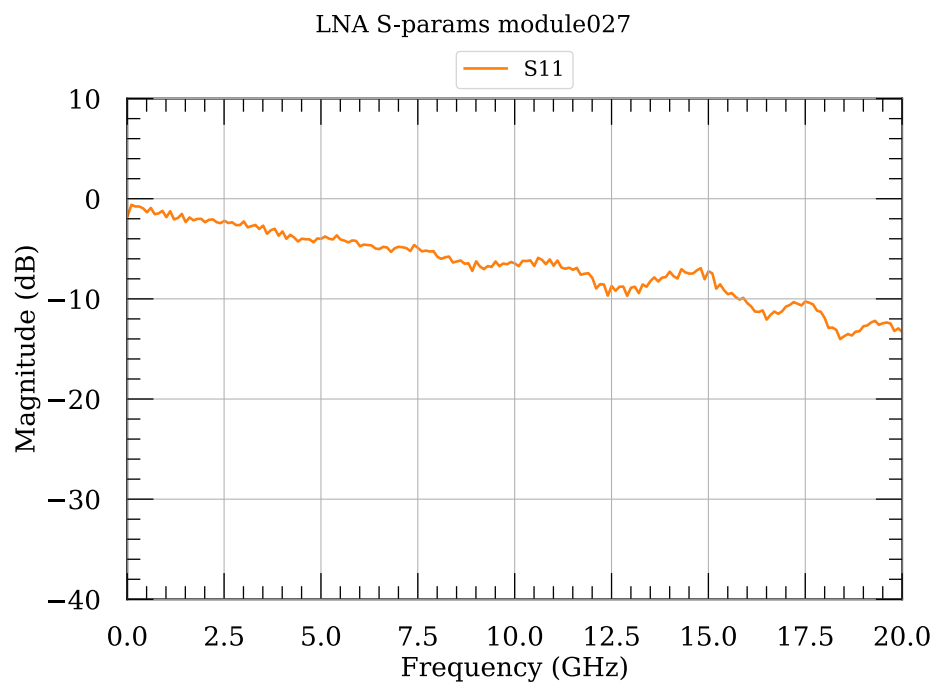
Reworked module S-parameters

First build S-parameters
