PAM Detector Module 028

Test Report and Datasheet

Built and tested March 2026 by Jay Frothingham and Colin Rush

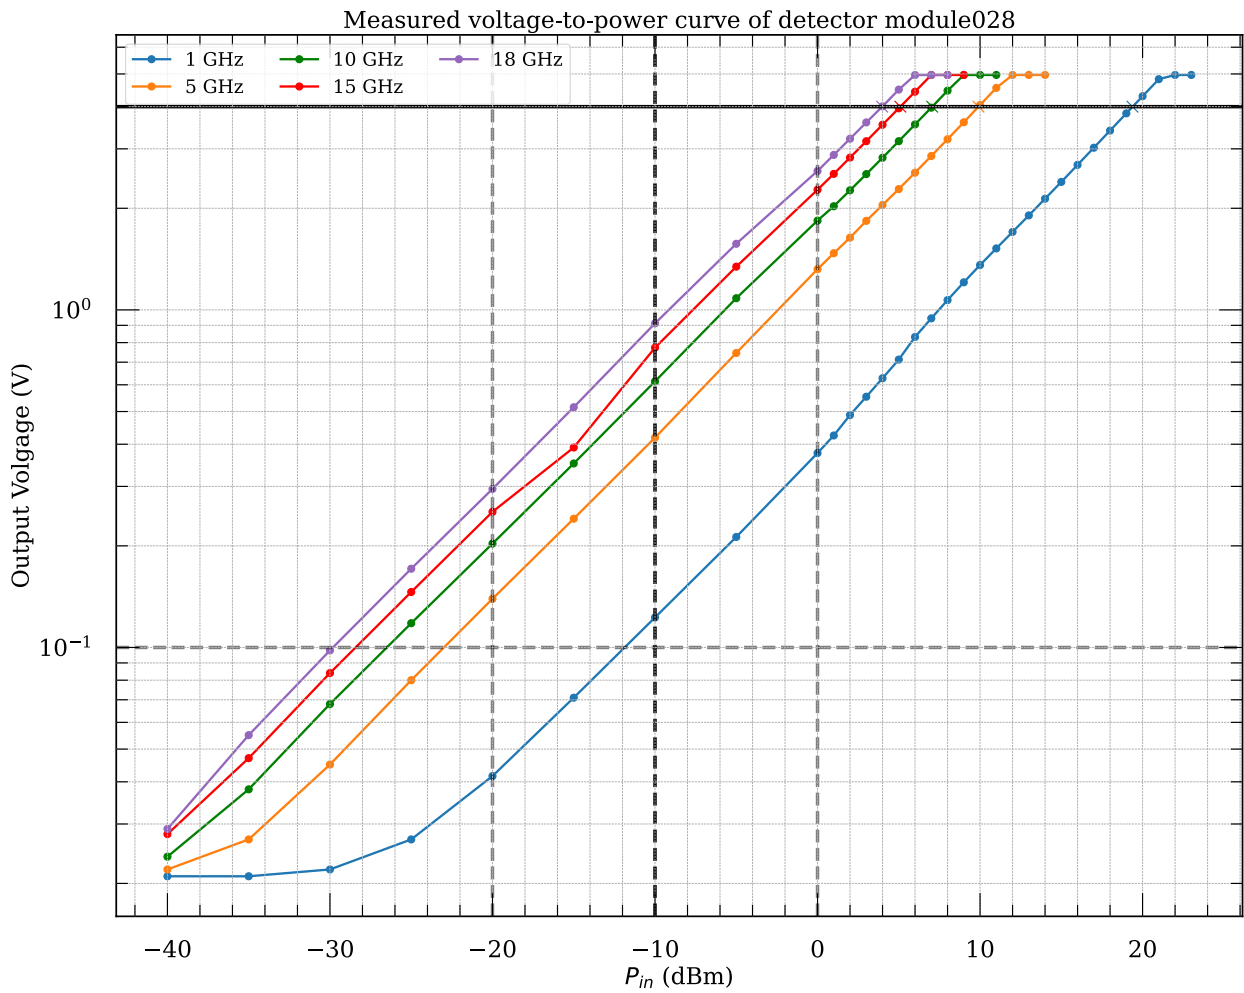
First build failed due to impedance mismatch at low frequencies. Success after rework.

Reworked module P-V curve

First build P-V curve

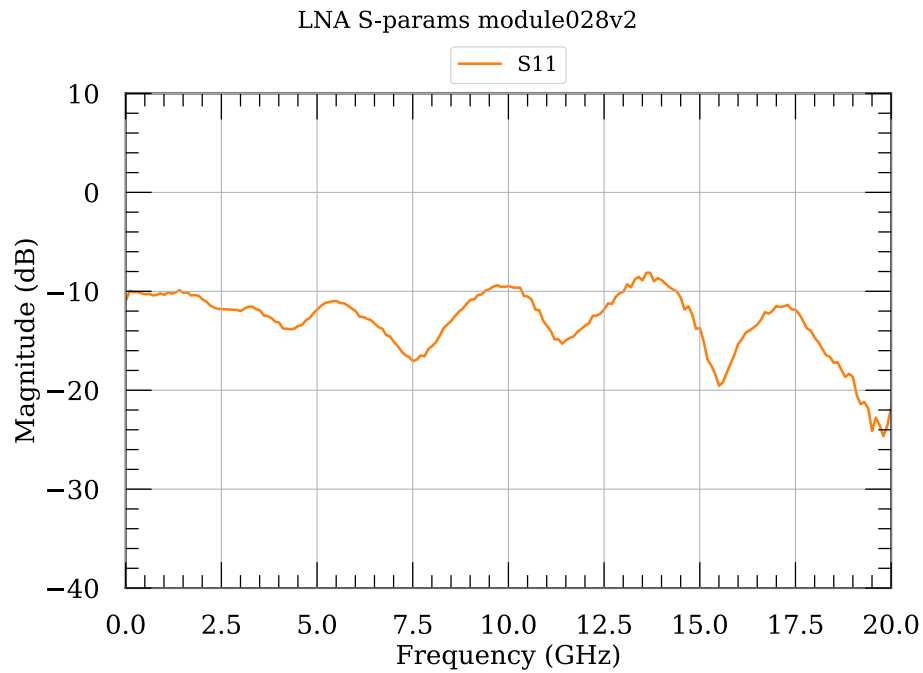
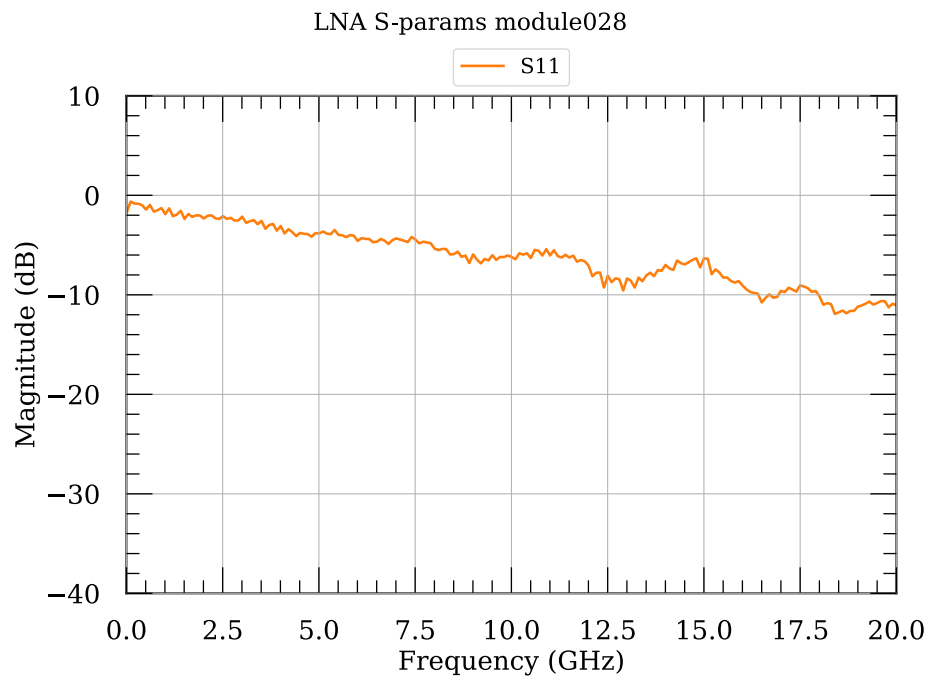
Reworked module S-parameters

First build S-parameters
