**Technical Report on the Preliminary Economic Assessment  
of the  
Harquahala Project  
La Paz County, Arizona**

**Report Date: June 30, 2017**

**Updated: June 25, 2018**

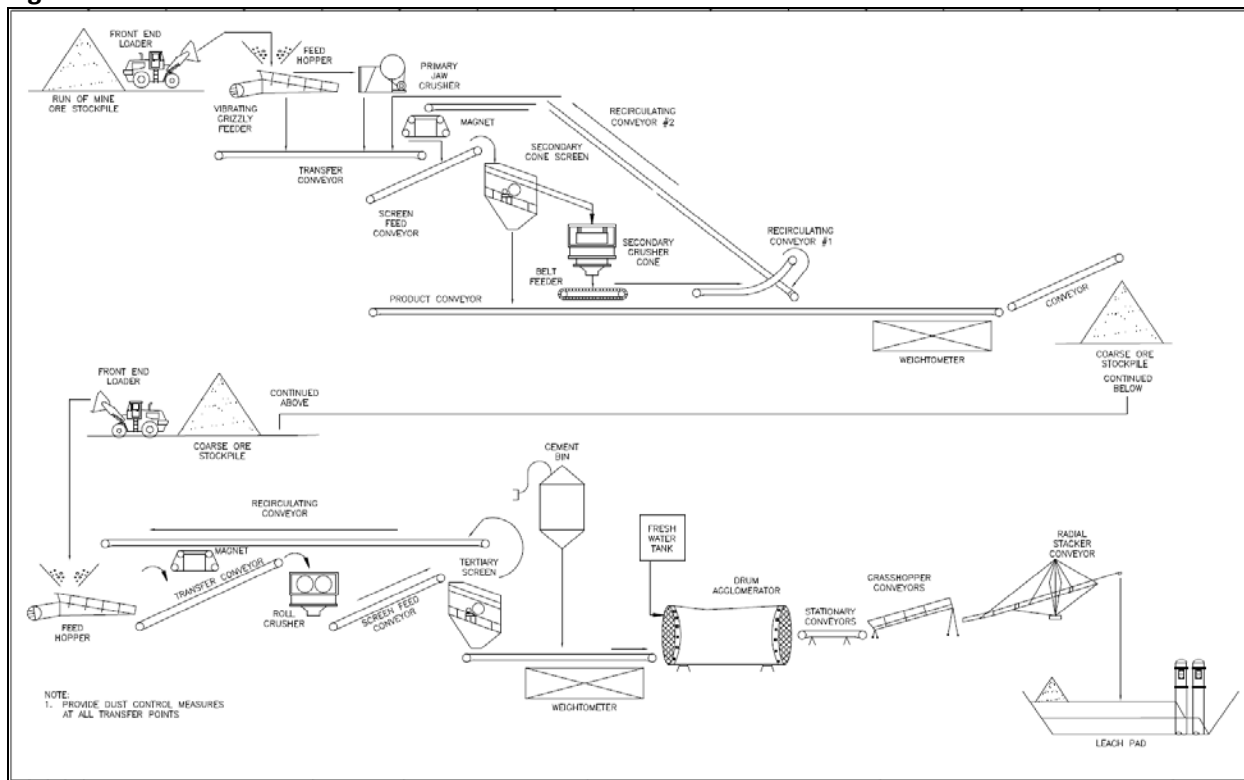
Figure 1-2: Overall Process Flowsheet

Ore will be processed by using cyanide heap leach. The overall process flowsheet can be found in Figure 1-2. Ore will be processed at a rate of 5000 ton/day for 180 days. The ore will be crushed and agglomerated by an on-site crusher (jaw, cone, and screen) at a rate of 5000 ton/day to minus ½". The crusher is expected to operate one shift per day.

Gold and silver will be recovered using a standard cyanide heap leach methods and carbon recovery. The carbon will be processed off-site for recovery of the gold and silver.

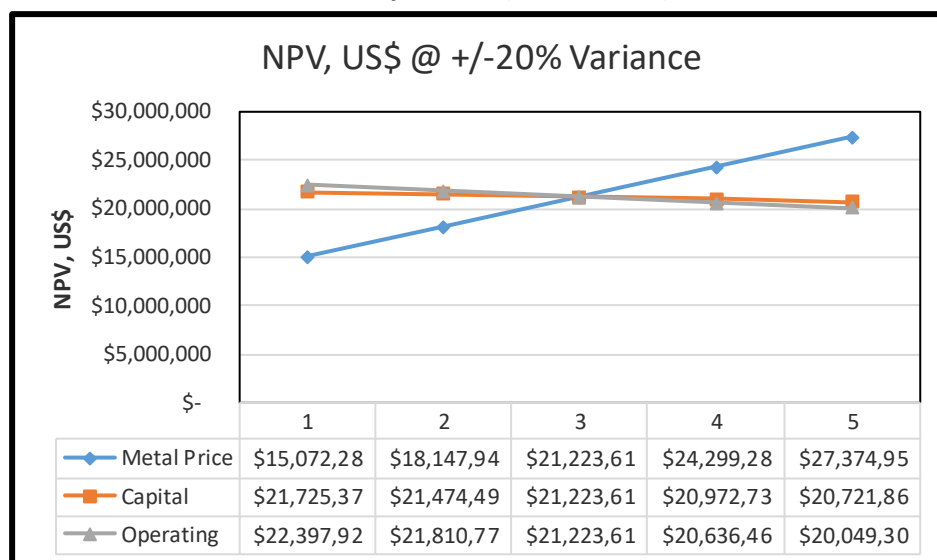
**Figure 1.3: Base Case Pre-Tax NPV Sensitivity Results (5% Discount)**

Variable	-20%	100%	+20%
Metal Price	15.1	21.2	27.3
Recovery	15.1	21.2	
Head Grade	15.1	21.2	27.3
Operating Costs	22.4	21.2	20.0
Capital Costs	21.7	21.2	20.7

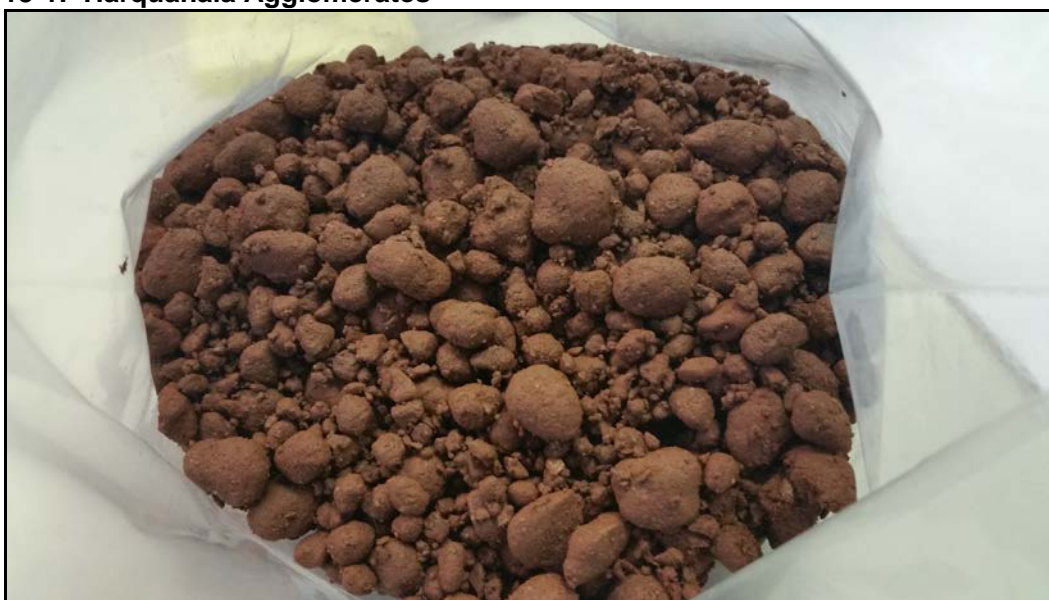
**Figure 13-1: Harquahala Agglomerates**

The agglomerates were made in a standard desk type drum agglomerator. The material was mixed based on the above noted parameters and rolled in the agglomerator for two minutes. Figure 13-1 identifies the rolled agglomerates:

The agglomerates were dried for 24 hours and reviewed. The agglomerates were placed in a small column and left to settle for 24 hours. There was little to no settling or agglomerate breakage in the column material.

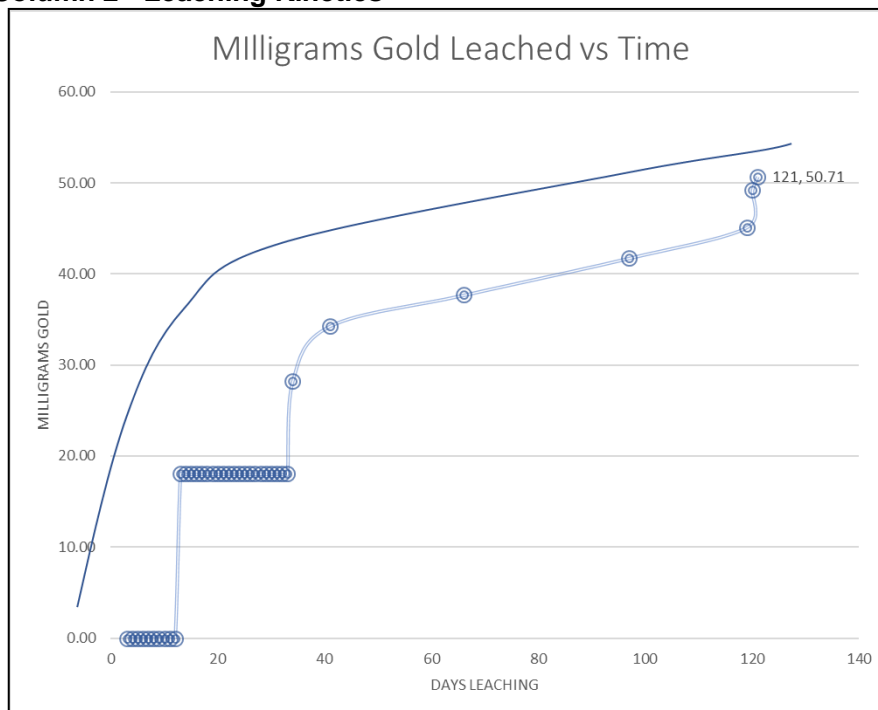
**Figure 13.2: Column 2 - Leaching Kinetics**

- Gold Recovery – 88.1% (Gold was still leaching when the column was taken off-line at 119 days. Solution recovery is based off of head grade and solution recovery. The tails assays are pending.).

Note: Areas of flat lines are when the column was operating but no assays were taken due to laboratory availability.

- Silver Recovery – 12.9%
- Final Solution Grade – Au 0.200 Gms/liter, Ag 0.15 gms/liter
- Back calculated head grade: Still awaiting final head grade.

- Due to laboratory commitments, the column was brought off-line while the column was still leaching. At current leach rates and kinetics, the column is estimated to leach well in excess of 62 milligrams of gold in about 160 days. At a column head grade of 0.046, this would push the column recovery in excess of 100%. At 62 grams of gold recovered at 90% recovery, this would back-calculate a head grade of approximately 0.055 oz/tn Au (1.76 grams/tn of gold).
- The agglomerates were stable with only 4.9% slump in 121 days. There was no degradation of agglomerates or fine migration.
- Gold recoveries project to the 90% as the column continues to leach after 119 days.
- Further review of the silver will be required to see if higher recoveries can be obtained.
- There were no percolation issues with the column.
- Cyanide usage was low. Lime usage was low.

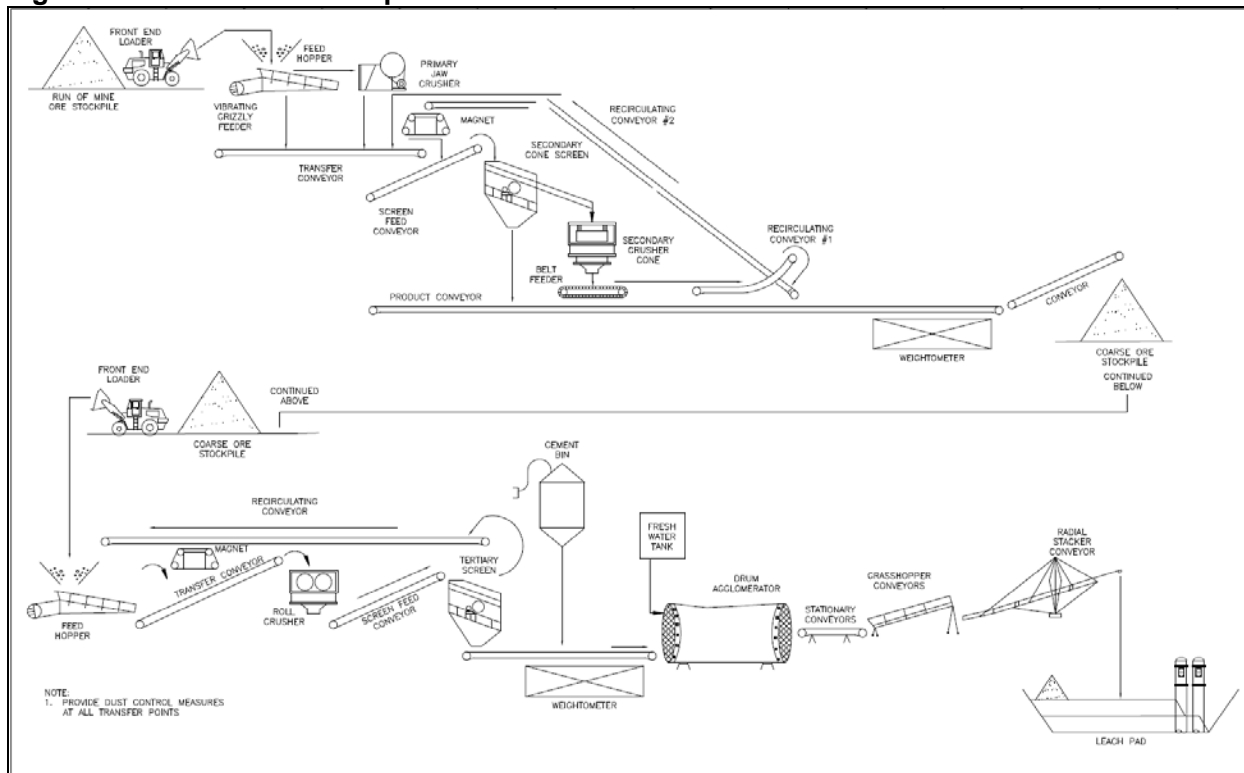
**Figure 17-1: Process Description**

metals, of which carbon has an affinity for. As the upstream carbon vessel is fully loaded and experiencing breakthrough to the downstream carbon vessels, the loaded carbon will be removed from service and sent offsite for processing. Regenerated or new carbon will be loaded in the furthest downstream vessel following the sequential upstream advancement of carbon from other vessels. The barren solution will exit the GAC system and report to the barren solution pond. The solution in the barren pond will be conditioned with cyanide, makeup water and caustic, as necessary, and re-applied to the top of the heap leach pad.

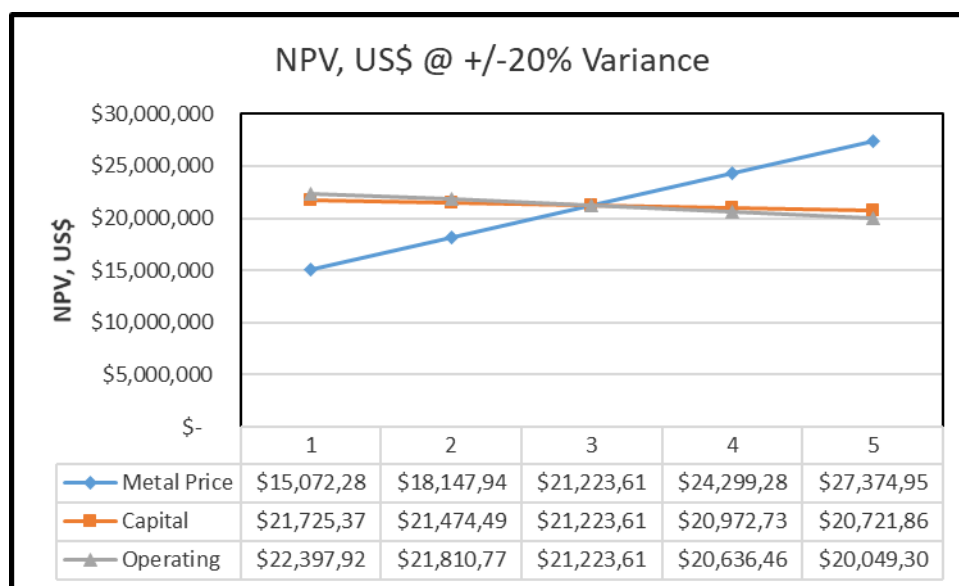
**Figure 21-2: Base Case Pre-Tax NPV Sensitivity Results (8% Discount)**

Variable	-20%	100%	+20%
Metal Price	15.1	21.2	27.3
Recovery	15.1	21.2	
Head Grade	15.1	21.2	27.3
Operating Costs	22.4	21.2	20.0
Capital Costs	21.7	21.2	20.7
