PAM Detector Module 046

Test Report and Datasheet

Built and tested March 2026 by Jay Frothingham and Colin Rush

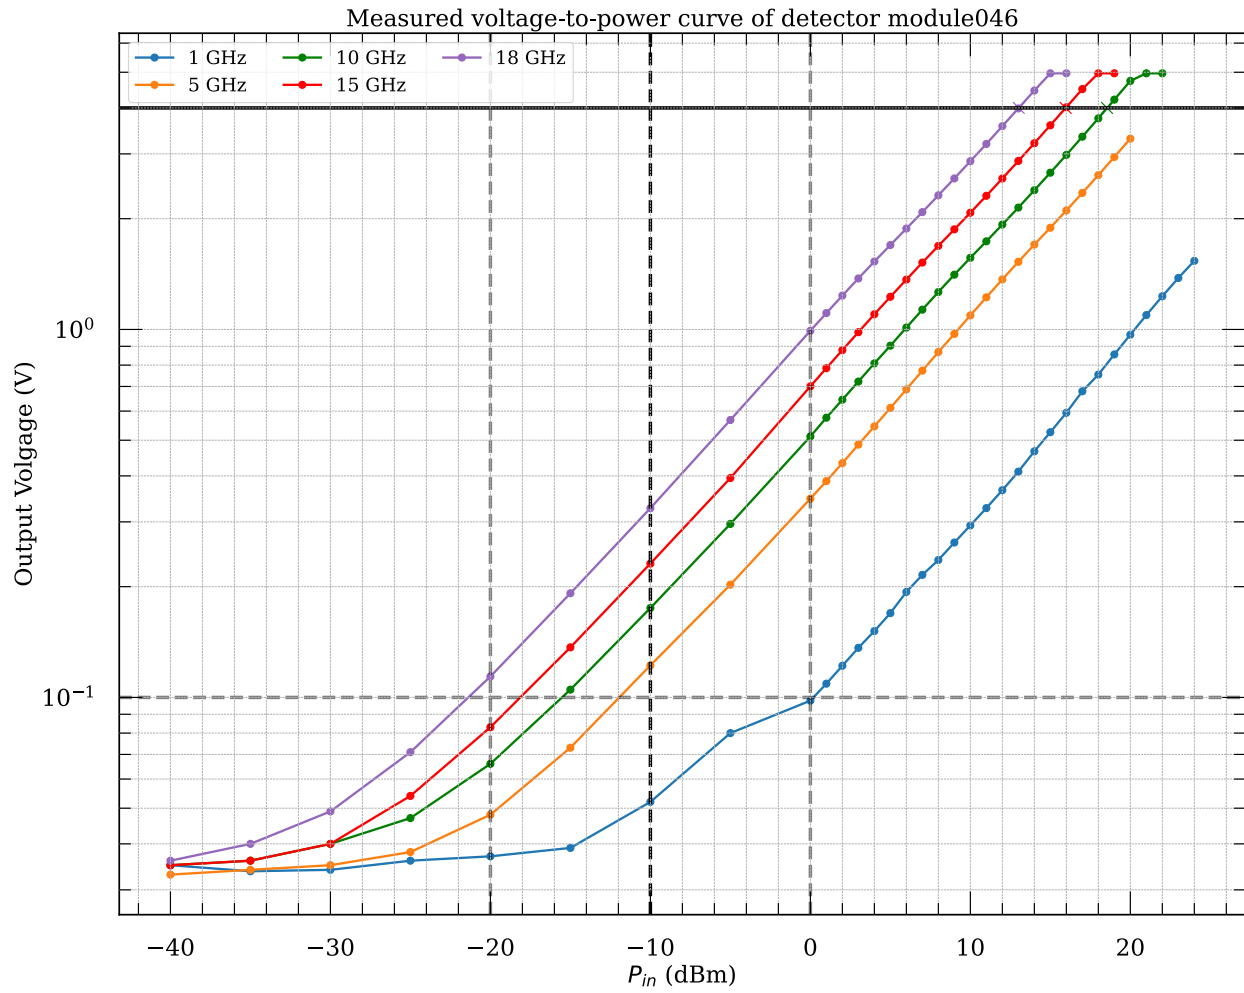
First build failed due to impedance mismatch at low frequencies. Success after rework.

Reworked module P-V curve

First build P-V curve

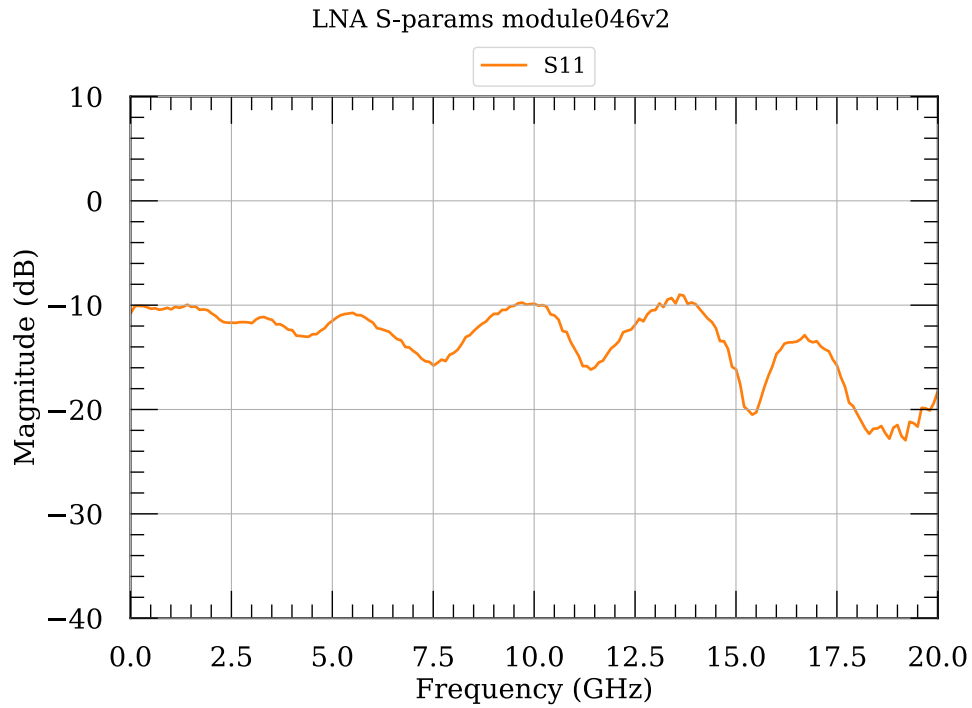
Reworked module S-parameters

S-parameter measurement with the VNA (N5230C) of detector module.

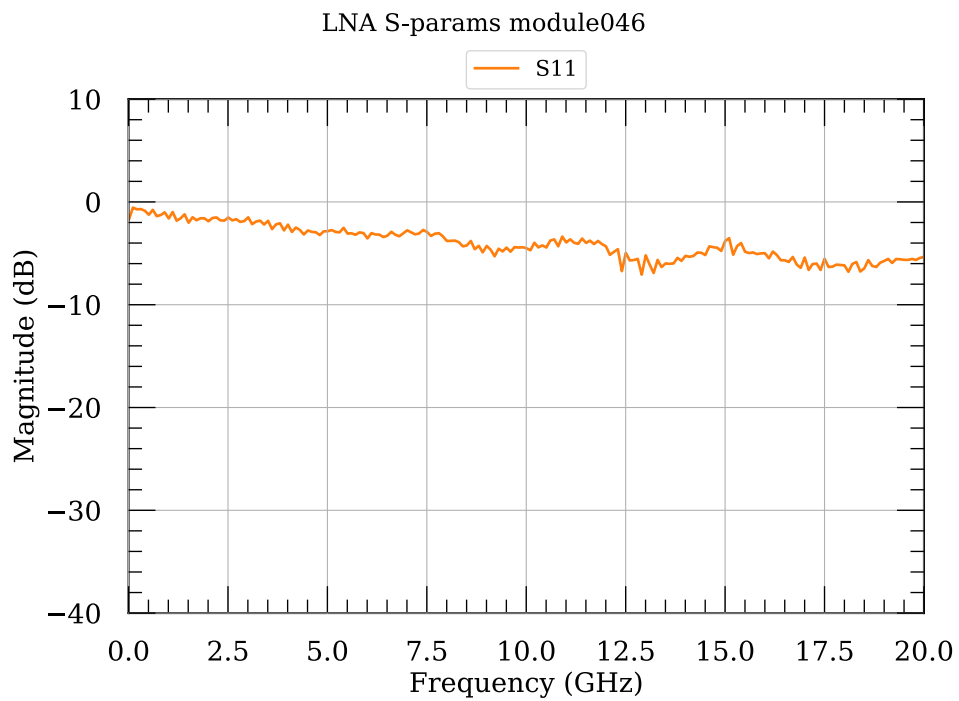
First build S-parameters
