EFFECTS OF TRANSIENT MOTION IN INTERMEDIATE STAGES OF FLOODING ON THE FINAL CONDITION OF A DAMAGED PCC

Yoshiho IKEDA and Tomoko KAMO, Osaka Prefecture University, Gakuen-cho, Sakai, Osaka, 599-8531 Japan, ikeda@marine.osakafu-u.ac.jp

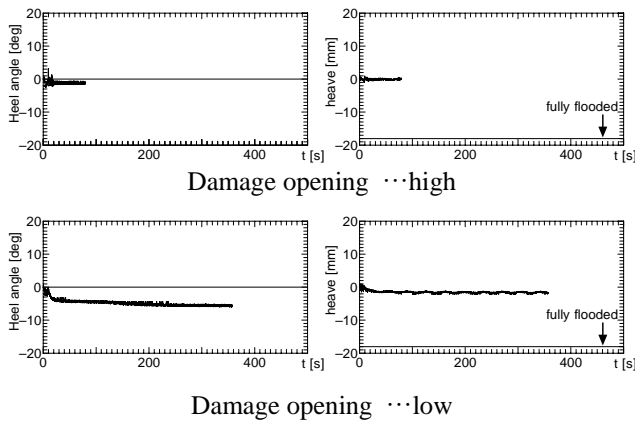
Fig.6 Time histories of ship motions in case of SOLAS damage opening with car decks in compartment (GM=23.5mm)

Figs. 6 and 7 show the experimental results in the case of maximum damage length determined in SOLAS. Longitudinal length of the damage opening is 70mm, vertical height of it is 10mm, and the depth the lower edge

of the opening from water surface at start of flooding is changed by 2mm and 8mm. As soon as the opening is released, water rushes into the compartment, and the ship heels to the opposite side of the damage opening. Then the opening comes up above water surface, and flooding stops. In the final stage, the ship heels at certain angle, and the amount of flooded water in the damaged compartment is limited. The same conclusion is obtained in the experiments for smaller damage opening of half size of the SOLAS damage opening as shown in Figs. 8 and 9. These experimental results demonstrate that ship motions in intermediate stages of flooding sometimes change the final result.

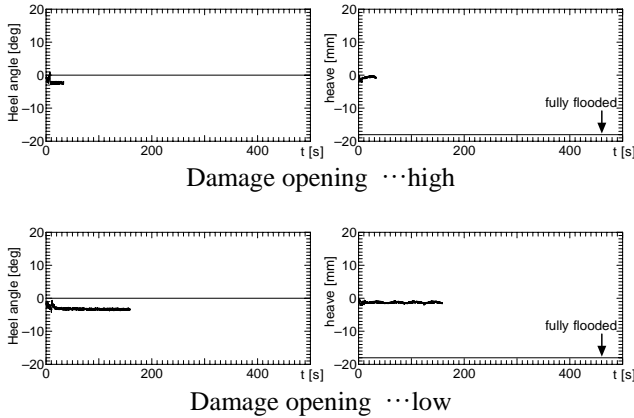
Fig.10 Time histories of ship motions for 1.5 degree of initial heel to the opposite side of damage opening in case of maximum damage opening with car decks in compartment (GM=23.5mm)

When the ship has initial heel angle to the opposite side of the damage opening, flooding always stops in intermediate stages of flooding. Fig.10 shows the experimental results for 1.5 degree of initial heel to the side. On the contrary, when the ship has opposite initial heel of the same degree, the opening has been kept underwater, and flooding reaches to almost 50~70% of permeability as shown in Fig.11. These results demonstrate that initial heel angle is also a very important factor to determine the final condition of a damaged ship. It seems to be realistic that a struck ship has a heel angle to the opposite side of damaged opening because the head of the forecastle of a striking ship collides with a struck ship first and this makes the struck ship heel to the opposite side as shown in Fig.12.
