PAM Detector Module 053

Test Report and Datasheet

Built and tested March 2026 by Jay Frothingham and Colin Rush

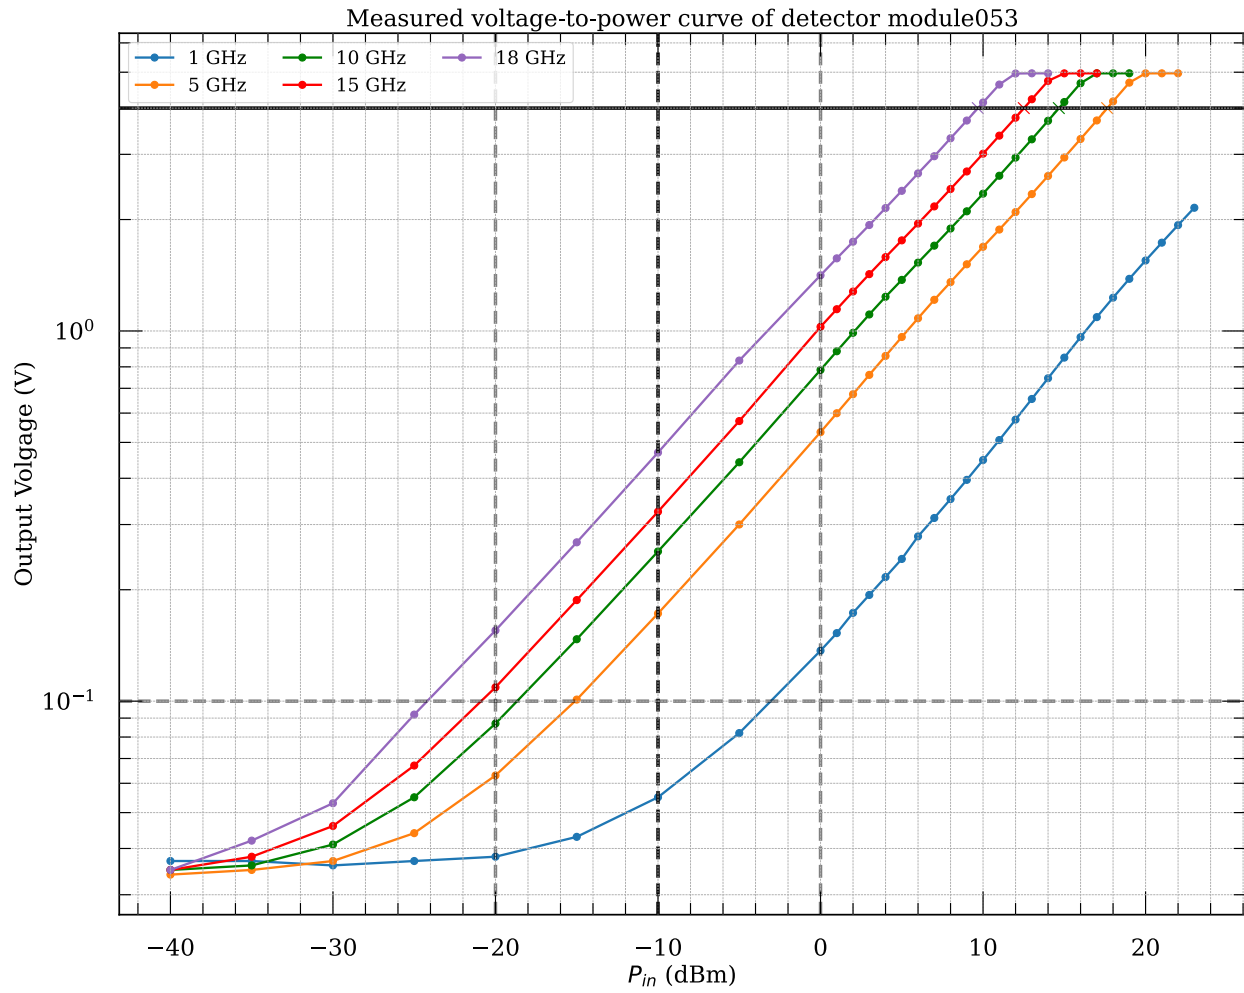
First build failed due to impedance mismatch at low frequencies. Success after rework.

Reworked module P-V curve

First build P-V curve

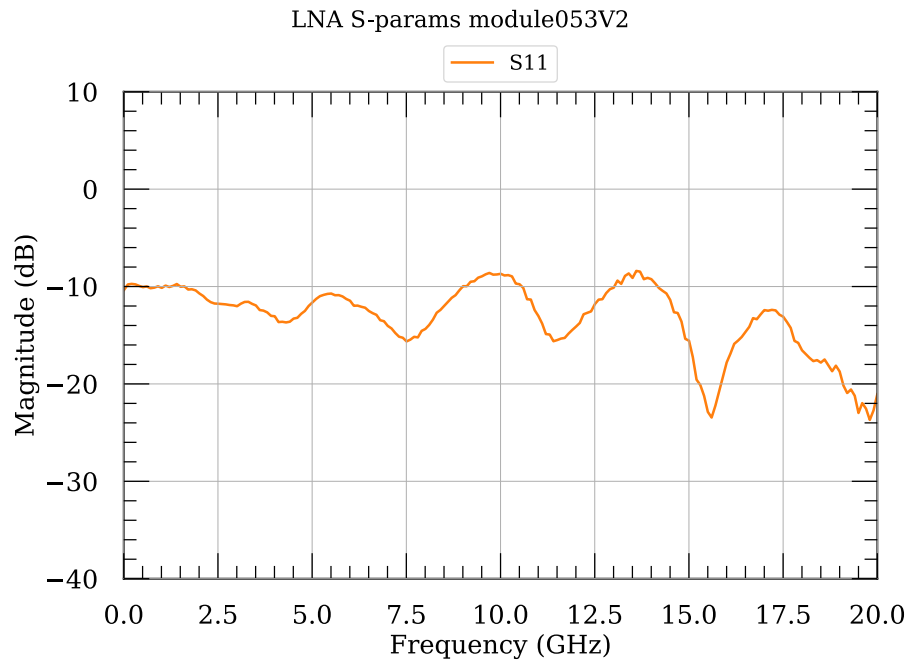
Reworked module S-parameters

S-parameter measurement with the VNA (N5230C) of detector module.

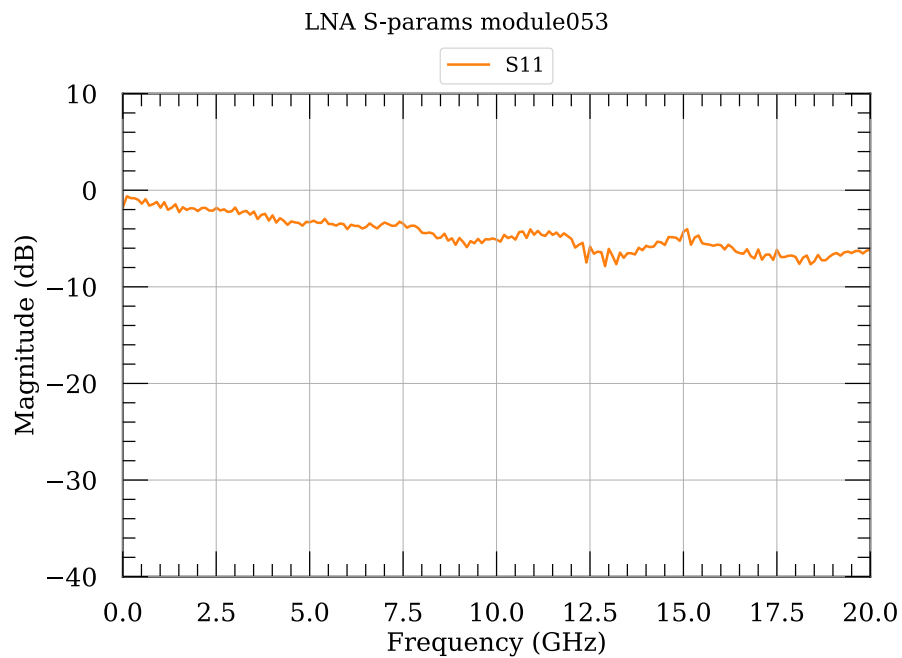
First build S-parameters
