Smart Experience Sampling

Code Walkthrough

This document is for made to give the user a better understanding of the software that runs on the S.E.S. system. It will go into detail about the way we have developed the code and how user can change the code based on the environment the system is used in.

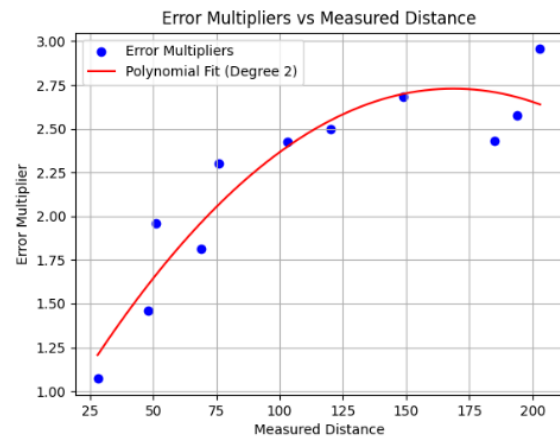
If a distance measurement is returned the distance gets combined to centimeters meaning the meters will be multiplied by 100 and the remaining centimetres will be added. This measurement will then be corrected using a polynomial error correction formula previously calibrated by testing different known measurements.

Figure 3 Polynomial Error correction.
