PAM Detector Module 084

Test Report and Datasheet

Built and tested March 2026 by Jay Frothingham and Colin Rush

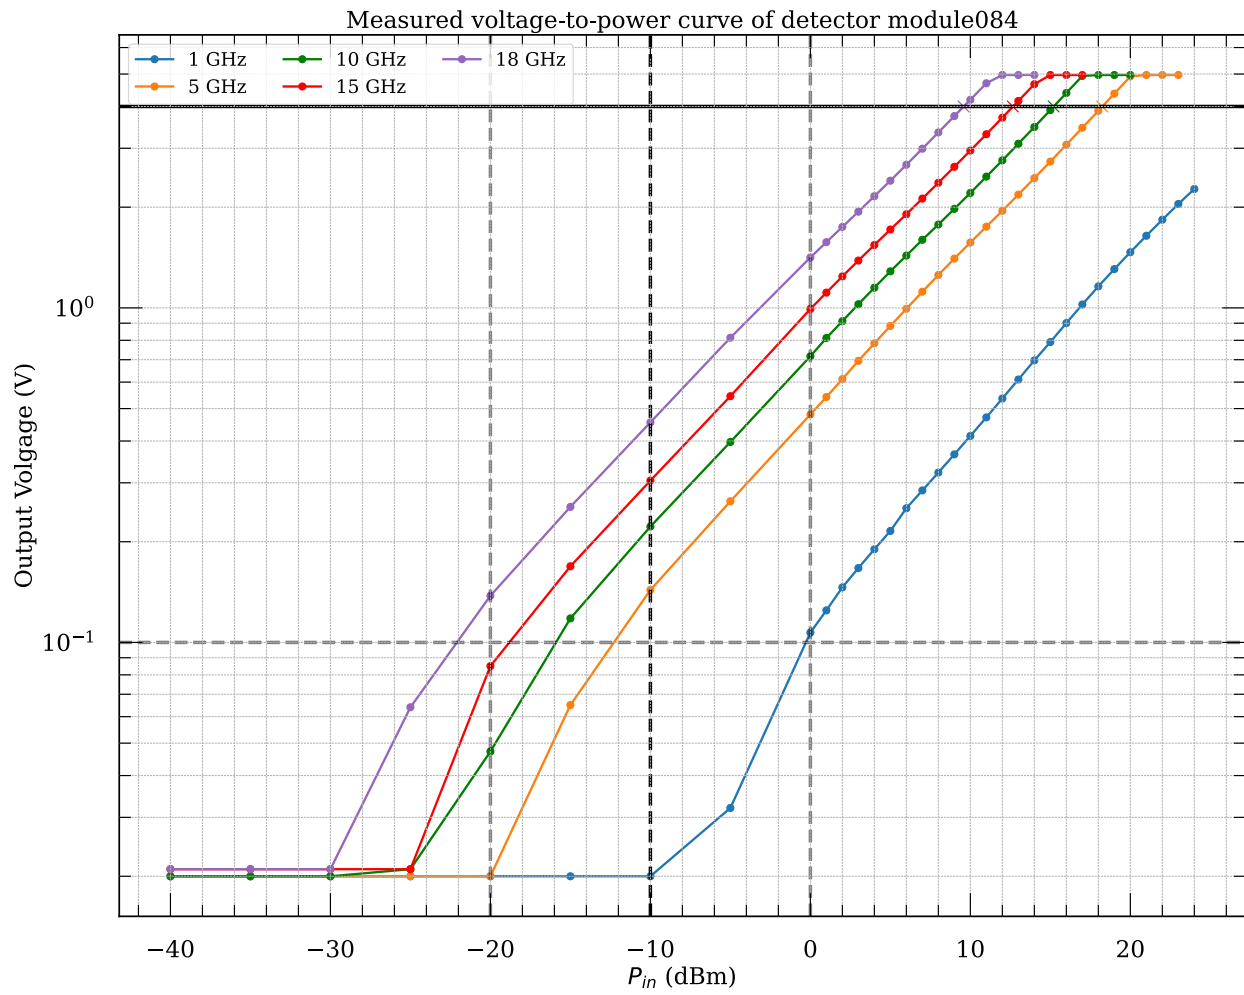
Voltage-to-power Curve

First build failed due to impedance mismatch. Successful after rework.

Reworked module P-V curve

First build P-V curve

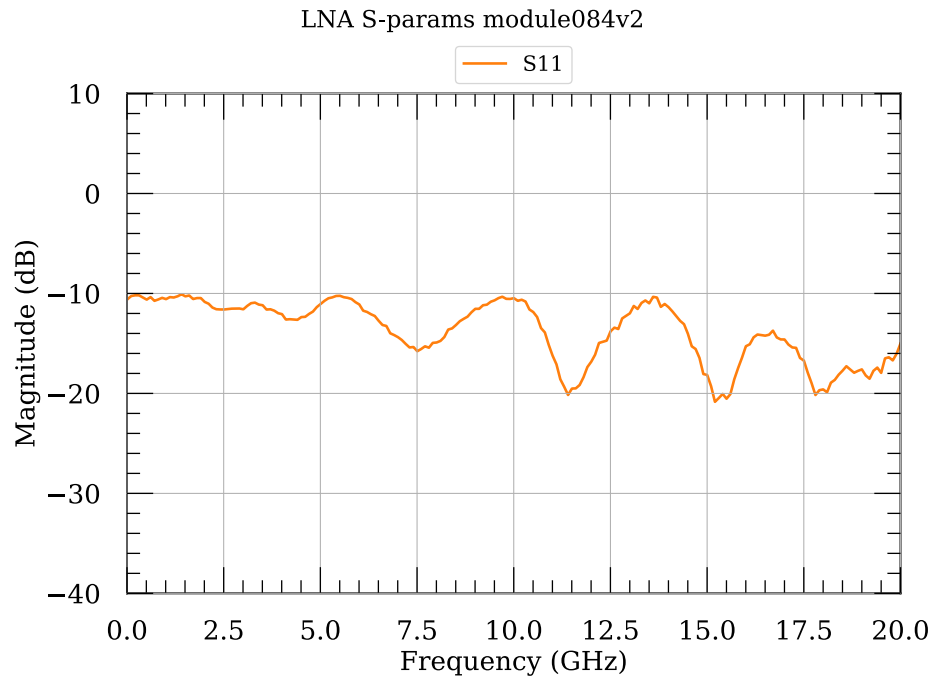
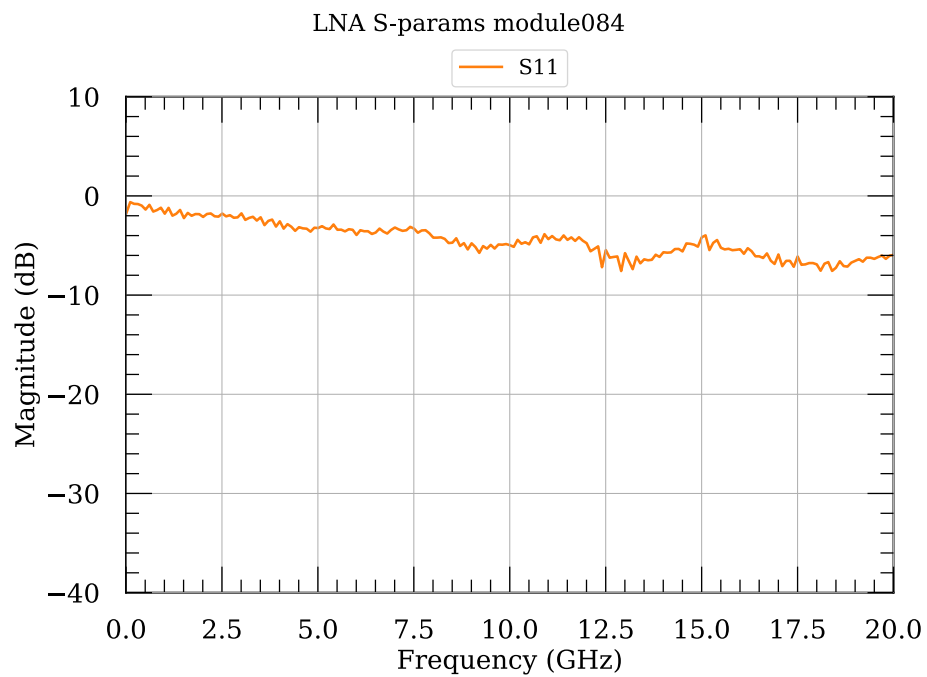
S-parameter

Reworked module S-parameters

First build S-parameters
