MediaTek LinkIt™ SDK v4 Release Notes

Version: 4.3.1

Release date: 2 June 2017

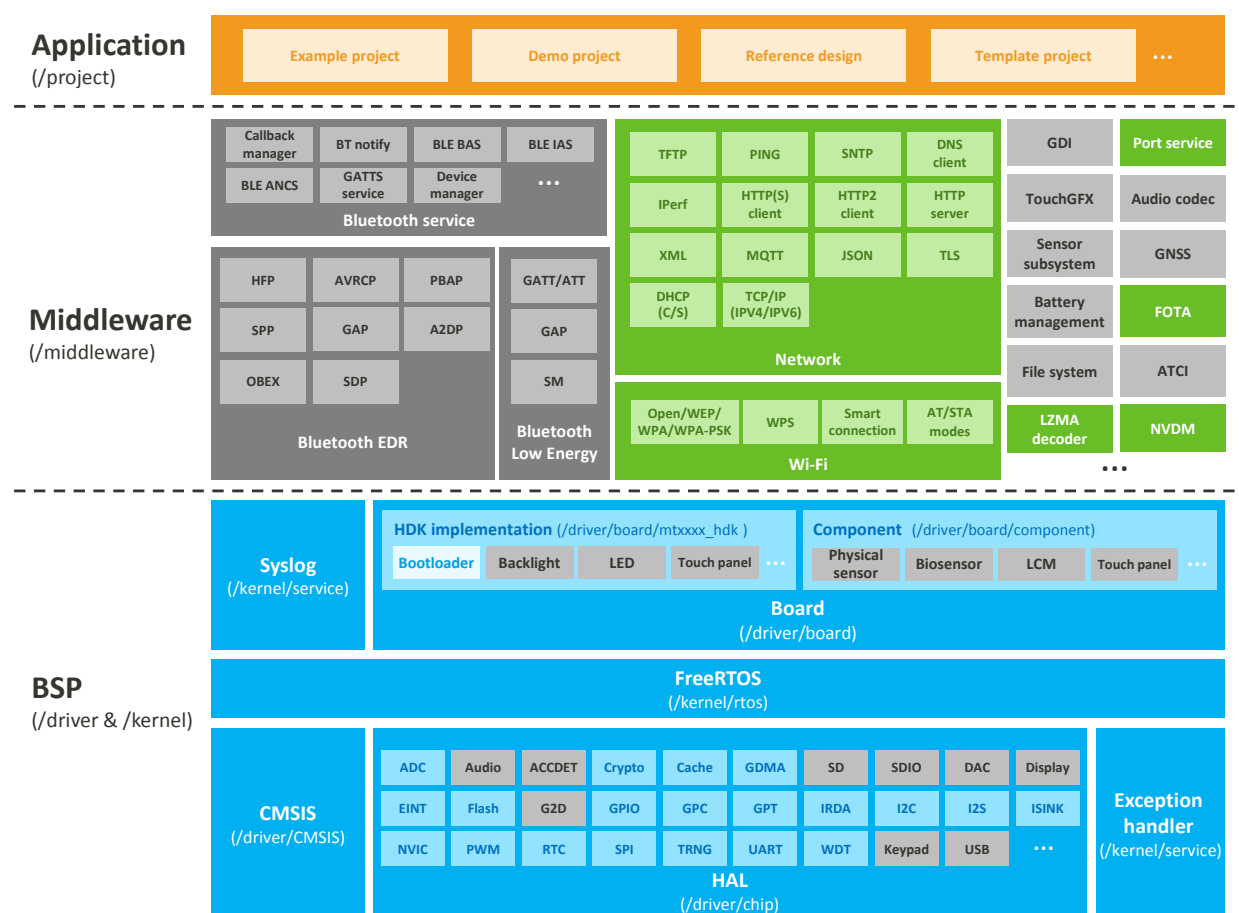
Modules shown in gray color are not supported by MT7687

Figure 1. Architecture layout of the LinkIt SDK v4 for LinkIt 7687 HDK

A functional block in grey means the HDK does not support the feature. The top layer includes the application projects running on the SDK. They are based on Middleware, OS and HAL layers. These layers provide rich features for application development, such as the Middleware provides the network connectivity, Wi-Fi and Bluetooth Low Energy Stack. The FreeRTOS provides the underlying real-time operating system.

The three-layer architecture layout of the SDK for LinkIt 7687 HDK includes Applications, Middleware and BSP, as shown in Figure 1.
