BeSafe Repair instruction iZi Twist

Removal of headrest height adjustment stops

7.2.3.14b Repair manual iZi Twist headrest adjustment stops

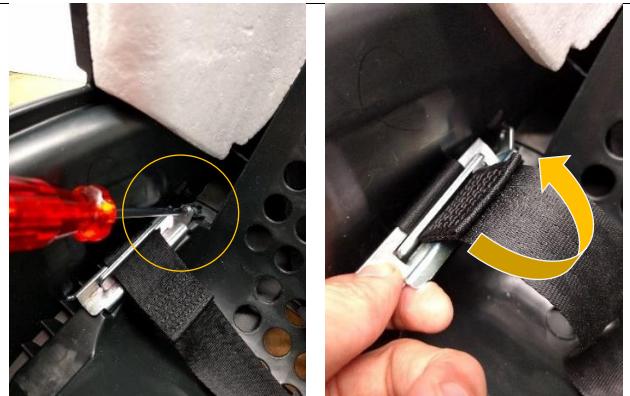
When a consumer is complaining about the limited headrest height adjustment (bottom three positions not possible to use).
This manual explains how to remove the headrest height adjustment stops, that have been fitted to the first two batches of iZi Twist seats.

No.	Action	Picture
1.	Place the iZi Twist seat on a protective surface.	
2.	Release the harness buckle and remove the seat fabric cover. For more information about this step, see document '7.2.3.10.a Service instruction to replace iZi Modular fabric'.	
3.	Remove the lower EPS inserts.
