Computer Assignment 3

Antenna Effect

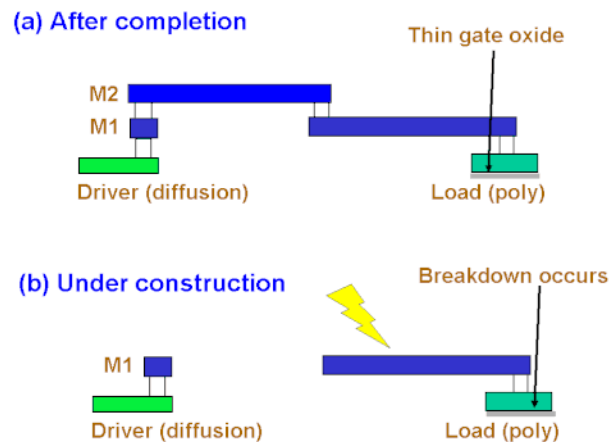
Figure 1 illustrating antenna effect

The antenna effect or plasma induced gate oxide damage is done during plasma etching (dry etching) in manufacturing process. This charge can discharge through gate oxide and therefore can damage the gate oxide. During plasma Etching, the charges accumulated on metal or poly. Once it reaches certain potential and hence damages the gate oxide. If $\frac{\text{exposed conductor area}}{\text{gate oxide area}} > \text{Max Antenna Ratio}$ is true then we have antenna effect.

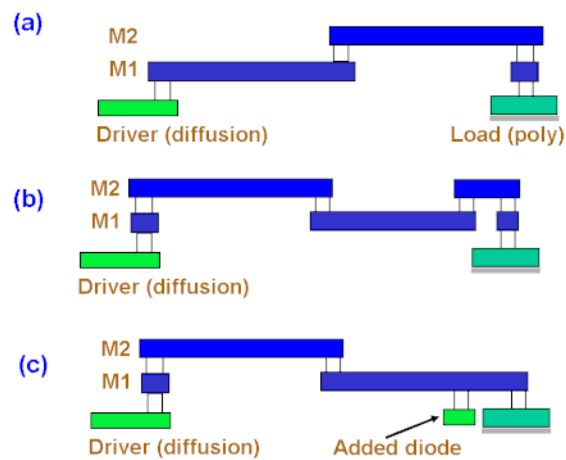
Figure 2 depicts how to fix antenna effect

- Change the order of the routing layers. If the gate(s) immediately connects to the highest metal layer, no antenna violation will normally occur. The reason for this is because the

highest layer would be constructed at the latest and so the charge can be easily discharged through diffusion area. This solution is shown in Figure 3(a).

- Add vias near the gate(s), to connect the gate to the highest layer used. This adds more vias but involves fewer changes to the rest of the net. This is shown in Figure 3(b).
- Add diode(s) to the net, as shown in Figure 3(c). This diode should be connected to metal reversed biased so if voltage gets too high it saves gate from getting damage.

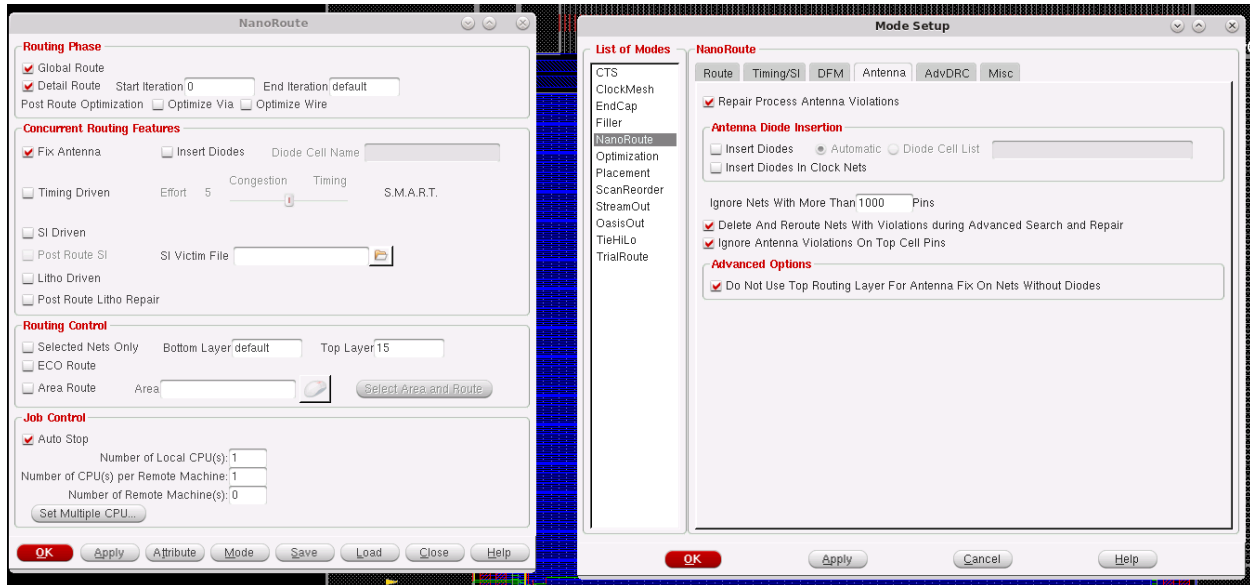
Figure 3 Antenna setting in Innovus GUI

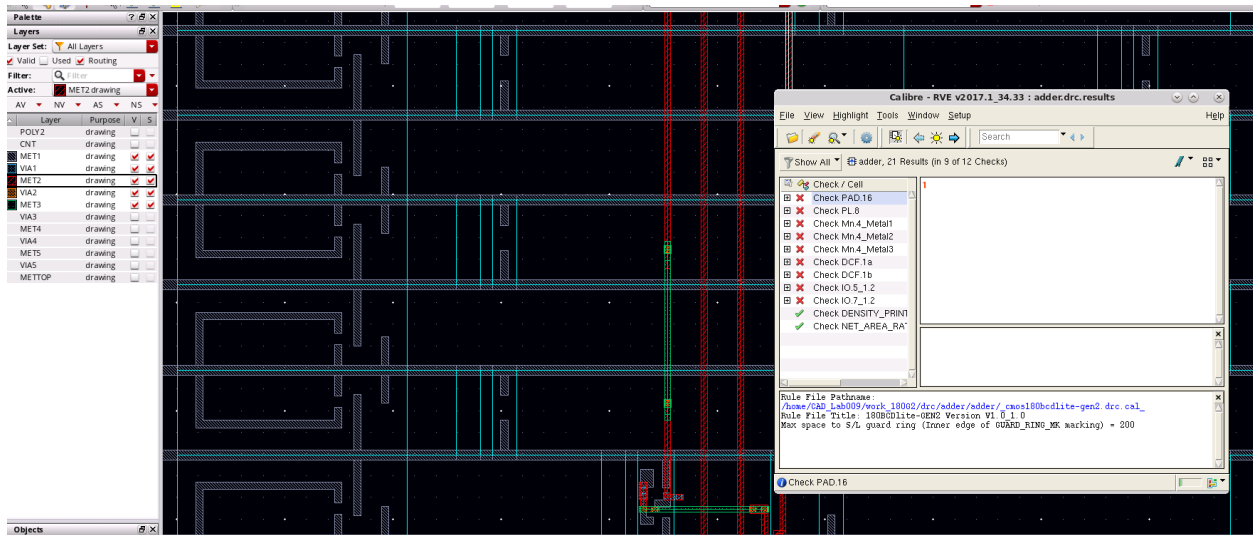
Figure 5 The immediate result

As I recall from the hands-on session, there was an ANT.3 error related to the antenna effect. In this project, I attempted to fix that issue by modifying the routing manually.

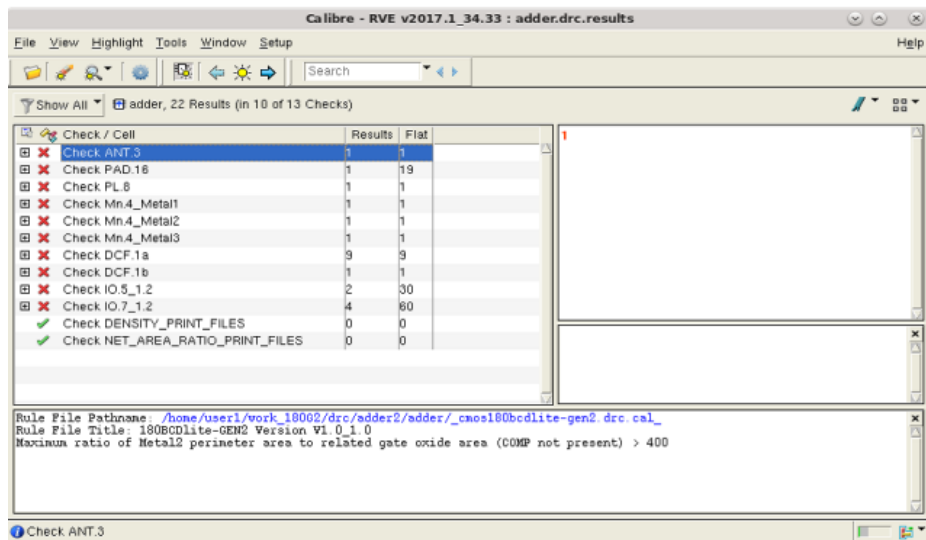
Figure 6 All errors without any fix

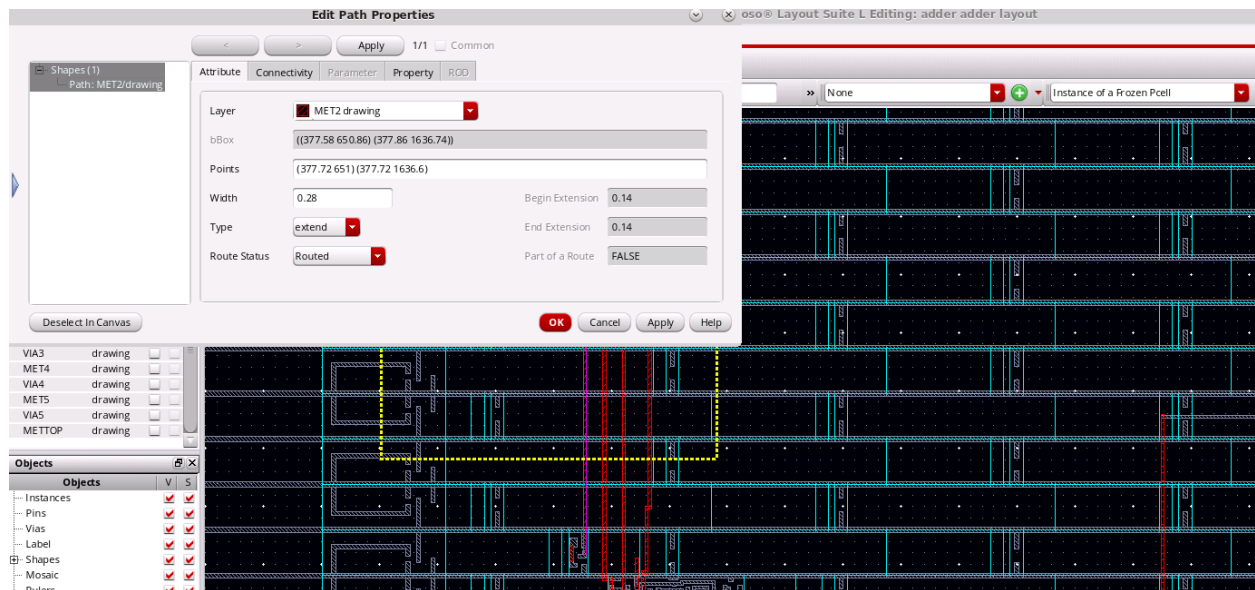
There is a long metal2 that stretches from the clock IO to a DFF standard cell as illustrated in figure 7.

Figure 7 size and the location of routing before change

So as previously explained near where metal2(red) is connected to DFF we cut it and jump to a higher layer metal3(green). Here two visa 2-3 and a small piece of metal3 used. If before reaching the io there was a higher metal, we should continue our work to reach it. In this case it suffices. For every case if reach to the highest level (in our scenario is 5) it will always solve the problem.
