Bryce Canyon (WyWinn)

EMC TEST REPORT

IN ACCORDANCE WITH THE EUROPEAN UNION'S DIRECTIVE ON EMC 2014/30/EU

ITRenew 8356 Central Ave. Newark, CA 94560 USA

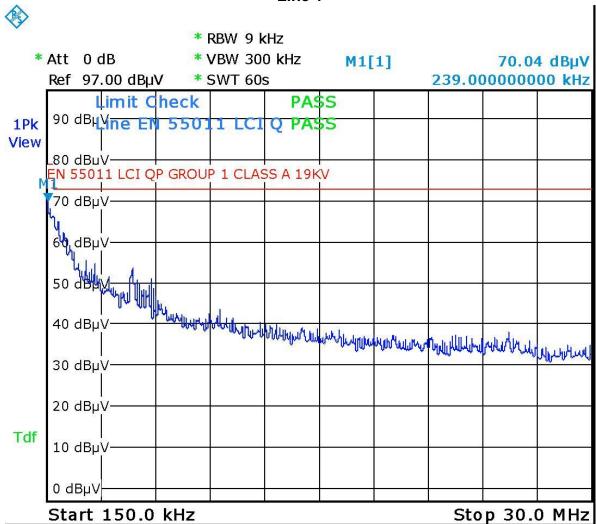
Test Results - AC Mains Input

Refer to the plots provided on the following pages – Complies with Class A limits

Freq. Range MHz	Quasi-Peak Limit dBμV	Line 1 dBμV	Line 2 dBμV	Line 3 dBμV
ļ	0.150-0.500	79	239 kHz	180 kHz	299 kHz
	0.500-30.0	73	70.04 dBμV Peak	69.22 dBμV Peak	70.85 dBμV Peak
